Docket No. UE-141335
Petitioners' Exhibit List

**Docket No. UE-141335
Puget Sound Energy, Inc.'s
Petition for Declaratory Order of King County et al.
Regarding Maloney Ridge Line**

WUTC STAFF DATA REQUEST NO. 019

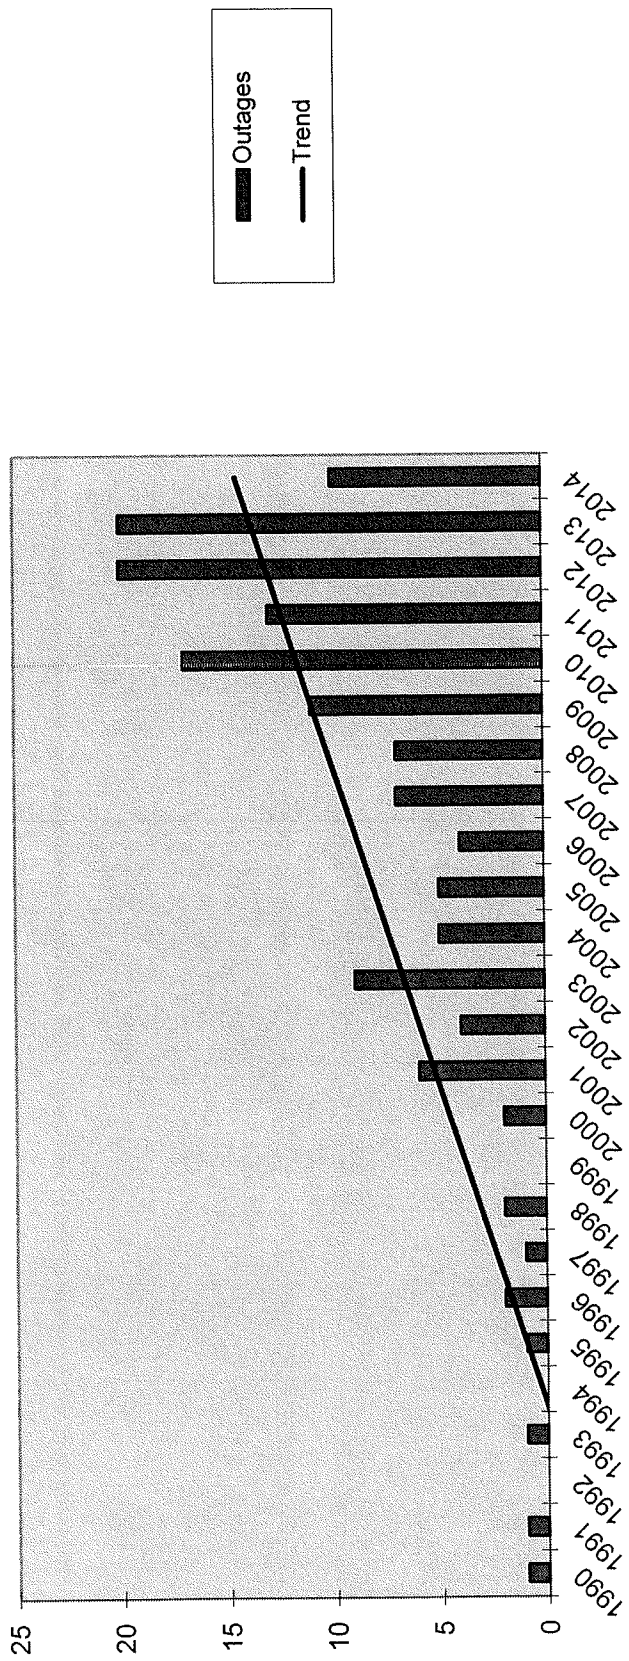
Outage History and Trend for all Cables

Outage history for all cables	
Year	Outages by year
1990	1
1991	1
1992	0
1993	1
1994	0
1995	1
1996	2
1997	1
1998	2
1999	0
2000	2
2001	6
2002	4
2003	9
2004	5
2005	5
2006	4
2007	7
2008	7
2009	11
2010	17
2011	13
2012	20
2013	20
2014	10
Total	149

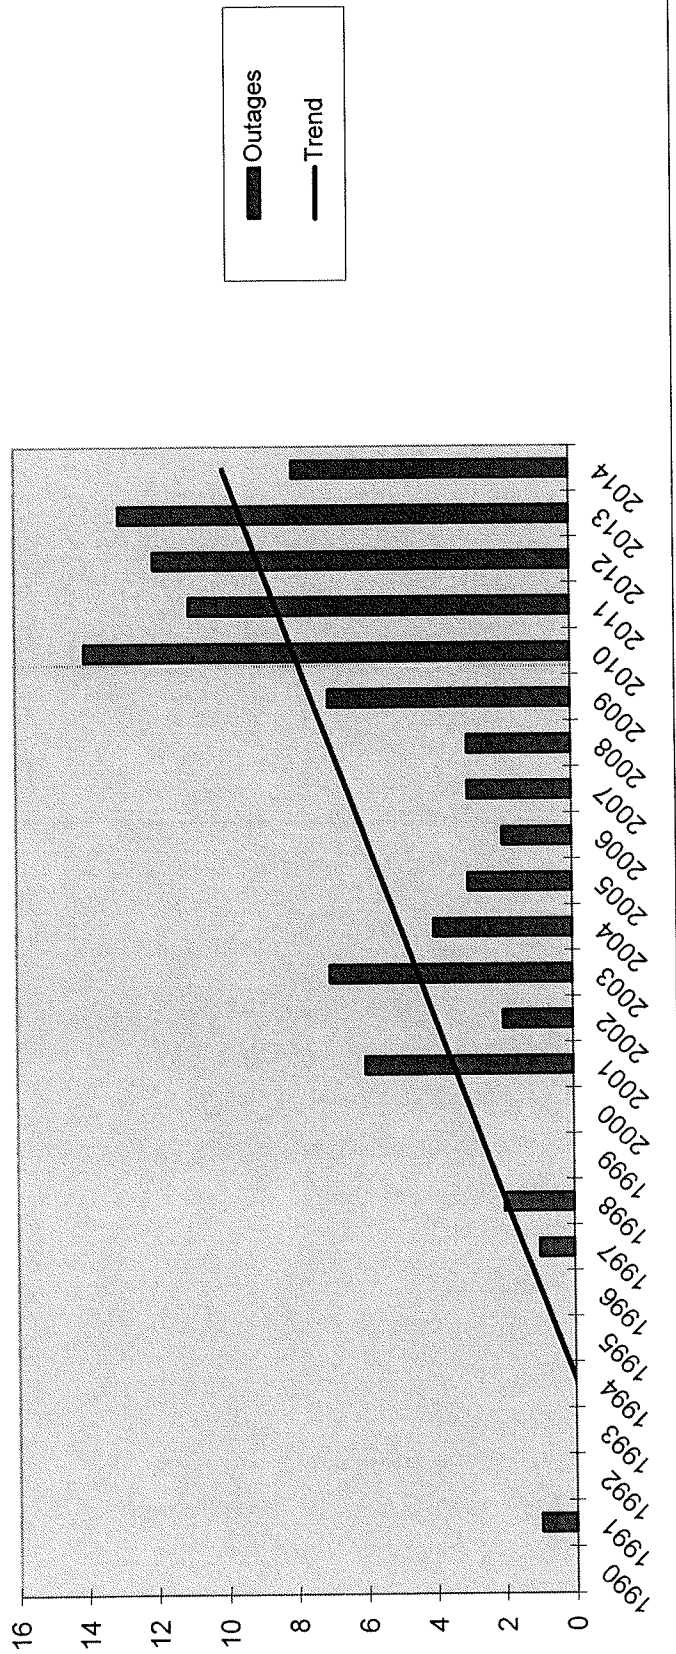
Outage History and Trend of Cables 33546, 47 & 48

Outage history for cables 33546, 47, & 48	
Year	Outages by year
1990	0
1991	1
1992	0
1993	0
1994	0
1995	0
1996	0
1997	1
1998	2
1999	0
2000	0
2001	6
2002	2
2003	7
2004	4
2005	3
2006	2
2007	3
2008	3
2009	7
2010	14
2011	11
2012	12
2013	13
2014	8
Total	99

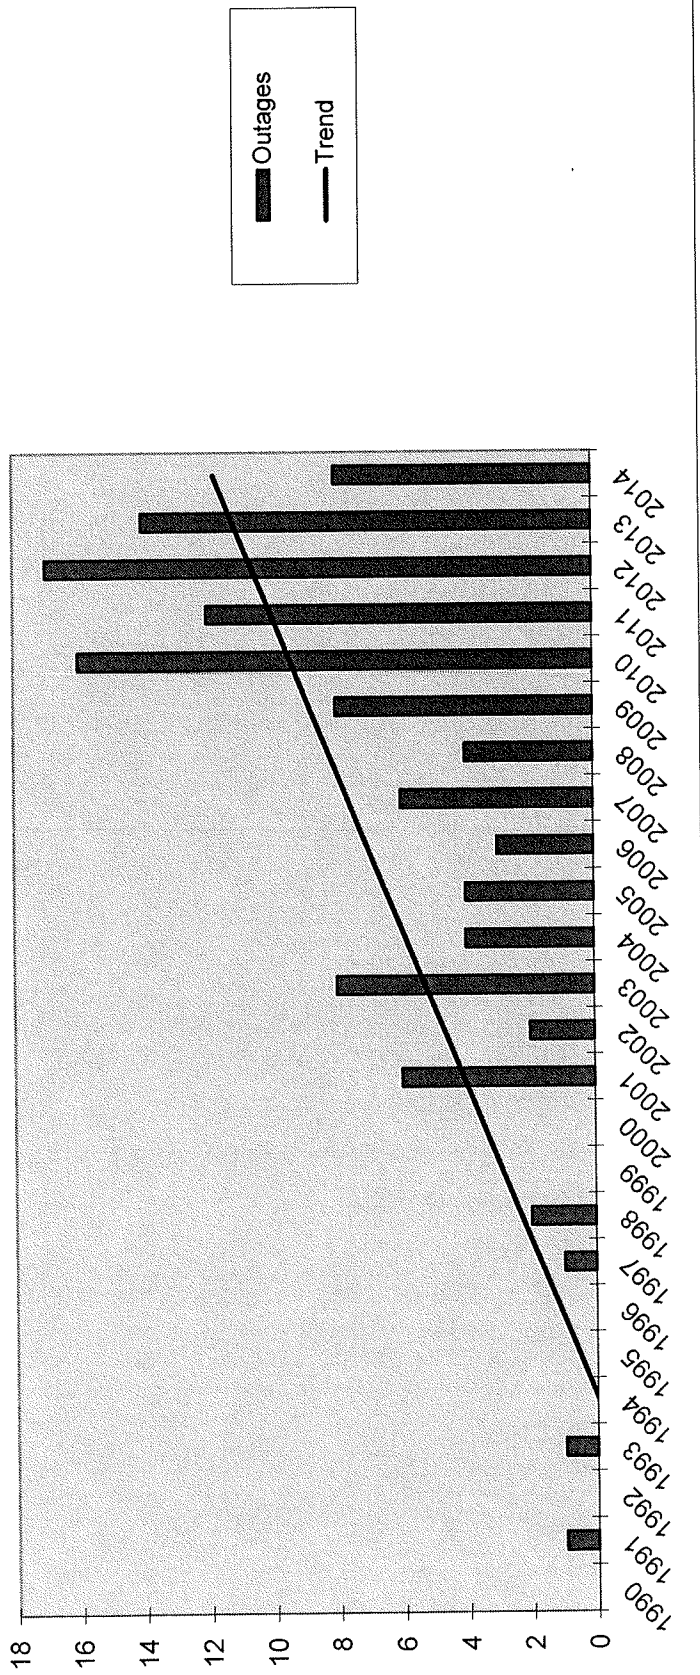
Outage History and Trend of Cables 33546, 47, 48 & 49

Outage history for cables 33546, 47, 48, & 49	
Year	Outages by year
1990	0
1991	1
1992	0
1993	1
1994	0
1995	0
1996	0
1997	1
1998	2
1999	0
2000	0
2001	6
2002	2
2003	8
2004	4
2005	4
2006	3
2007	6
2008	4
2009	8
2010	16
2011	12
2012	17
2013	14
2014	8
Total	117
