WASHINGTON UTILITIES AND TRANSPORTATION COMMISSION

Washington State Dept. of Transportation	)	DOCKET NO. TR-
_____	)	
Petitioner,	)	PETITION TO MODIFY HIGHWAY-
	)	RAIL GRADE CROSSING ACTIVE
	)	WARNING DEVICES
vs.	)	
BNSF Railway Company	)	
_____	)	
Respondent	)	USDOT #104520Y
	)	
.....	)	
	)

# WSDOT RAILROAD GRADE CROSSING DIAGNOSTIC TEAM REVIEW WORKSHEET\*

## **Section 130 Diagnostic Evaluation Meeting Summary SR 223, USDOT 104520Y**

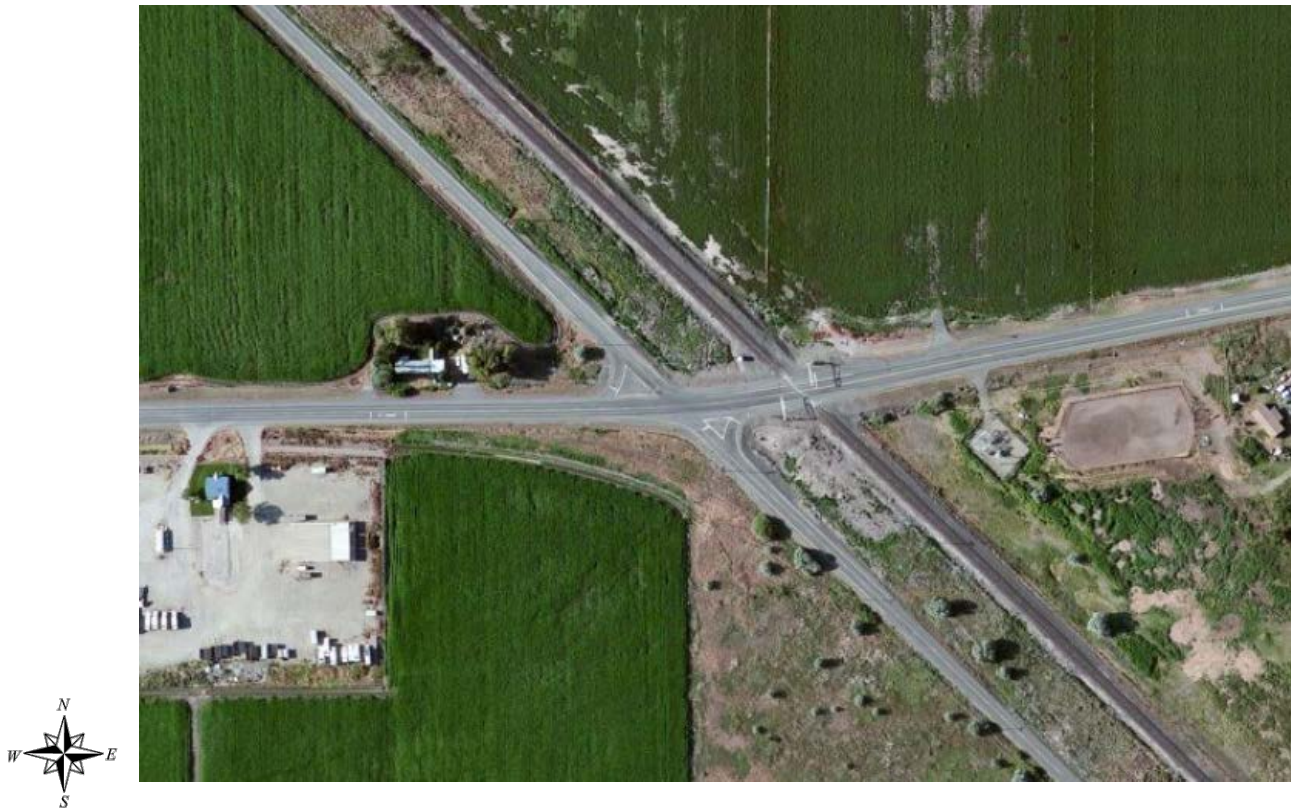
## Crossing Diagram

Approach curvature: SR 223 has an 1100' radius curve 30' west of the crossing. Crossing is in a tangent section.

Includes stop refuge in both directions. The intersection of South Track Road and SR 223 is about 150 feet west of the crossing. The intersection is not signalized.

Are there any roadway intersections in the vicinity of the crossing that may cause traffic to queue back over the tracks? Yes. Queue may form due to left turn movements at S. Track Rd

RR work: Install new four quadrant gate system with upgraded LED signals and upgrade circuitry to constant warning

WSDOT work: Install active advance warning system with intertie to RR system and install guard rail (standard plan) if not included in BNSF work
