Washington State Dept. of Transportation	) DOCKET NO. TR-
Petitioner,	<ul> <li>) PETITION TO MODIFY HIGHWAY-</li> <li>) RAIL GRADE CROSSING ACTIVE</li> <li>) WARNING DEVICES</li> </ul>
vs. BNSF Railway Company	)
Respondent	) ) USDOT #104520Y )
·····	) ) )

### WSDOT RAILROAD GRADE CROSSING DIAGNOSTIC TEAM REVIEW WORKSHEET\*

# Section 130 Diagnostic Evaluation Meeting Summary SR 223, USDOT 104520Y

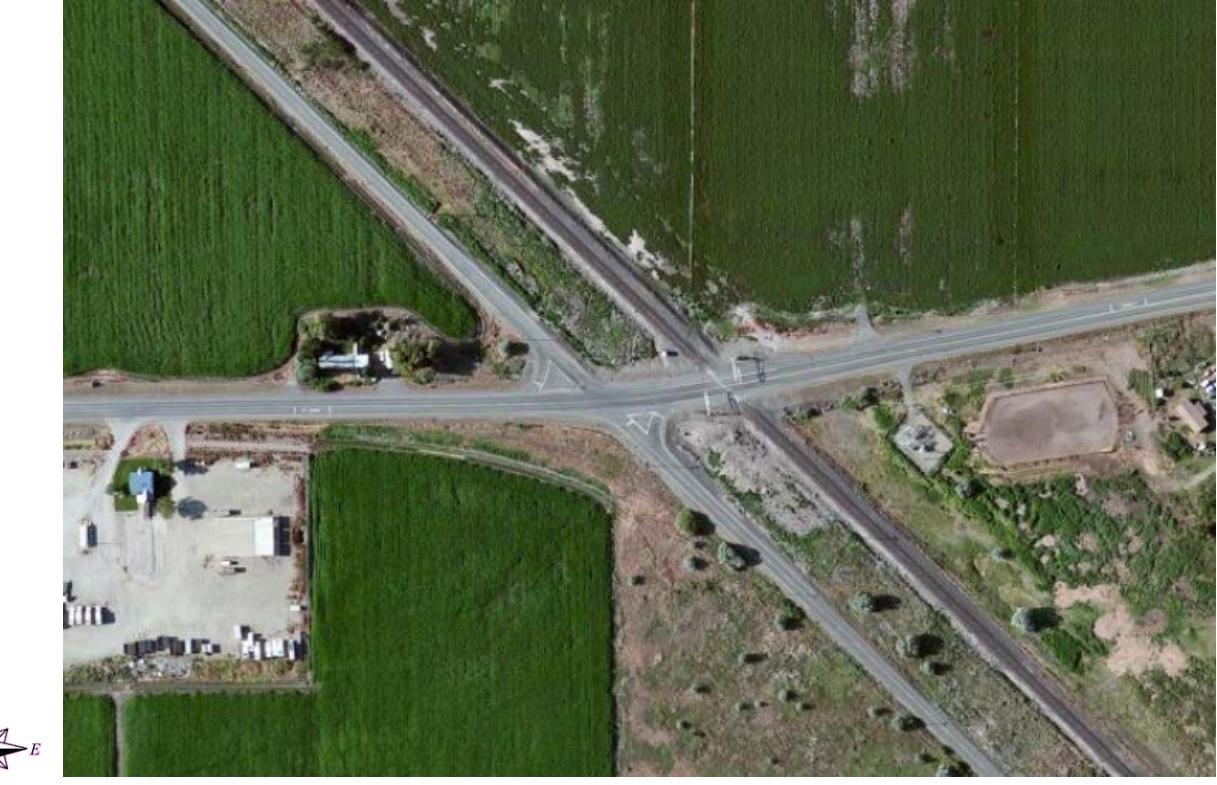
### **Crossing Diagram**

If "no" explain <u>the W10-1 sign and railroad symbol are in good condition but not placed in conjunction with</u> each other, as required by the standard plan and MUTCD\_\_\_\_\_\_

Are there any roadway intersections in the vicinity of the crossing that may cause traffic to queue back over the tracks? <u>Yes.</u> Queue may form due to left turn movements at S. Track Rd

• What is the available storage space? Approximately 175 feet

RR work: Install new four quadrant gate system with upgraded LED signals and upgrade circuitry as needed

WSDOT work: Install active advance warning system with intertie to RR system and install guard rail (standard plan) if not included in BNSF work
