RE: TR-171142 – Petition on Behalf of WSDOT to Modify Active Warning Devices at SR-223 in Toppenish – Response due Dec. 11, 2017

WSDOT RAILROAD GRADE CROSSING DIAGNOSTIC TEAM REVIEW WORKSHEET*

Location: SR 223 Mile Post 0.51 WSDOT Region - SCR

Railroad: BNSF Railway USDOT No.: 104520Y

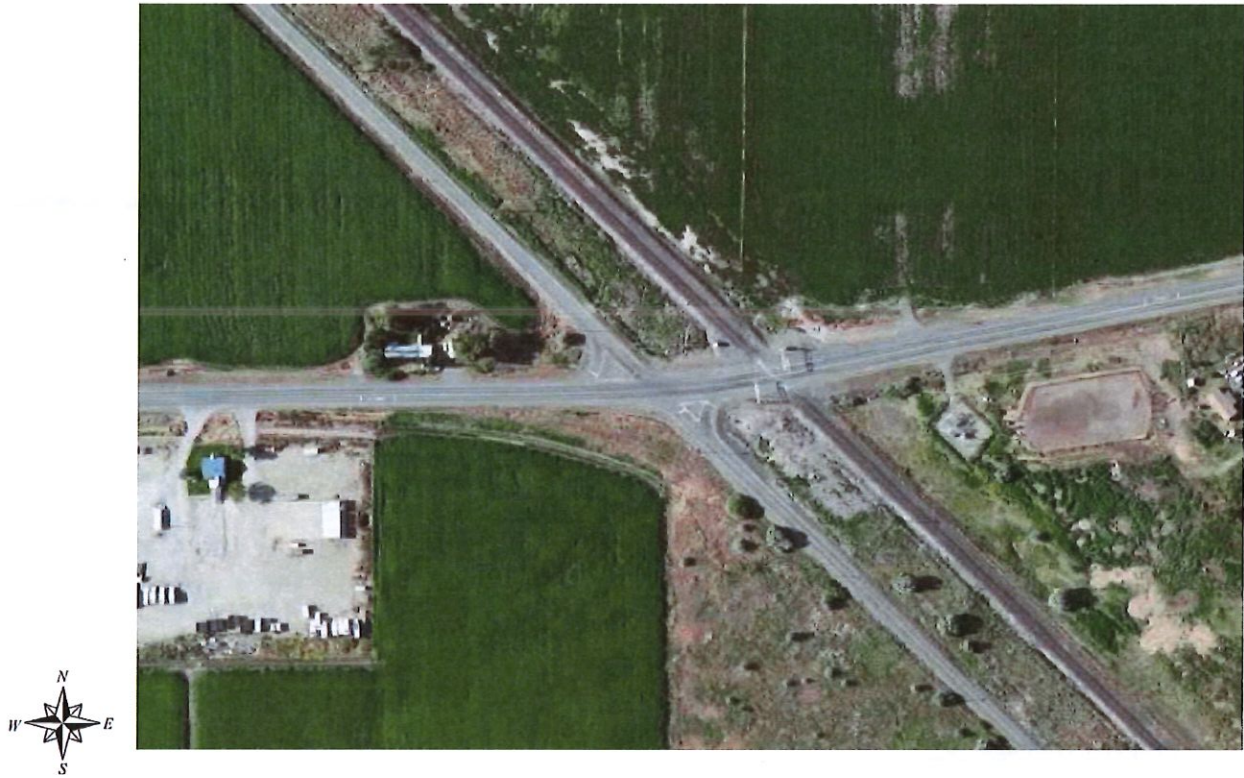
Crossing Diagram

Includes stop refuge in both directions. The intersection of South Track Road and SR 223 is about 150 feet west of the crossing. The intersection is not signalized.

If "no" explain the W10-1 sign and railroad symbol are in good condition but not placed in conjunction with each other, as required by the standard plan and MUTCD

Are there any roadway intersections in the vicinity of the crossing that may cause traffic to queue back over the tracks? Yes. Queue may form due to left turn movements at S. Track Rd

- What is the available storage space? Approximately 175 feet

RR work: Install new four quadrant gate system with upgraded LED signals and upgrade circuitry to constant warning

WSDOT work: Install active advance warning system with intertie to RR system and install guard rail (standard plan) if not included in BNSF work
