GEOTECHNICAL REPORT FOUNDATION FAILURE MODES REPORT Upper Baker Dam CONCRETE, WASHINGTON

December 22, 2022 Shannon & Wilson No: 105102-033 **SHANNON & WILSON**

Upper Baker Dam Geotechnical Report Foundation Failure Modes Report

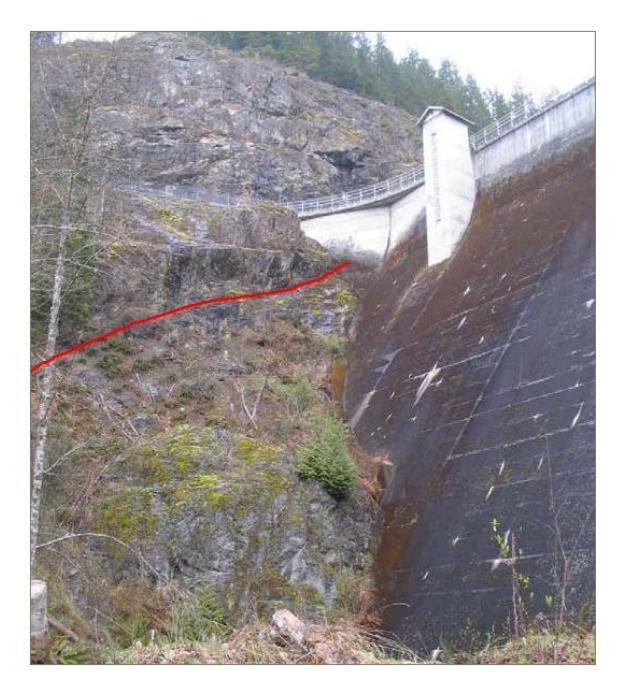
Exhibit 10-1: View of Right Abutment and Approximate Trace of Fault A (shown in red)

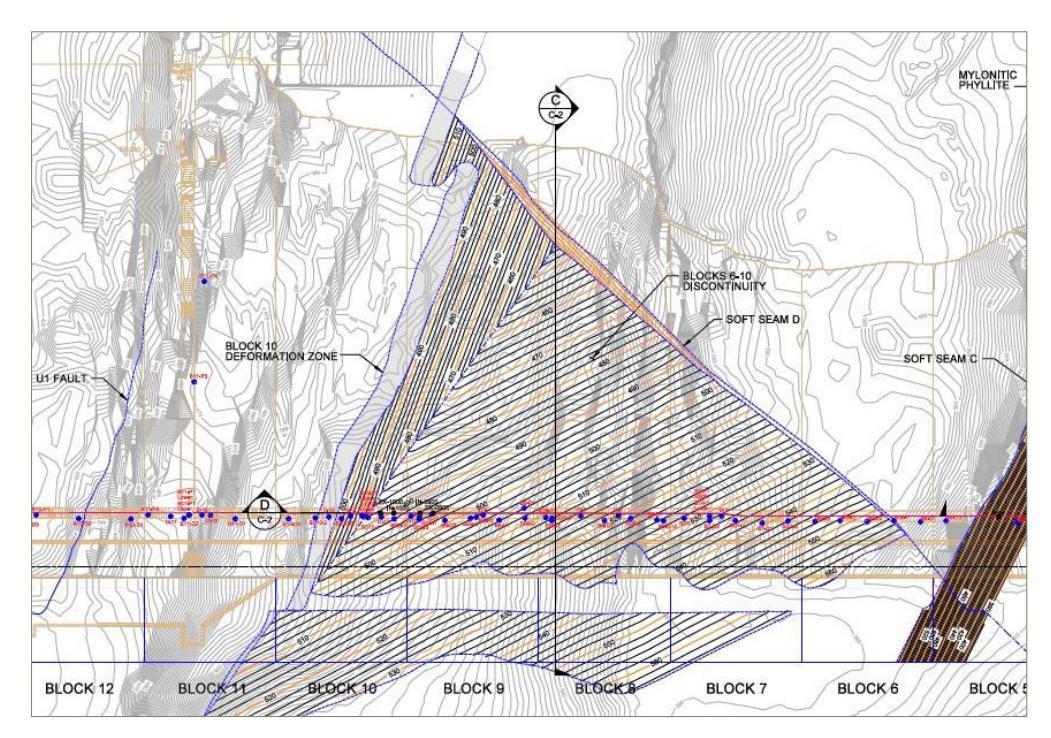
Exhibit 10-5: Plan View Showing Soft Seam D, Block 10 Deformation Zone, and the Block 6-10 Discontinuity

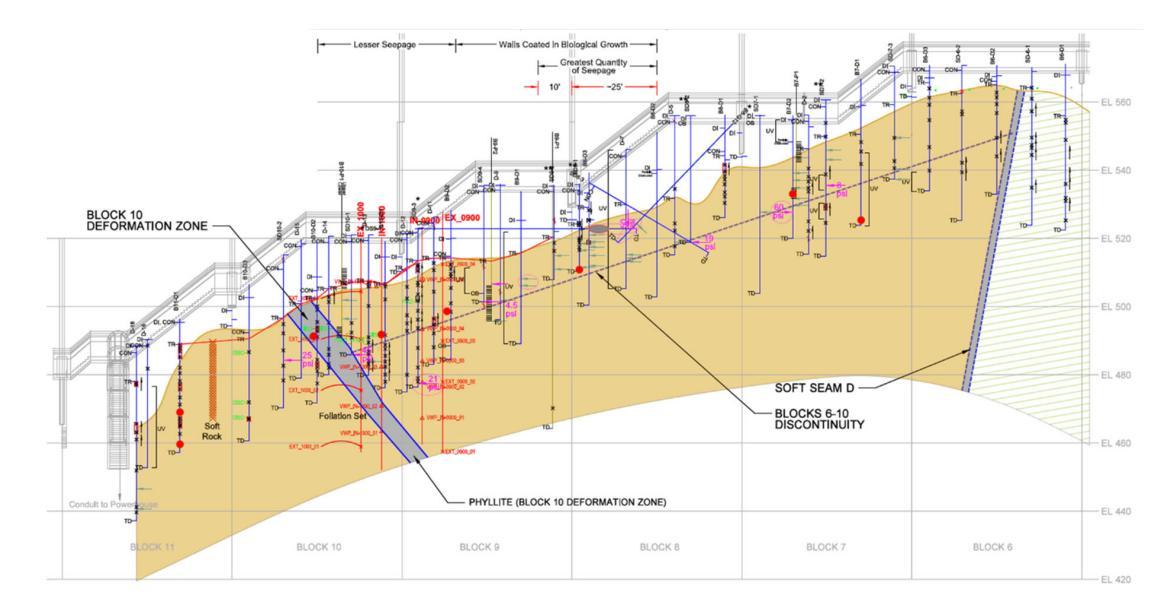
# Exhibit 10-6: Section Showing Soft Seam D, Block 10 Deformation Zone, and the Block 6-10 Discontinuity

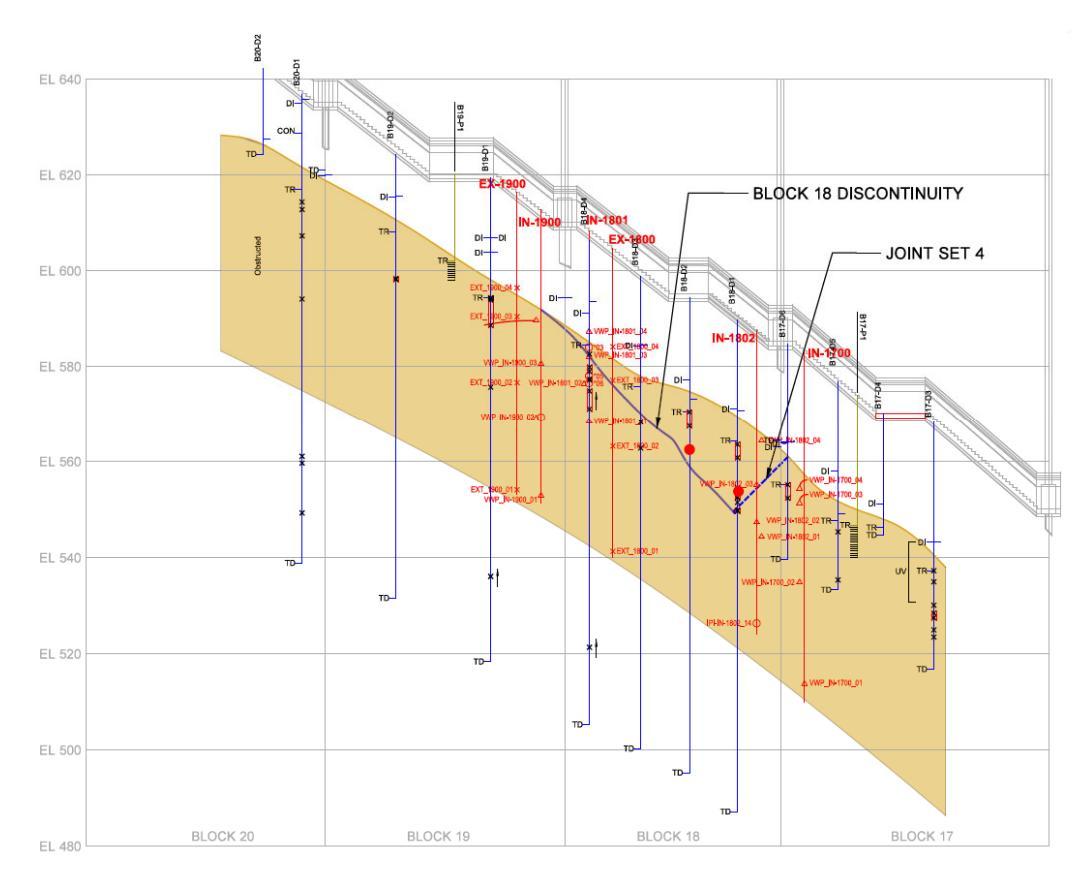
Exhibit 10-10: Cross Section Along Gallery of Monolith 18 Showing Inferred Slide Plane and Features Observed in Drain Review; Red Dots Indicate Observed Offsets in Drains

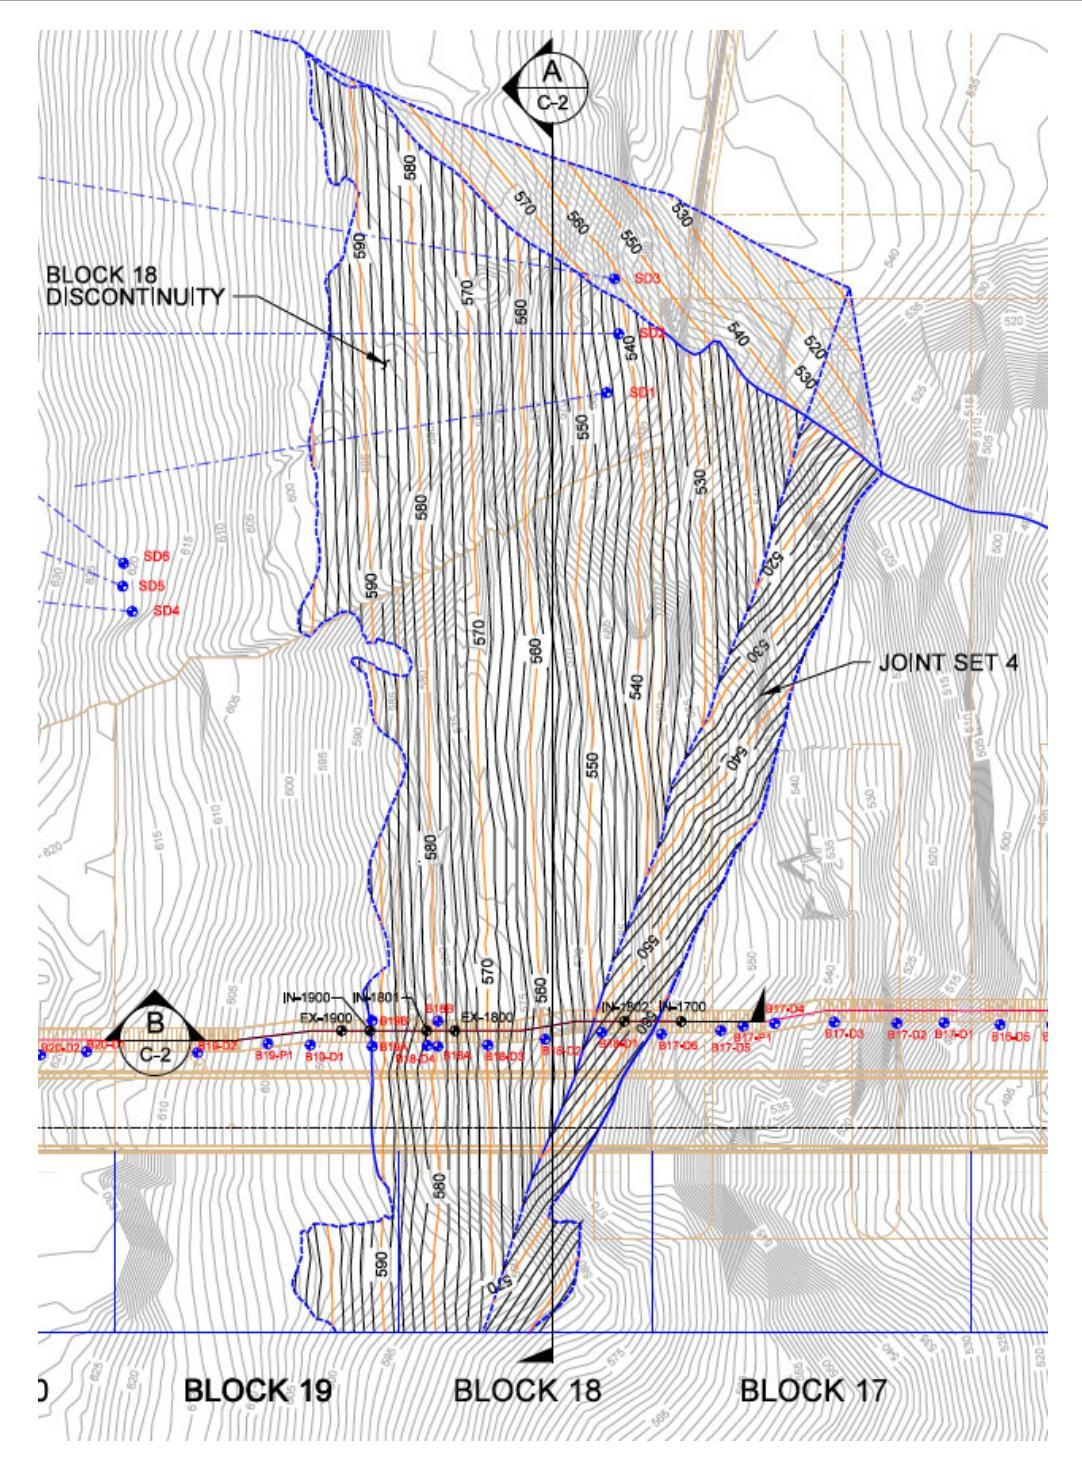
Exhibit 10-11: Plan View of Extent of Inferred Rock Wedge under Monolith 18; Green Lines are Topographic Expression of Foliation Slip Surface; Purple Lines Represent the Side-Release Plane Along J4

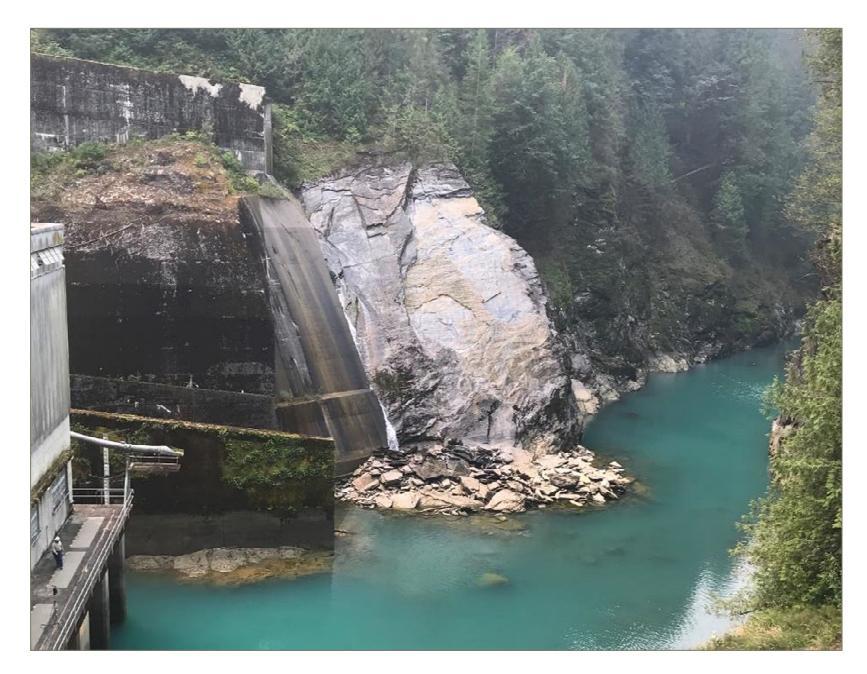
Exhibit 10-58: Photo of Slope Downstream of the Spillway with Rock Pile at Base of Slope

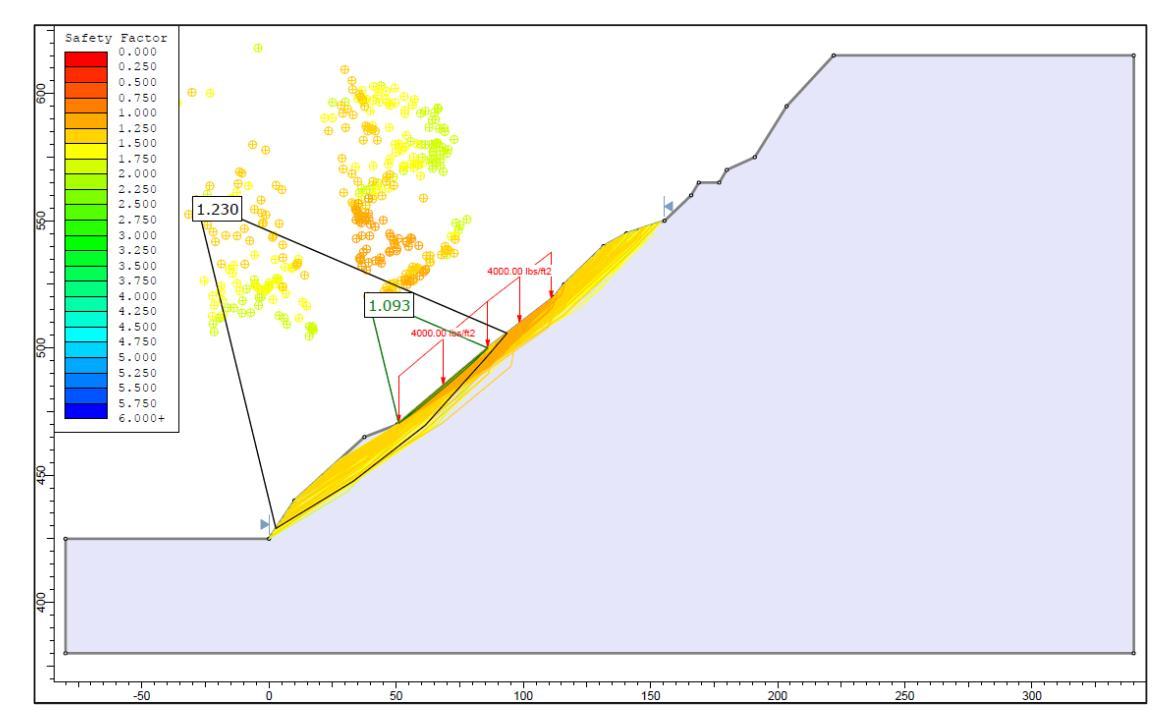
Exhibit 10-59: Existing Conditions with Hydraulic Loading Analysis

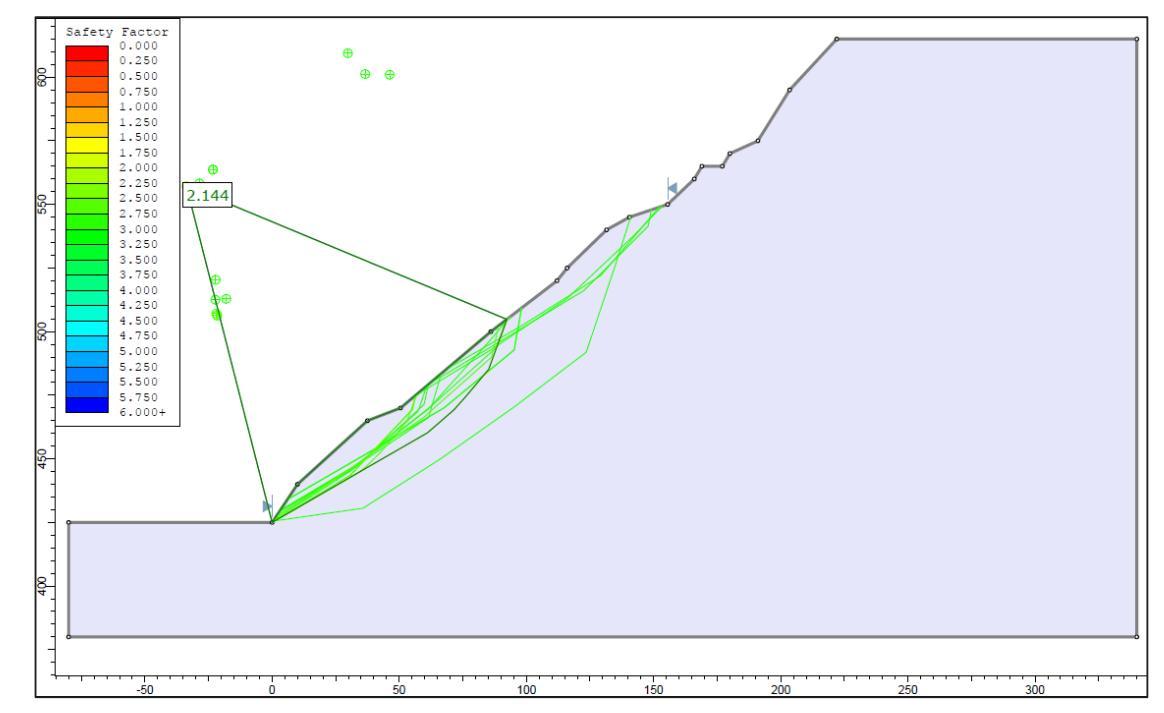
Exhibit 10-60: Existing Conditions without Hydraulic Loading Analysis

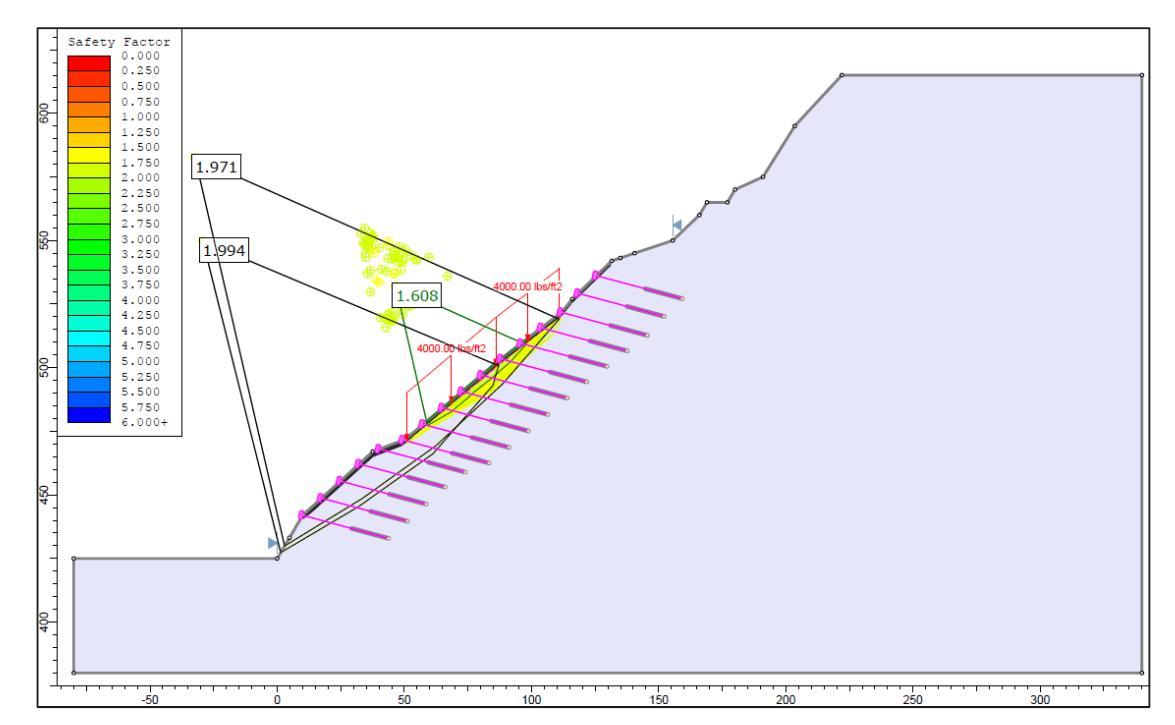
Exhibit 10-61: Static Support Case Analysis
