Appendix I

RE: Puget Sound Energy- Ingham Fire
SEAL Job No. 21151.

I have reviewed the photographs of the gas pipe lines with "holes" from the following addresses in Seattle, Washington:

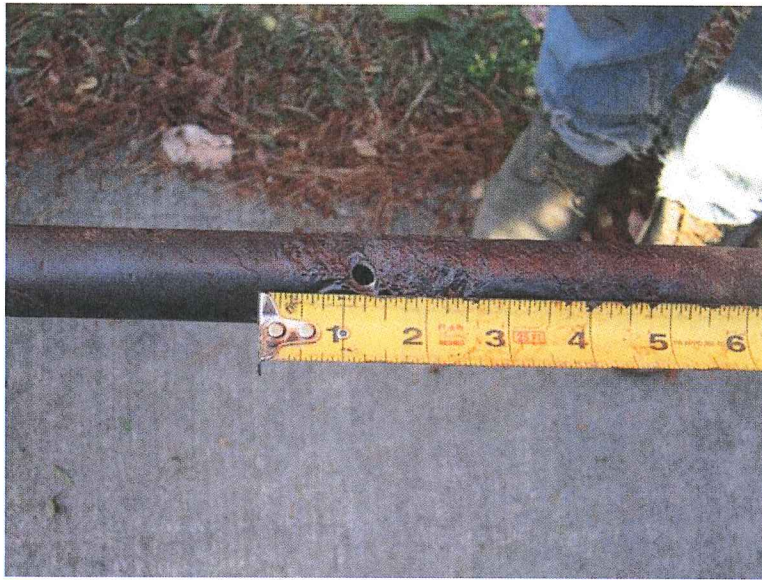
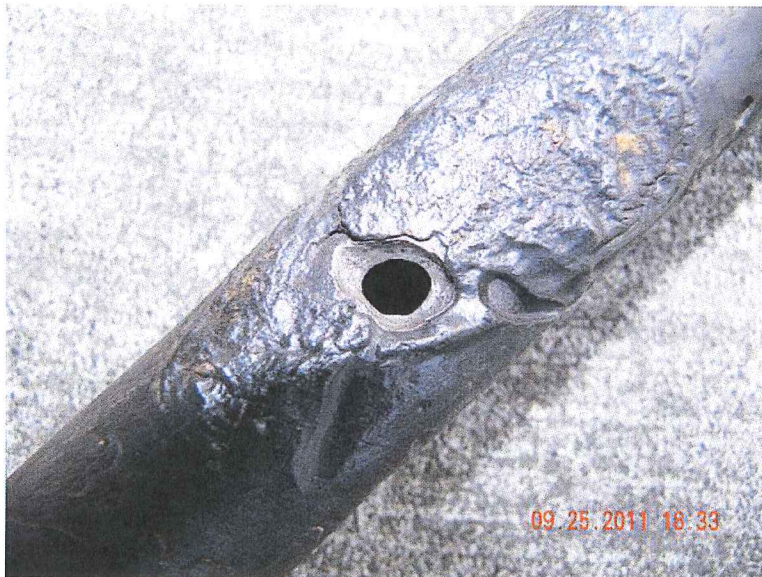
Figure 1. Color photographs showing the "hole" in the gas pipe line from 12040 Ave NE.

1. 12040 Avenue NE (gas line crossing oil vent line); Figure 1
2. 913 NE Street (gas line crossing water service line); Figure 2
3. 1020 NE Street (gas line crossing abandoned water pipe); Figure 3
4. 12312 Avenue NE (gas line crossing sewer service); Figure 4.

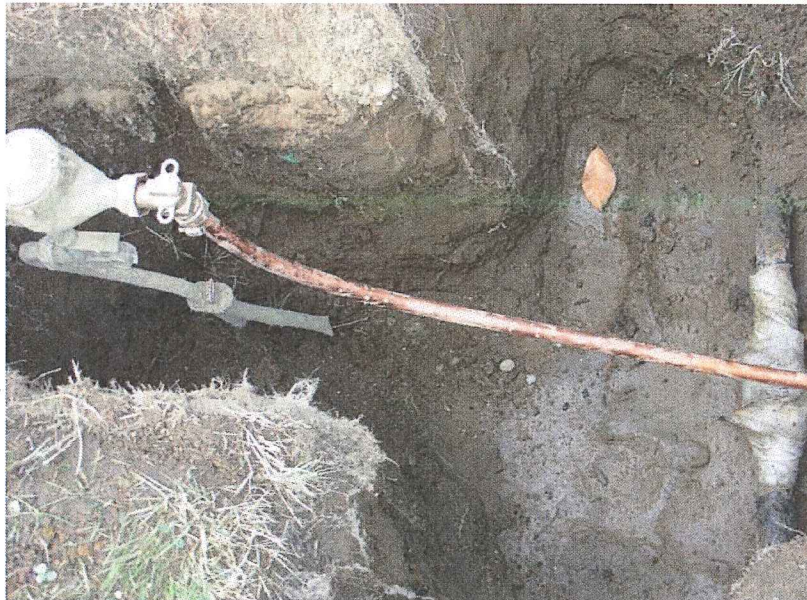
Figure 2. A color photograph showing the wrapped gas pipe line (right) from 913 NE Street containing a "hole".

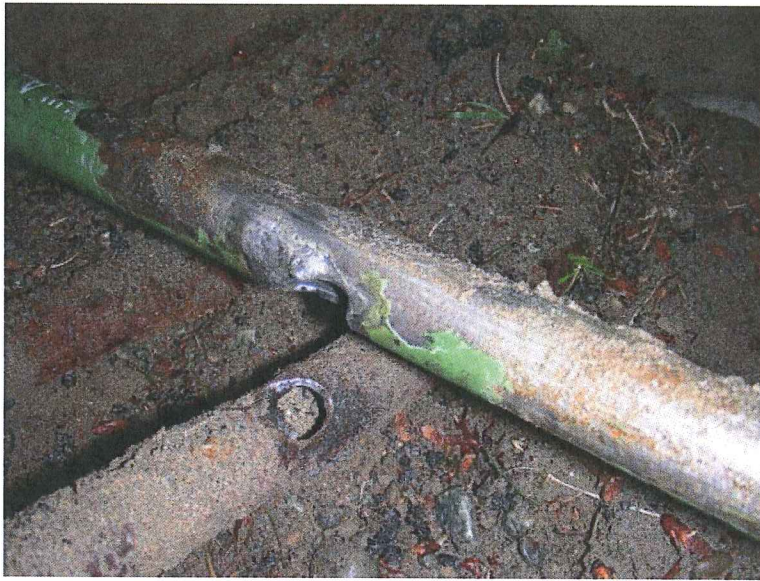
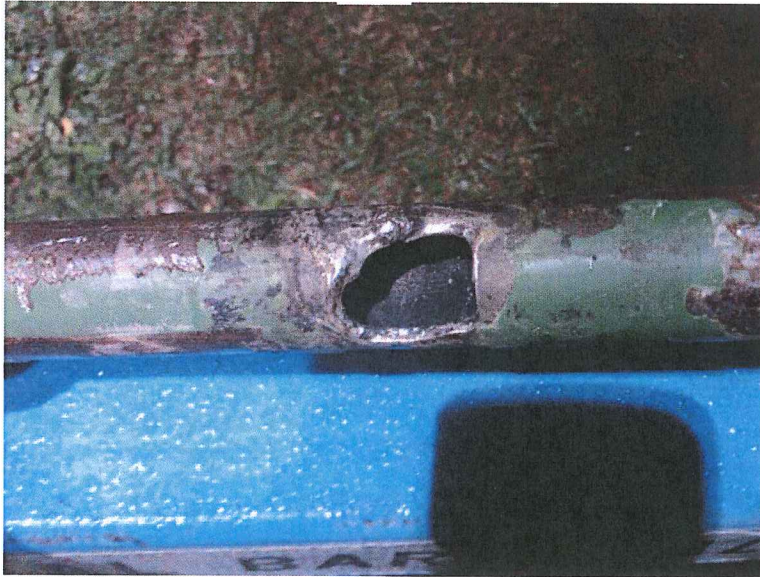
Figure 3. Color photographs showing the “hole” in the gas pipe line from 1020 NE Street.

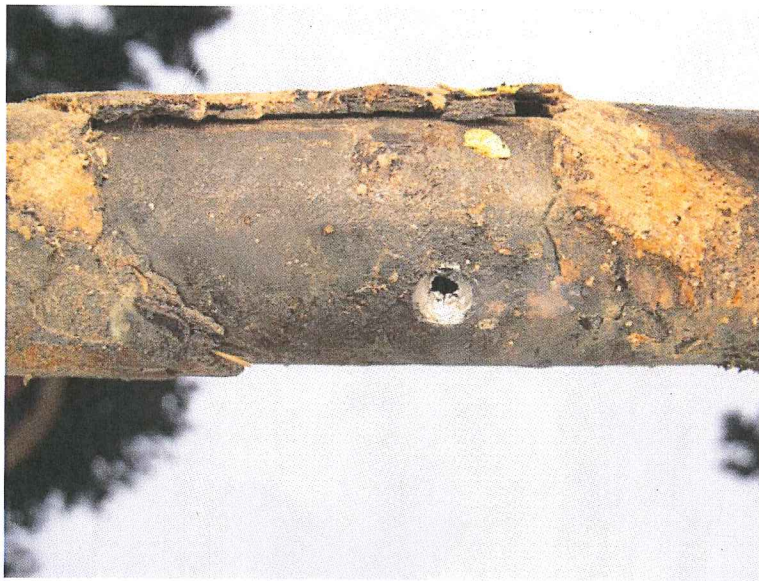
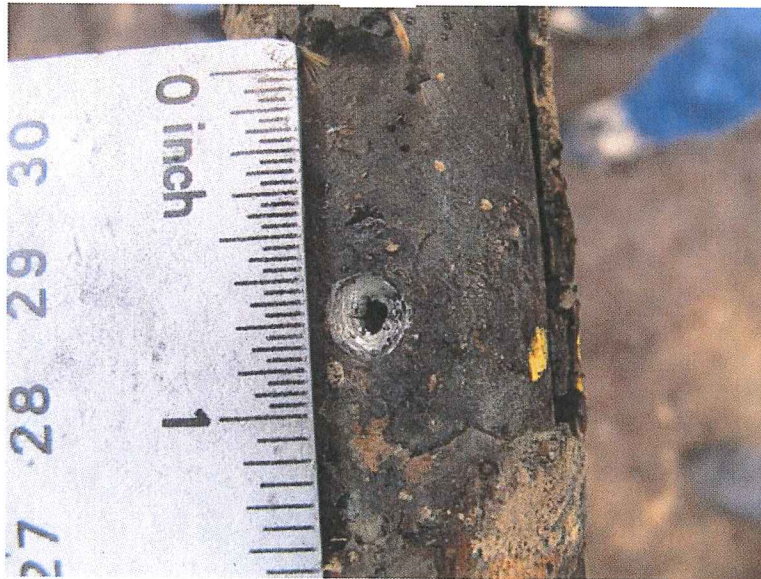
Figure 4. Color photographs showing the “hole” in the gas pipe line from 12312 Ave NE.
