Re: August 2020 Monthly Progress Report
Administrative Settlement Agreement and Order on Consent for Removal Action
EPA Region 10 Docket No. CERCLA 10-2009-0255
Gasco Sediments Site within the Portland Harbor Superfund Site

Attachment A Monthly Visual Monitoring Report for Pilot Cap Vicinity

Visual Observations Log Form

Project: NW Natural – Gasco

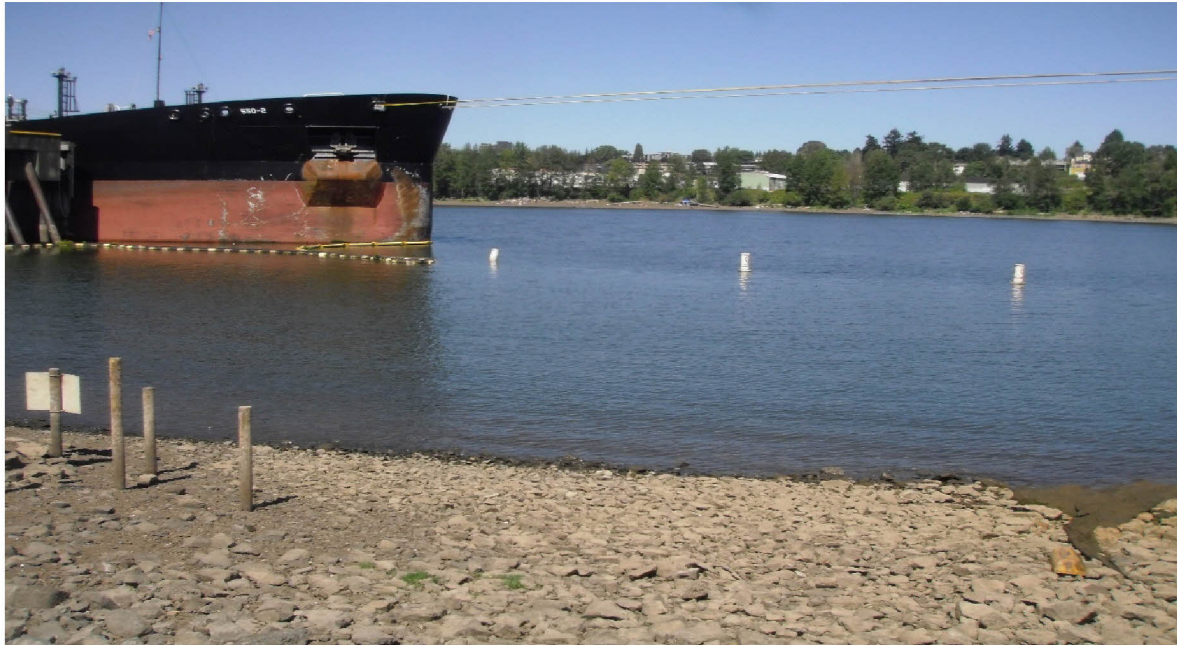
During the observation, a barge was moored at the dock, and the PacTerm containment boom was placed around the barge. The three buoys identifying the cap area to mariners were in place as installed. The positions of the PacTerm oil boom and warning buoys are shown in Photo 1.

Photo 1
PacTerm Oil Boom Placement Around the Barge with Three Mariner Warning Buoys at Pilot Cap Area (8/17/2020)

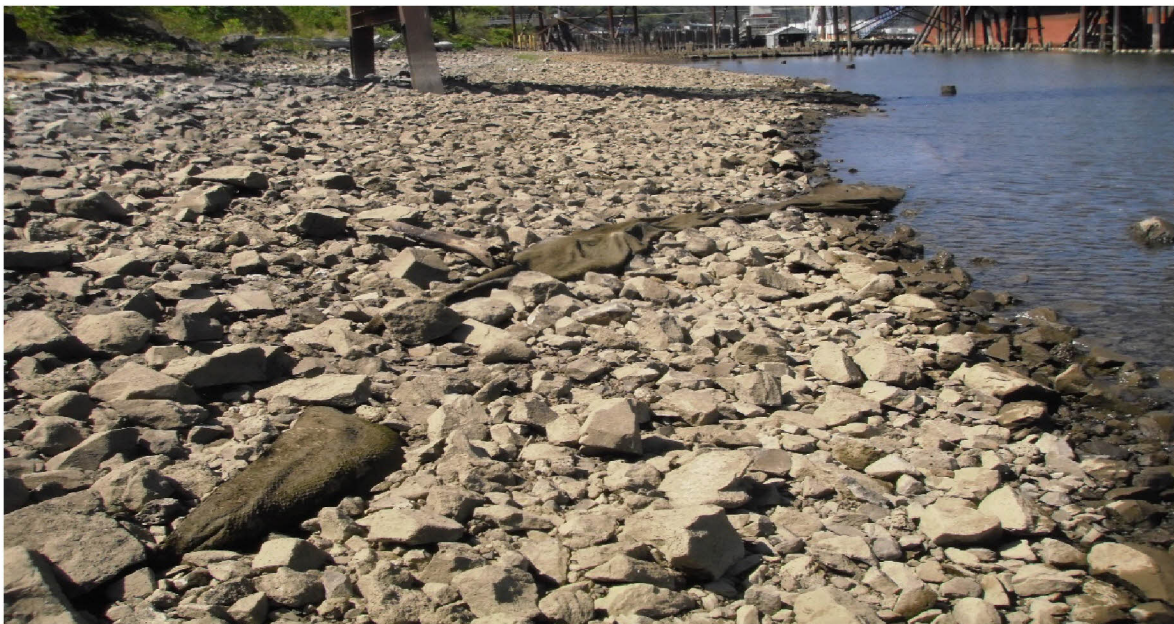
Exposed organoclay mat material segments are visible. A segment 6 feet in length is exposed approximately 8 feet from the water's edge near the lateral mid-point of the cap area. A 12-foot section is exposed perpendicular to the shoreline at the upriver boundary of the cap area. A section of organoclay mat material measuring 40 feet in length is exposed along the shoreline, partially submerged (Photo 2). The exposed segments of mat were in visually good condition.

Photo 2
Exposed Organoclay Mat Material Along the Shoreline of the Cap (8/17/2020)

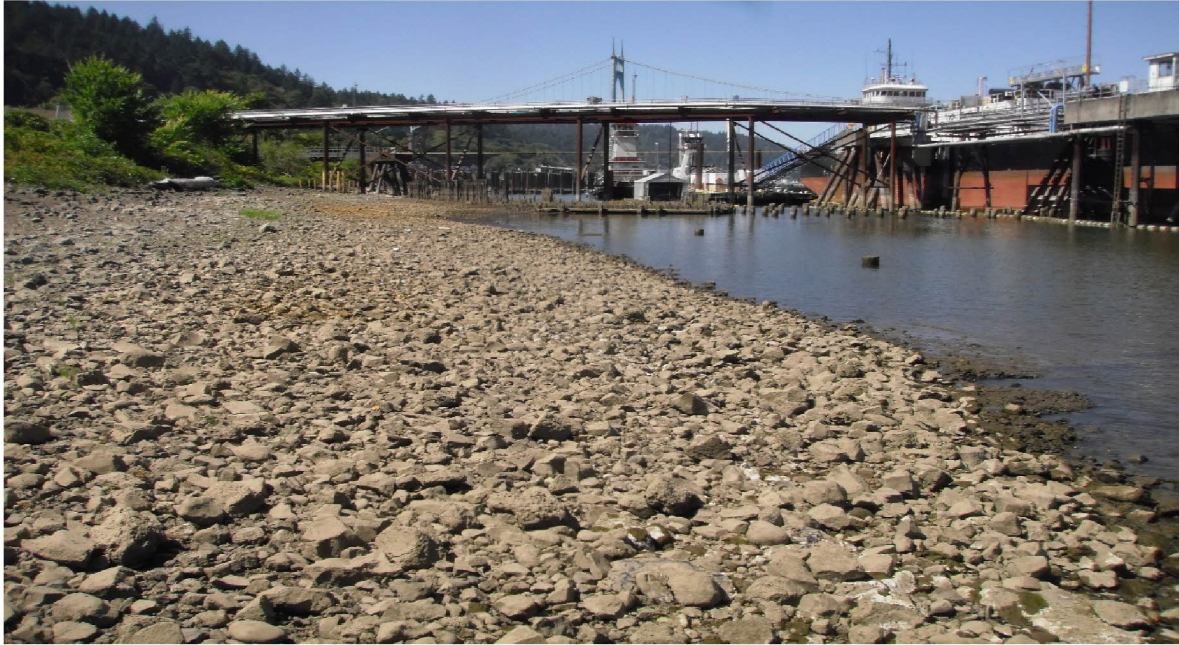
No sheen was observed. Photo 3 shows the water surface and shoreline immediately downriver of the sediment cap.

Photo 3
Conditions Immediately Downriver of Cap Area (8/17/2020)
