Re: September 2020 Monthly Progress Report
Administrative Settlement Agreement and Order on Consent for Removal Action
EPA Region 10 Docket No. CERCLA 10-2009-0255
Gasco Sediments Site within the Portland Harbor Superfund Site

Attachment A Monthly Visual Monitoring Report for Pilot Cap Vicinity

Visual Observations Log Form

Project: NW Natural – Gasco

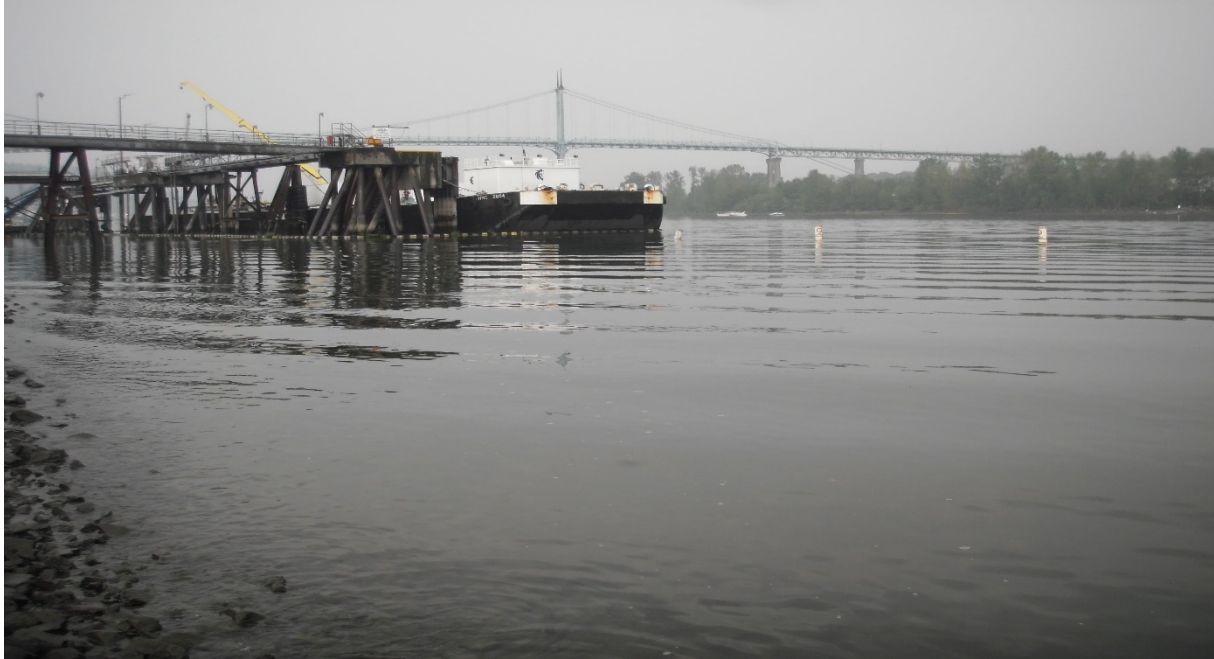
Photo 1
PacTerm Oil Boom Placement Around the Barge with Three Mariner Warning Buoys at Pilot Cap Area (9/18/2020)

During the observation, a barge was moored at the dock, and the PacTerm containment boom was placed around the barge. The three buoys identifying the cap area to mariners were in place as installed. The positions of the PacTerm oil boom and warning buoys are shown in Photo 1.

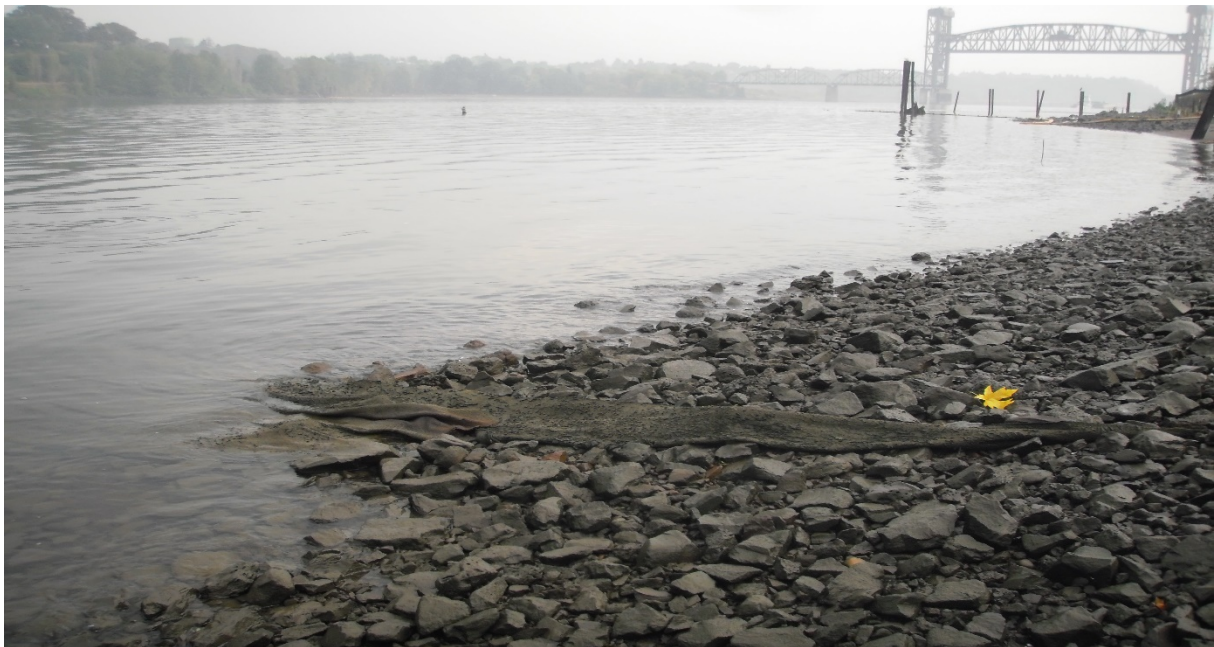
Photo 2
Exposed Organoclay Mat Material at the Upriver End of the Cap (9/18/2020)

All exposed organoclay mat material segments are visible. A segment 6 feet in length is exposed and is 3 feet from the water's edge near the lateral mid-point of the cap area. Eight feet of the 15-foot section is exposed perpendicular to the shoreline at the upriver boundary of the cap area (Photo 2). A section of organoclay mat material measuring 40 feet in length is exposed along the shoreline with about two-thirds in and one-third out of the water. The exposed segments of mat were in visually good condition.

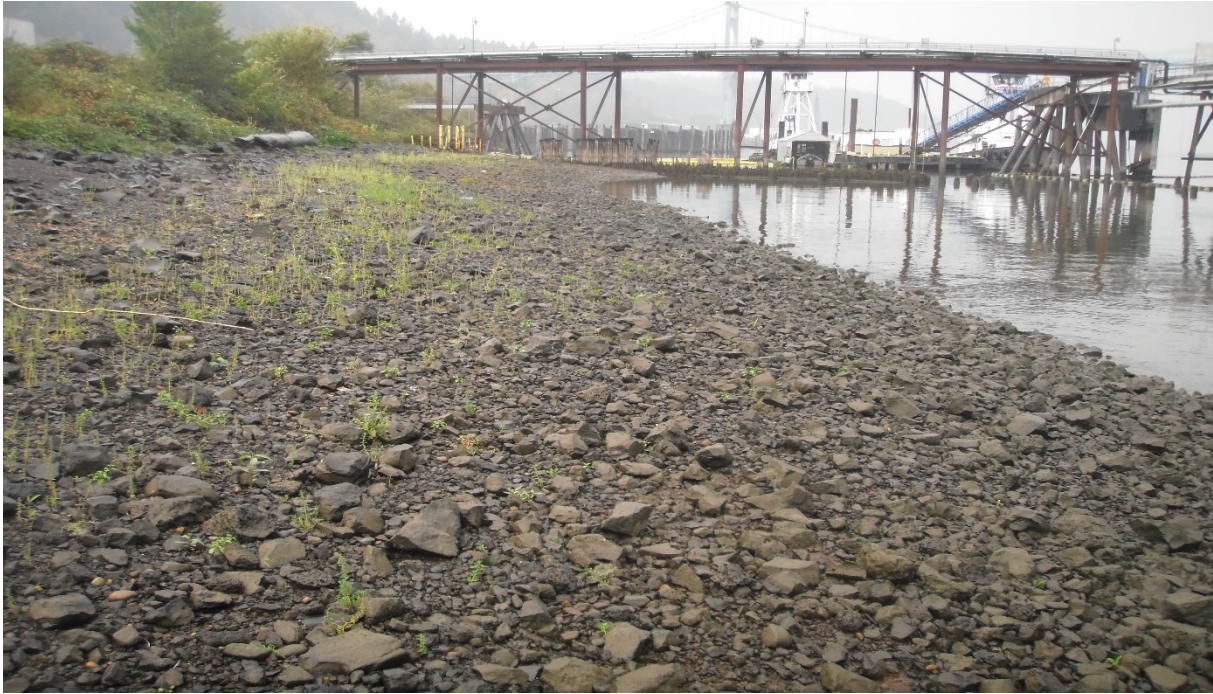
Photo 3
Conditions Immediately Downriver of Cap Area Looking Upriver (9/18/2020)

No erosion was evident along the shoreline.

No sheen was observed. Photo 3 shows the water surface and shoreline immediately downriver of the sediment cap.
