Re: October 2020 Monthly Progress Report
Administrative Settlement Agreement and Order on Consent for Removal Action
EPA Region 10 Docket No. CERCLA 10-2009-0255
Gasco Sediments Site within the Portland Harbor Superfund Site

Attachment A Monthly Visual Monitoring Report for Pilot Cap Vicinity

Project: NW Natural – Gasco

Monitoring Period: Monthly (Year 14)—October 2020

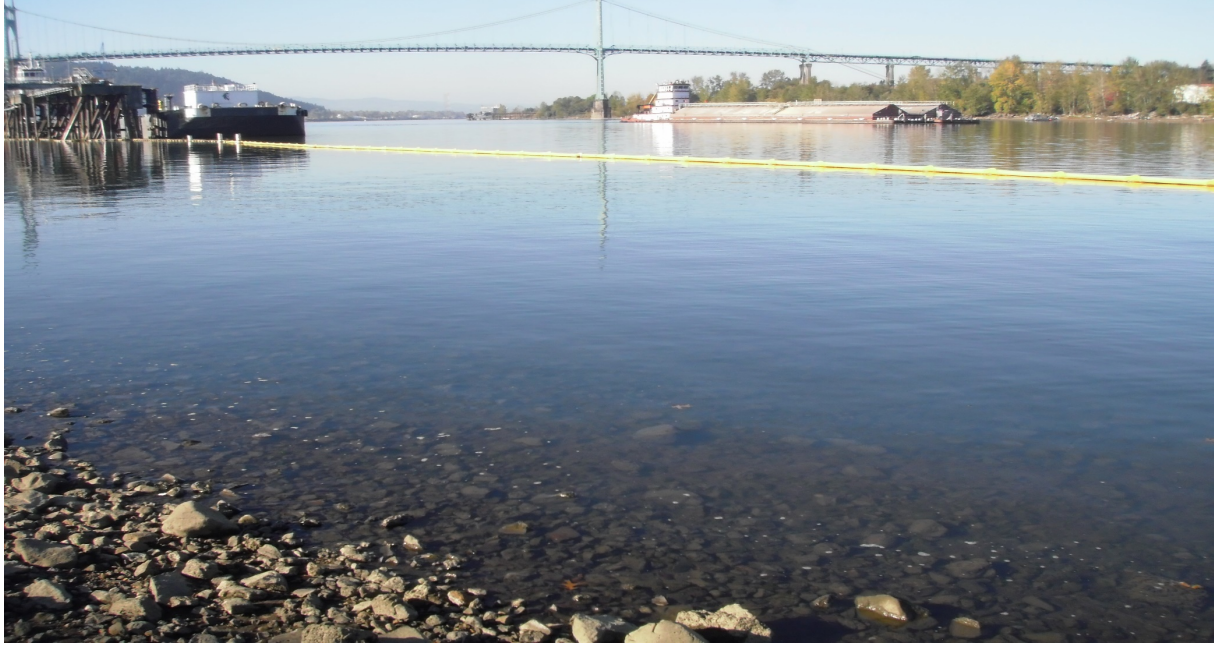
During the observation, a barge was moored at the ship dock, but the PacTerm containment boom was in place from dock to dolphin. The three buoys identifying the cap area to mariners were in place as installed. The positions of the PacTerm oil boom and warning buoys are shown in Photo 1.

Photo 1
PacTerm Oil Boom Placement from Dock to Dolphin with Three Mariner Warning Buoys at Pilot Cap Area (10/29/2020)

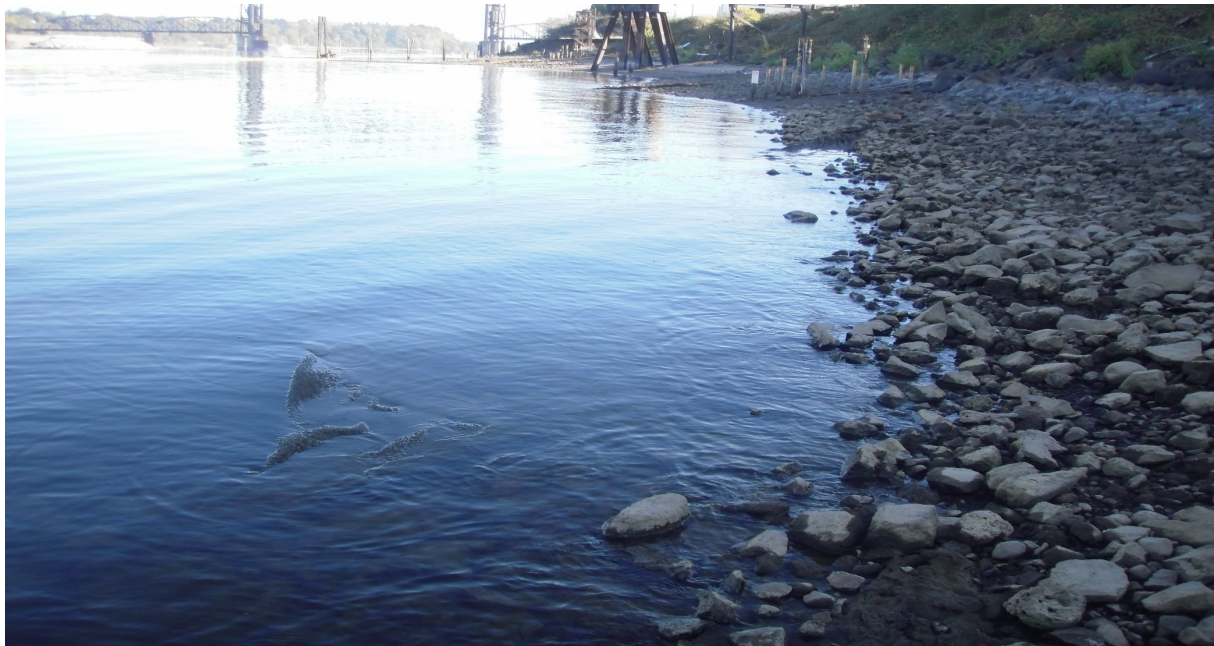
All exposed organoclay mat material segments are visible. A segment 6 feet in length is exposed and is 3 feet from the water's edge near the lateral mid-point of the cap area. 8 feet of a 15-foot section is exposed perpendicular to the shoreline at the upriver boundary of the cap area (Photo 2). A section of organoclay mat material measuring 40 feet in length is exposed along the cap area shoreline with about two-thirds of the width in the water and one-third out of the water. The exposed segments of mat were in visually good condition.

Photo 2
Exposed Organoclay Mat Material at the Downriver End of the Cap (10/29/2020)

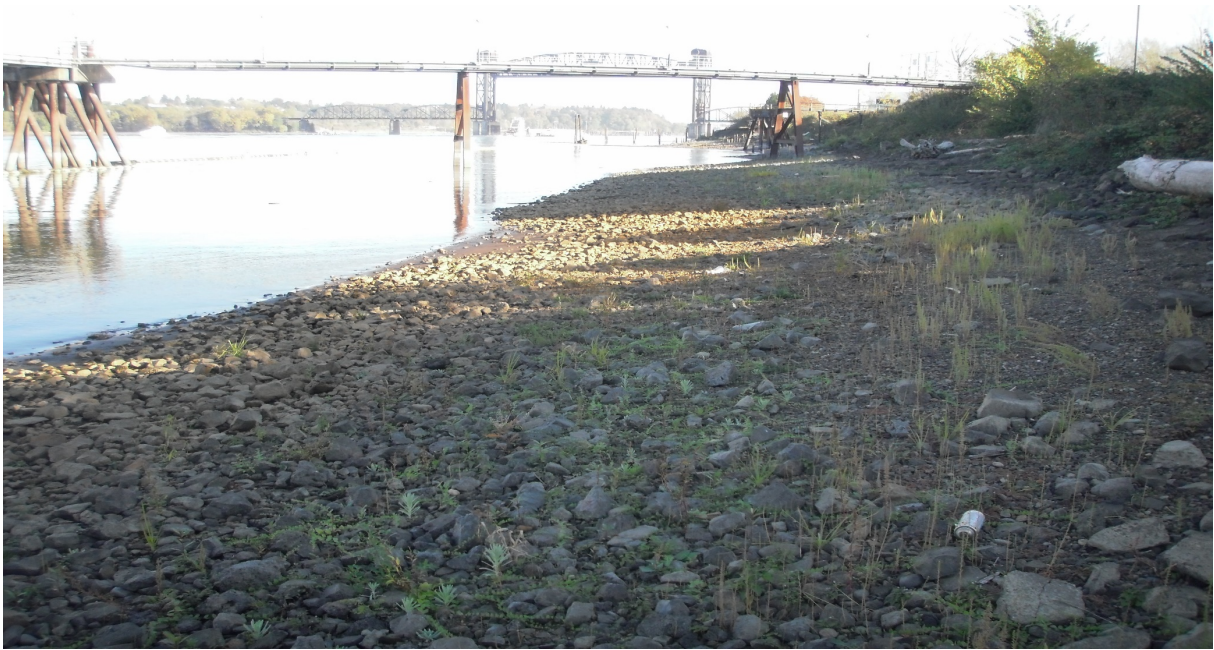
No sheen was observed. Photo 3 shows the water surface and shoreline immediately downriver of the sediment cap.

Photo 3
Conditions Immediately Downriver of Cap Area Looking Upriver (10/29/2020)
