Re: November 2020 Monthly Progress Report  
Administrative Settlement Agreement and Order on Consent for Removal Action  
EPA Region 10 Docket No. CERCLA 10-2009-0255  
Gasco Sediments Site within the Portland Harbor Superfund Site

Attachment A Monthly Visual Monitoring Report for Pilot Cap Vicinity

# Visual Observations Log Form

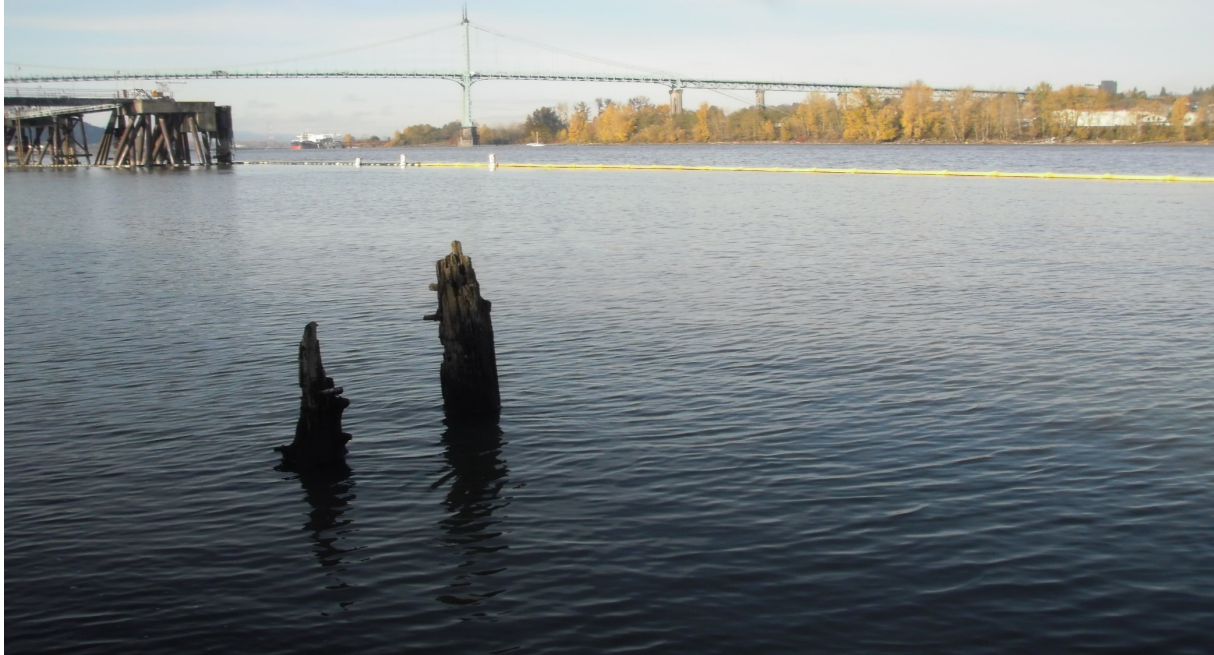
During the observation, the PacTerm containment boom was placed, as normal, from dock to dolphin. The three buoys identifying the cap area to mariners were in place as installed. The positions of the PacTerm oil boom and warning buoys are shown in Photo 1.

**Photo 1**  
**PacTerm Oil Boom Placement from Dock to Dolphin with Three Mariner Warning Buoys at Pilot Cap Area (11/20/2020)**

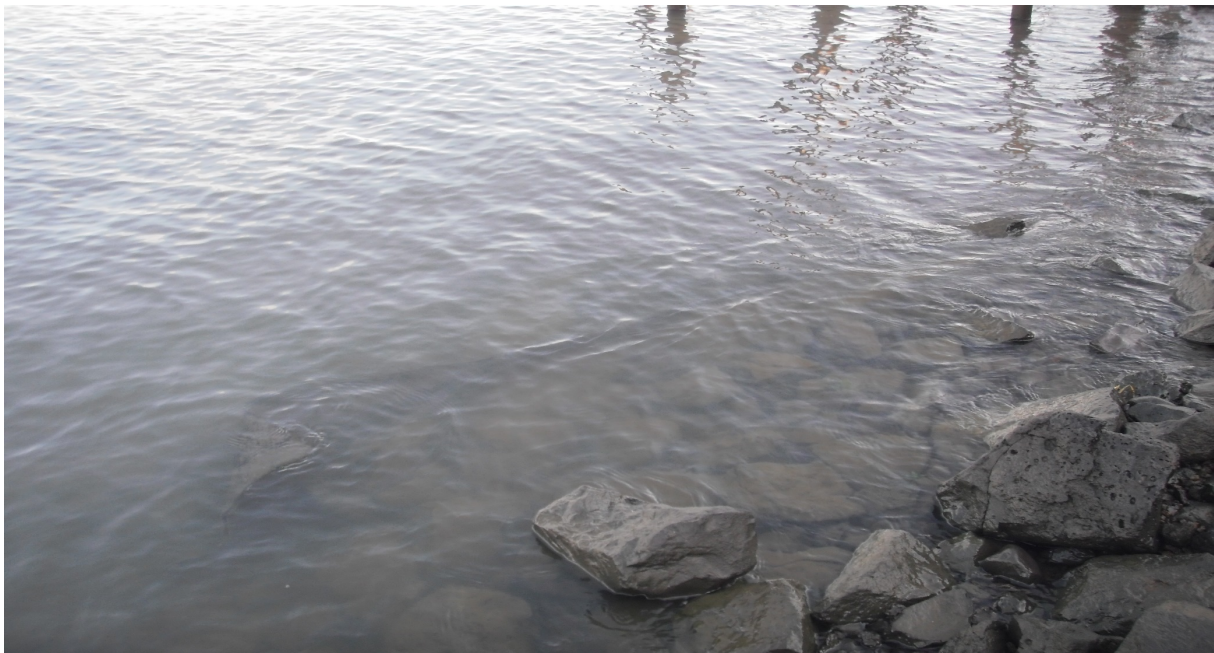
A 6-foot segment of organoclay mat at the lateral midpoint of the cap was submerged but visible 1 to 3 feet from the water's edge (Photo 2) and appears to be in visually good condition. The remainder of the organoclay mat material footprint was not visible due to high river elevations.

**Photo 2**  
**Exposed Organoclay Mat Material at the Mid-Point of the Cap (11/20/2020)**

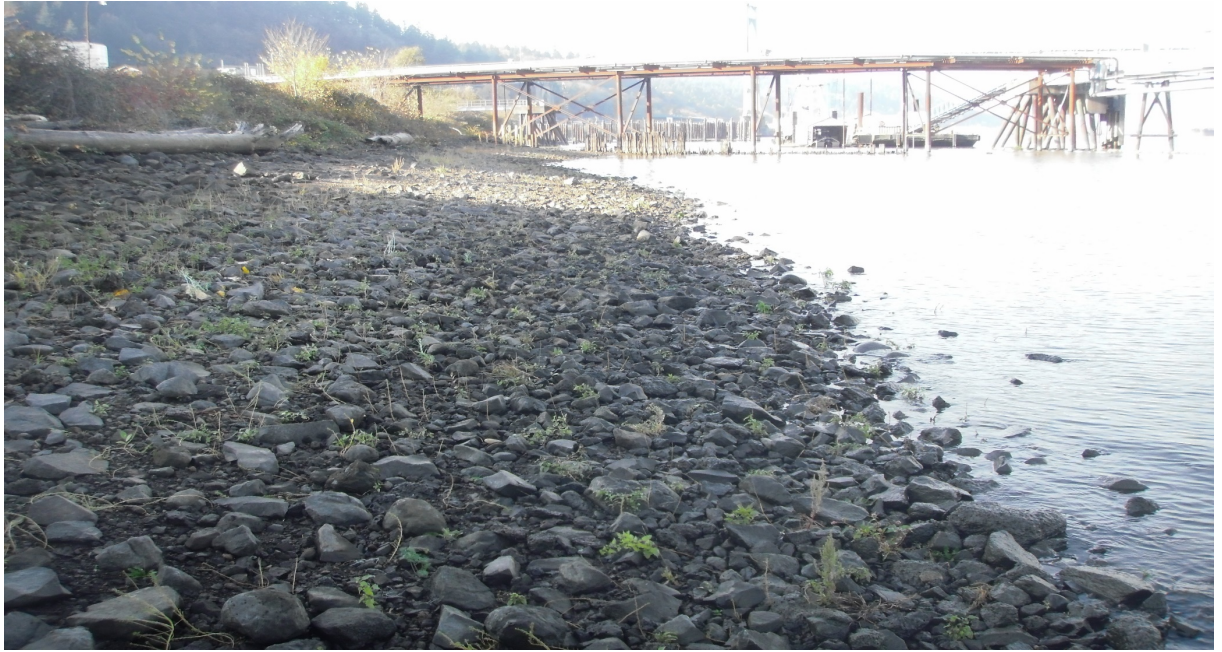
No sheen was observed in the vicinity of the pilot cap. Photo 3 shows the water surface and shoreline immediately downriver of the sediment cap.

**Photo 3**  
**Conditions Immediately Downriver of Cap Area Looking Upriver (11/20/2020)**
