ECSI No. 1138
October 26, 2023
Former Portland Gas Manufacturing Site

Year 3 Monitoring Report: PGM Long-Term Monitoring and Maintenance

Prepared for NW Natural

Prepared by
Anchor QEA, LLC
6720 South Macadam Avenue, Suite 300
Portland, Oregon 97219

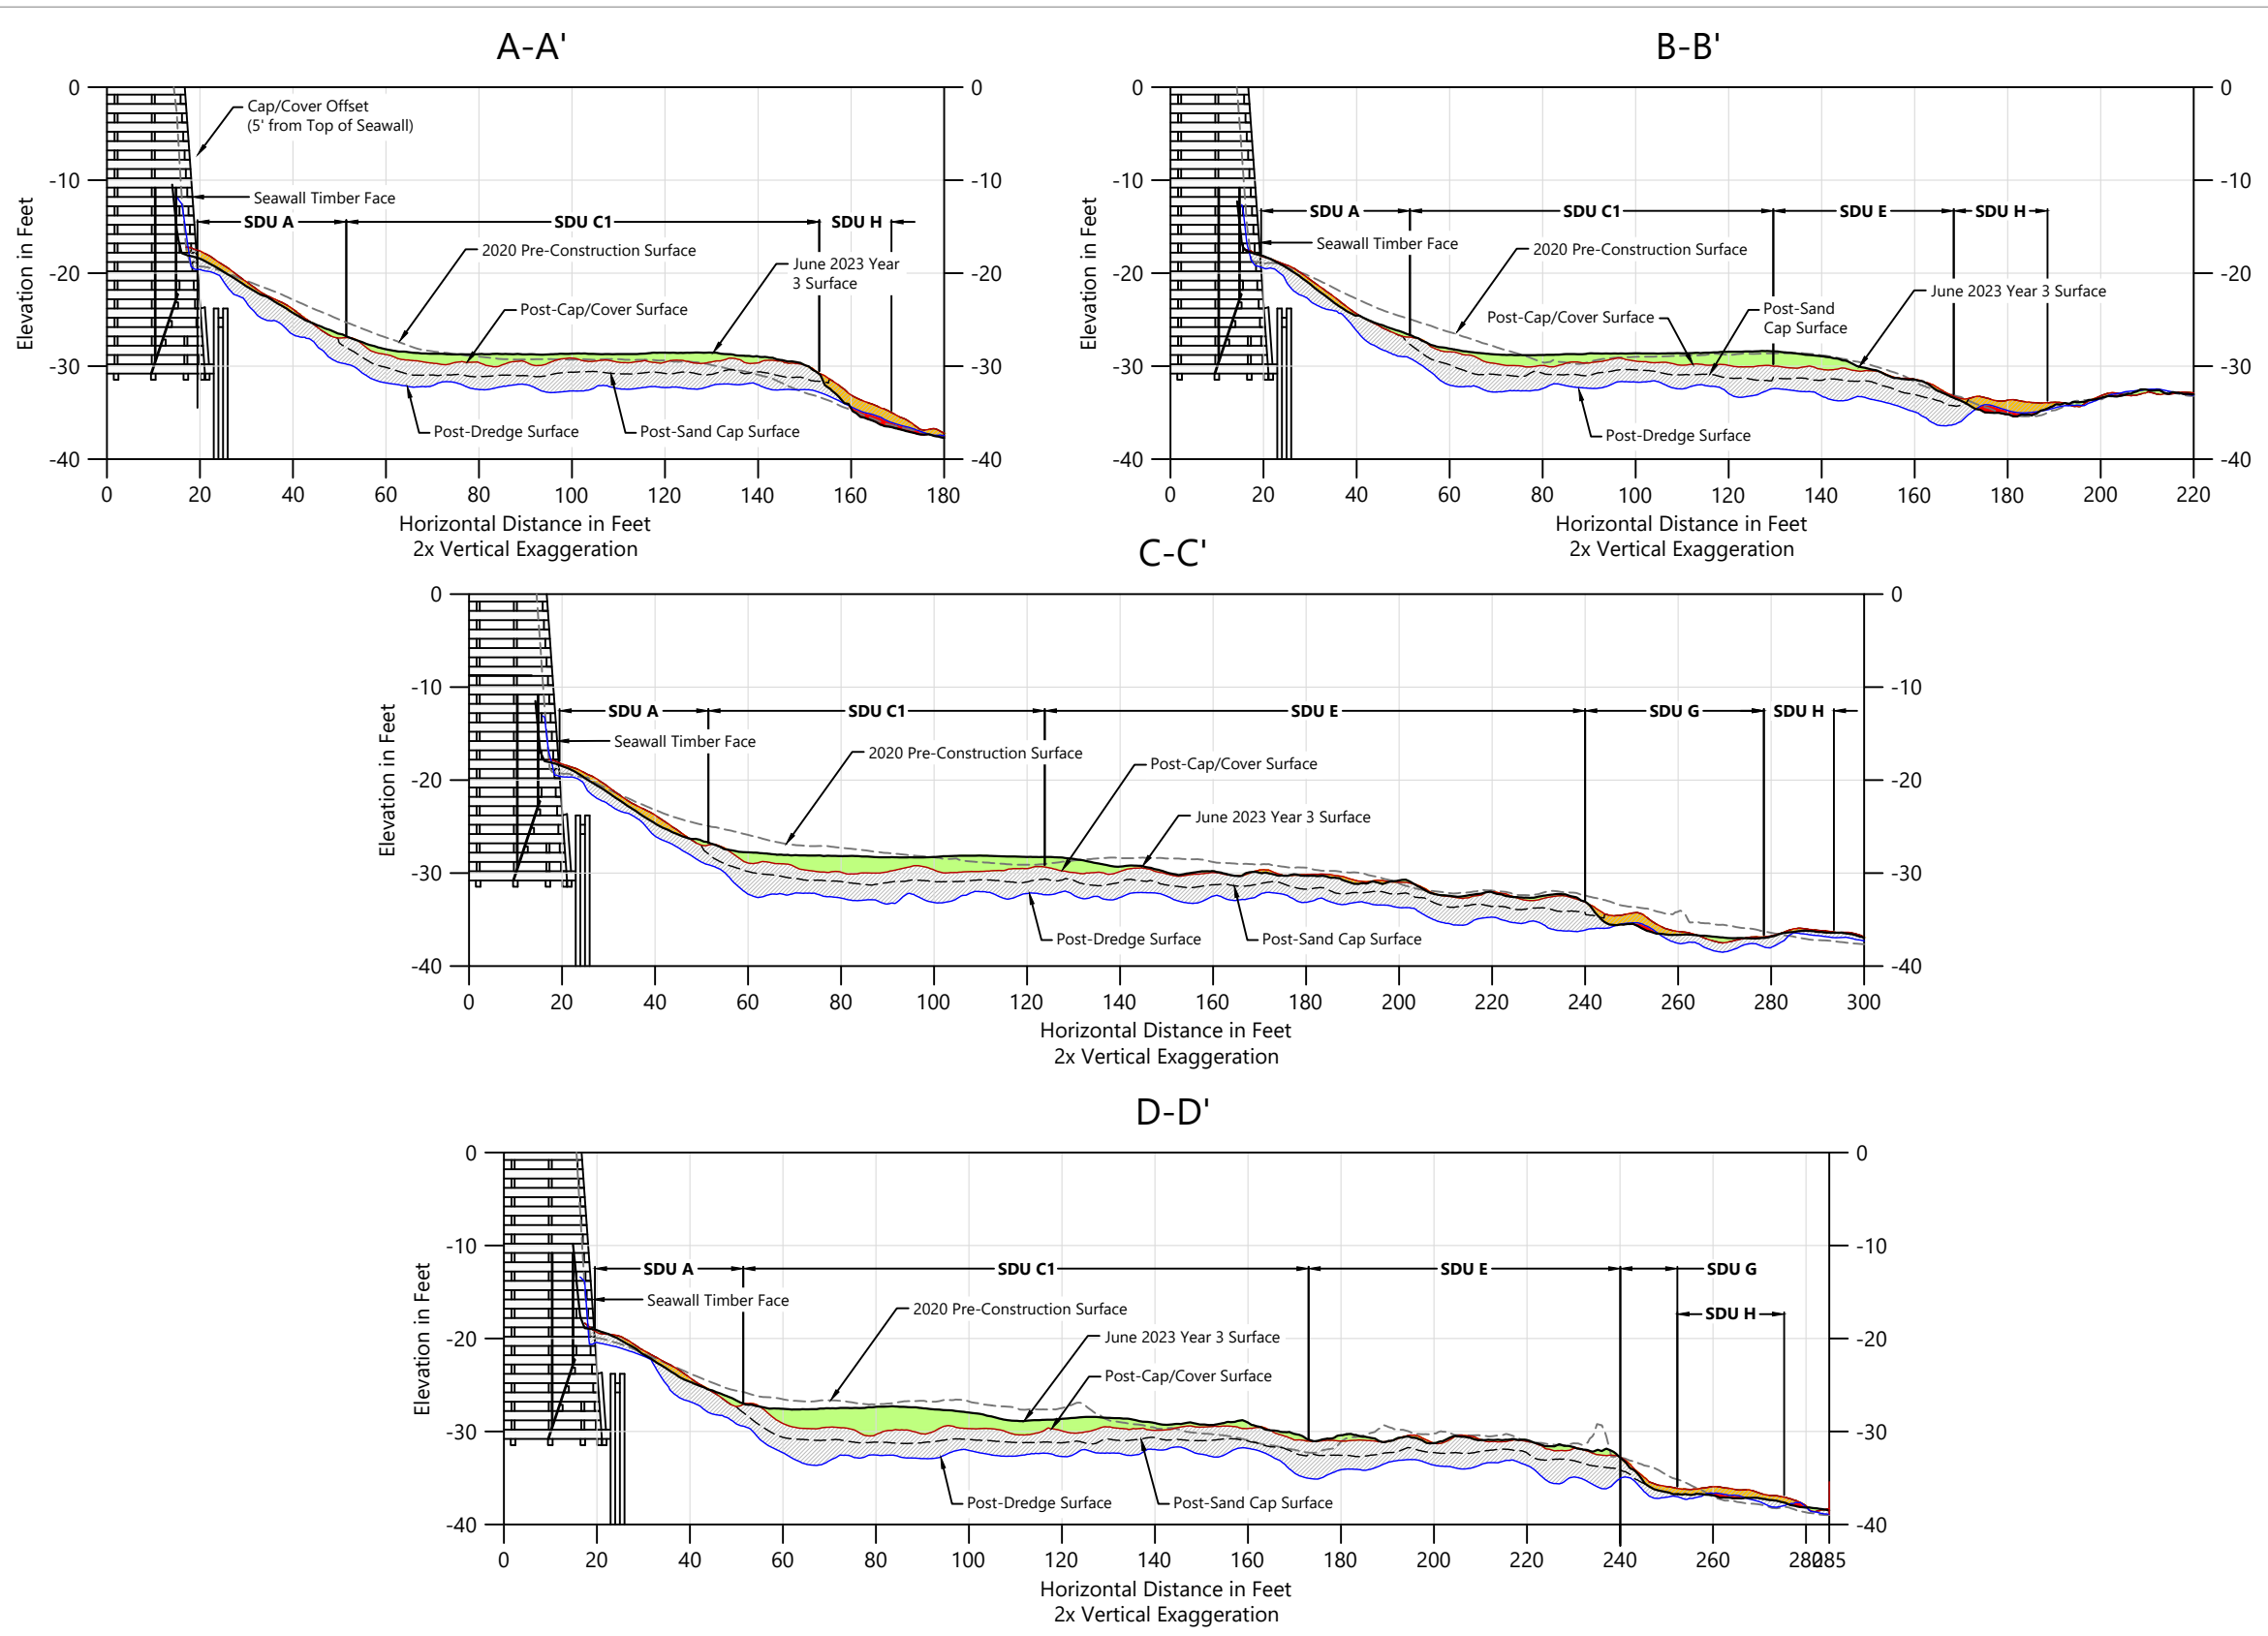
Figure 6a
2020 vs. 2023 Bathymetry Comparison Cross Sections (Part 1)

- **Figures 6a and 6b, 2020 vs. 2023 Bathymetry Comparison Cross Sections:** Longitudinal and transverse cross sections through the site showing the pre-construction riverbed elevation, extents and thicknesses of placed caps and covers, and areas of post-construction accretion or erosion; cross-section locations shown in Figure 4c
