Nondestructive Measurements of Tensile and Fracture Toughness

By
Fahmy M. Haggag
ABI Services, LLC
Oak Ridge, Tennessee
www.abiservices-usa.com

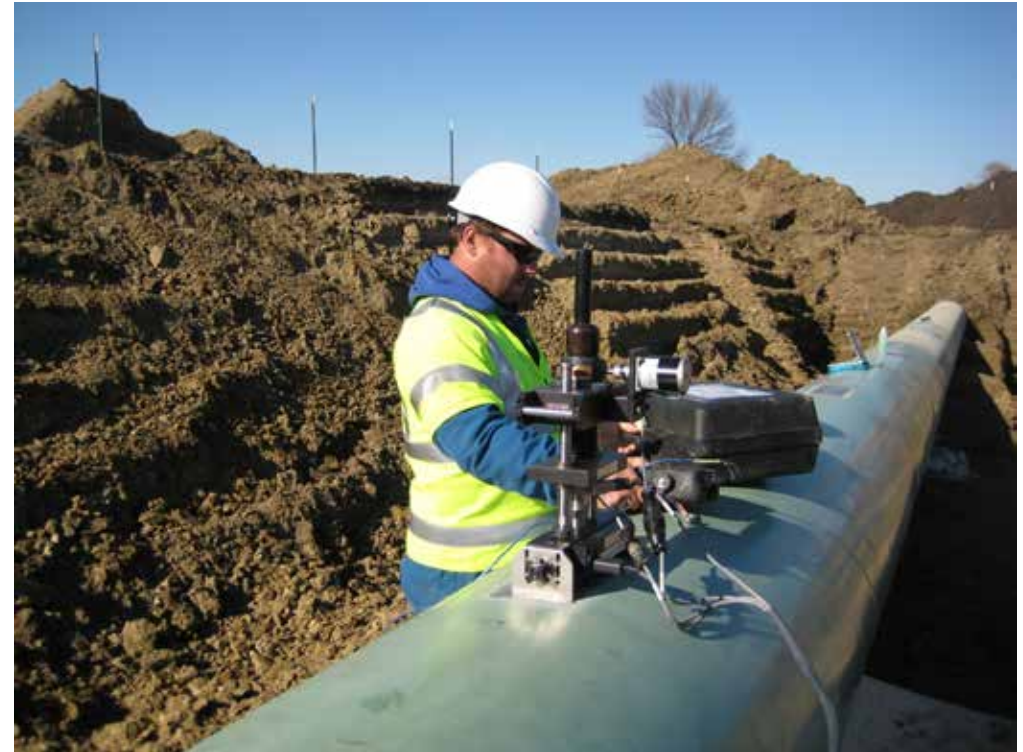
Automated Ball Indentation® (ABI®)

- ABI® is a nondestructive mechanical testing technique for determining Tensile and Fracture Toughness Properties
- It is based on progressive indentation with intermediate partial unloadings until the maximum depth (maximum strain) is reached, and then the indenter is fully unloaded.
- The ABI® test is a macroscopic (bulk) technique that measures the properties on a small volume of material.

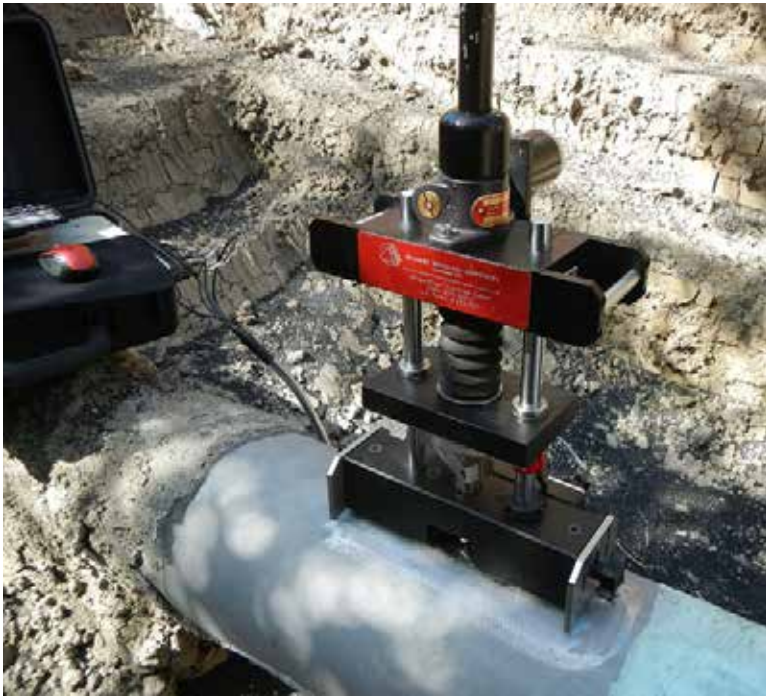
Stress-Strain Microprobe® (SSM)

- The ABI® technique is ideal for testing in-service components where cutting samples is either too costly or impractical – such as pipelines
- The spherical indentations produced on the pipe surface are shallow, smooth depressions with no sharp edges or stress concentration sites

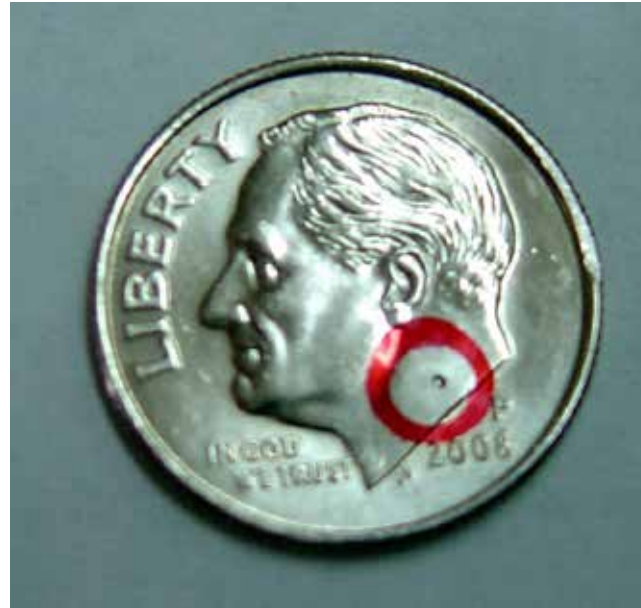
A nondestructive, spherical indentation shown to scale

- Ball indentations are shallow, with smooth edges and produce compressive stresses in the material that retard crack initiation
- The remaining ABI® depression is similar to one from shot-peening or sand blasting.

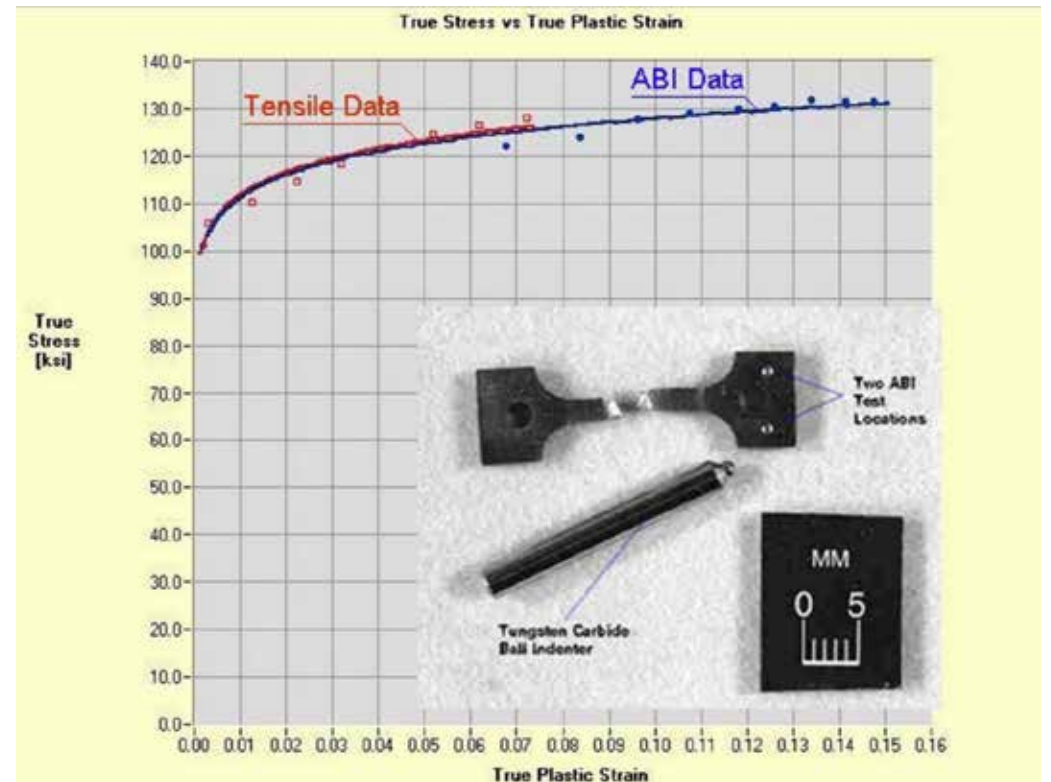
Stress-Strain Curves from ABI® and Tensile Tests on a High-Strength Steel Sample

- The ABI®-measured True- Stress versus True- Plastic-Strain curve is in excellent agreement with the curve from the destructive tensile test on a high strength material.

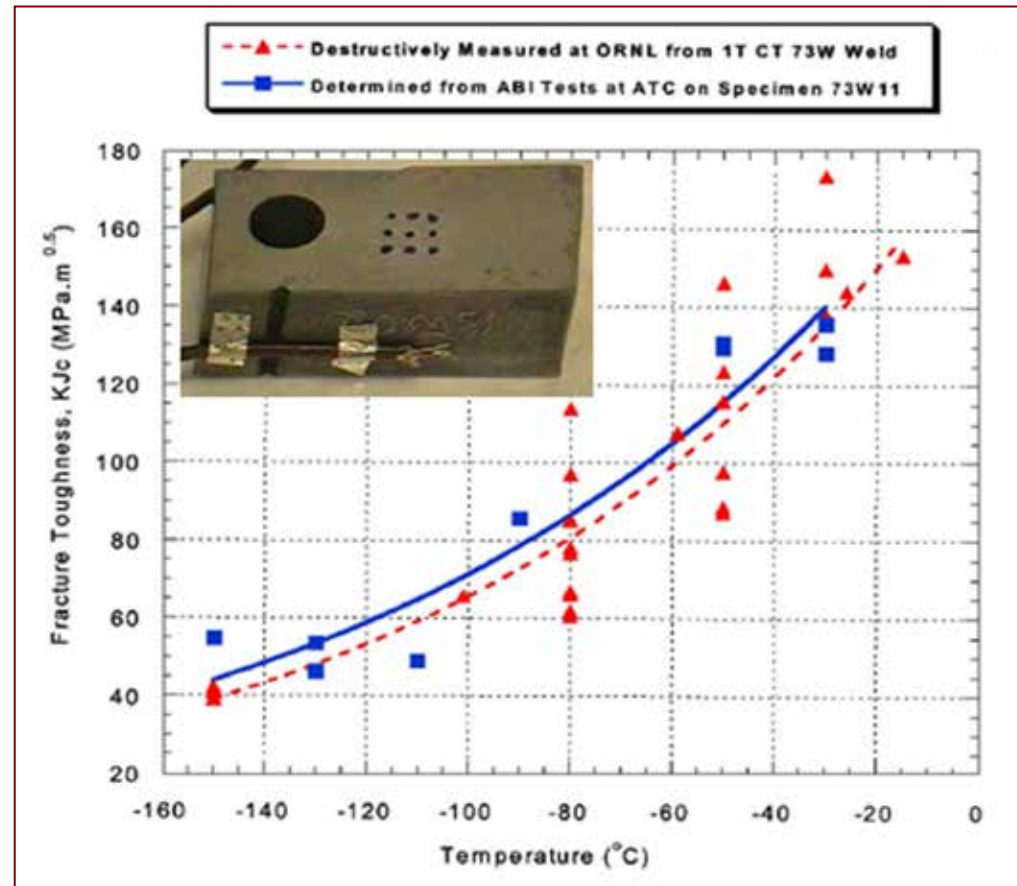
In-Situ/Nondestructive Measurement of Fracture Toughness

Comparison between nondestructively ABI®-measured $(K_{Jc})^{ABI}$ and destructive 1T CT fracture toughness test results of 73W Weld of Oak Ridge National Laboratory (ORNL)
