TransCanada Pipeline GTN; Milepost 231.5, Wallula District

Sinkhole Remediation at Babcock Road, Walla Walla County, Washington

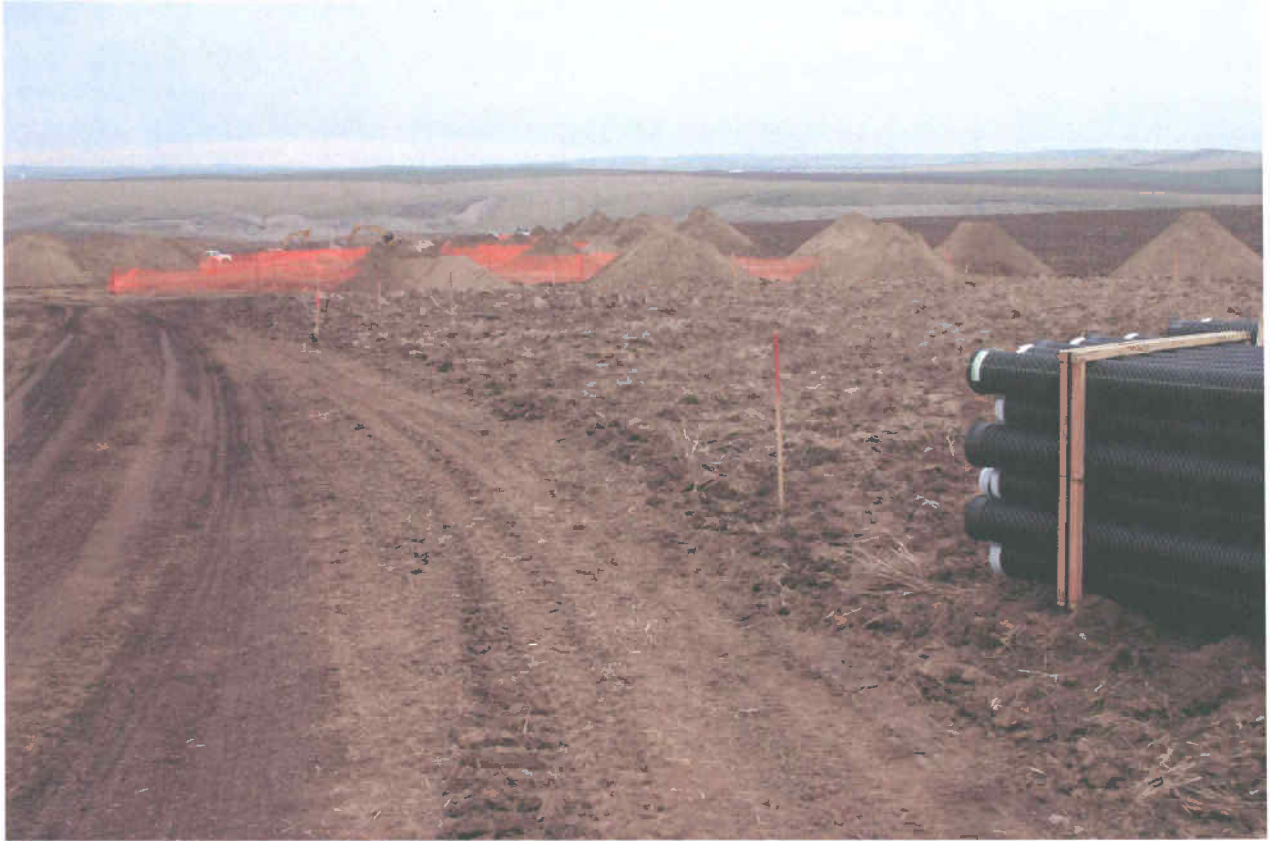
Photo 1/2

View looking south (downstream) at six excavated trench breakers placed about 250 feet apart.

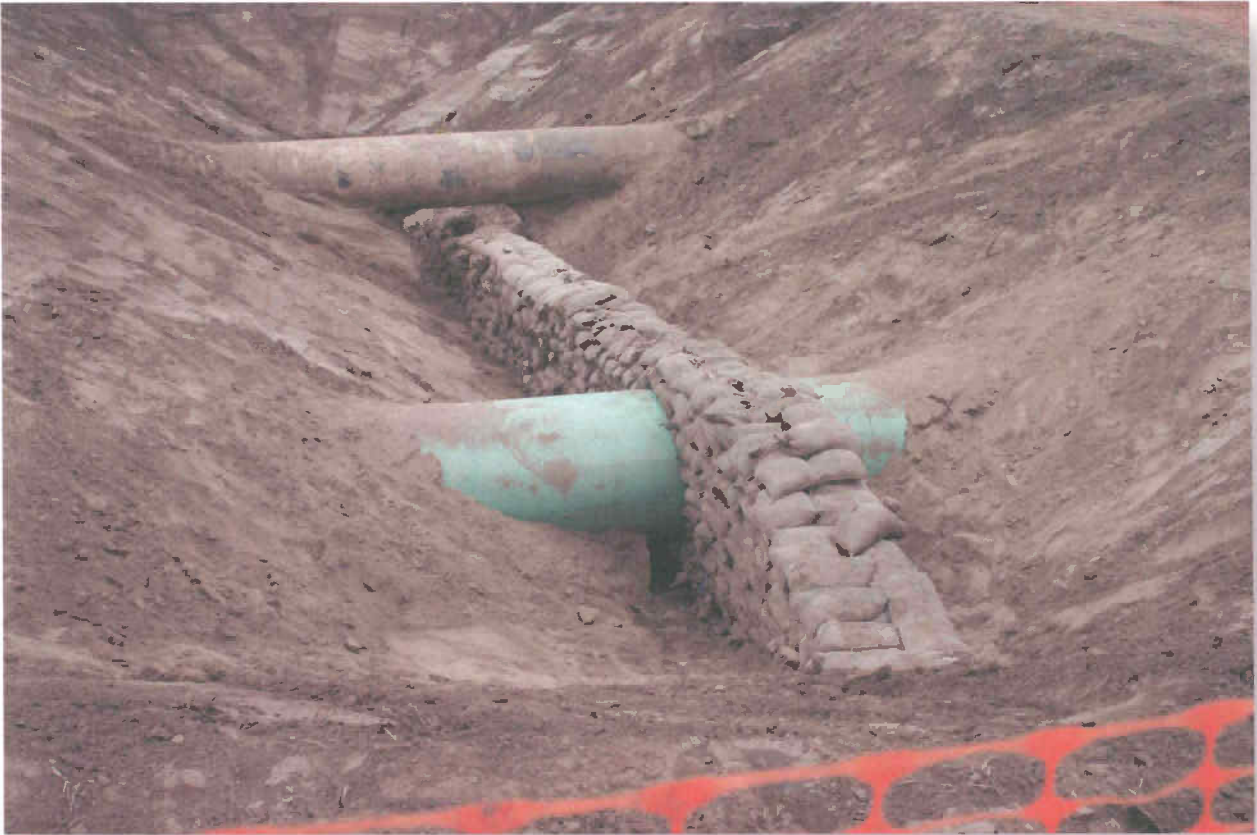
Photo 2/2

View looking at excavated trench breakers of 26-inch and 42-inch transmission pipelines. Drain pipe will be place under the pipelines adjacent to sandbags to intercept water and transfer it to a tight line placed parallel to the pipeline near edge of right-of-way.
