Re: December 2019 Monthly Progress Report
Administrative Settlement Agreement and Order on Consent for Removal Action
USEPA Region 10 Docket No. CERCLA 10-2009-0255
Gasco Sediments Site within the Portland Harbor Superfund Site

Attachment A Monthly Visual Monitoring Report for Pilot Cap Vicinity

Project: NW Natural – Gasco

Monitoring Period: Monthly (Year 13)—December 2019

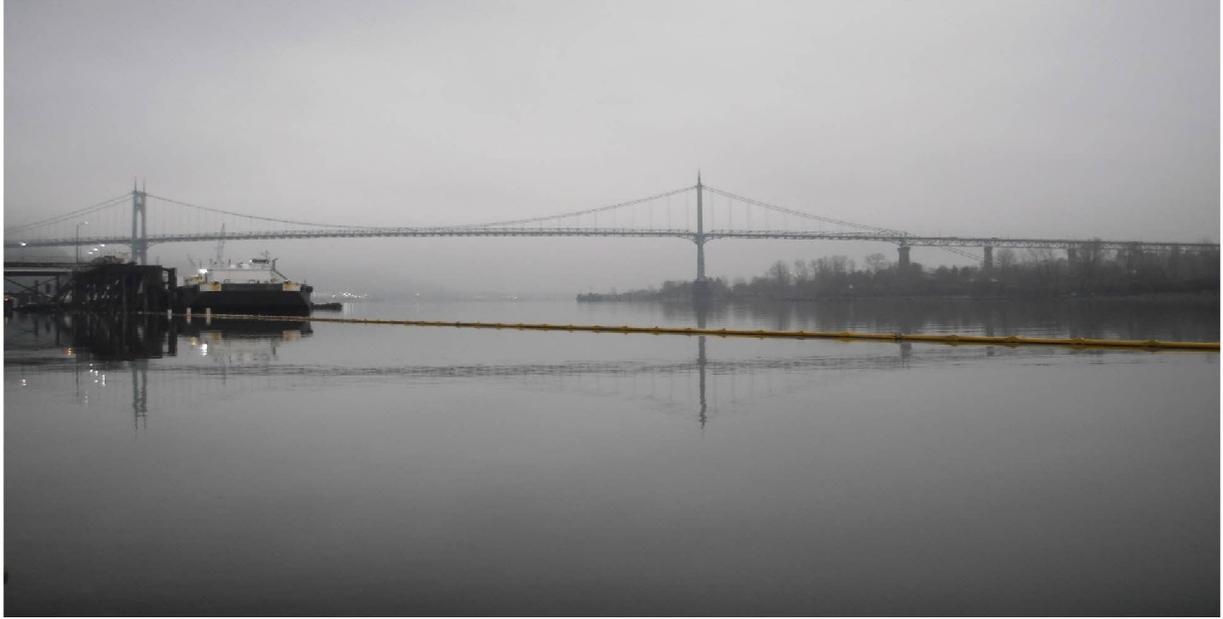
Photo 1

During the observation, a barge was moored to the ship dock, but the Pac Term containment boom was in place from the dock to the upriver dolphin. The 3 buoys identifying the cap area to mariners are in place as installed. The positions of the Pac Term oil boom and warning buoys are shown in Photo 1.

Pac Term Oil Boom Placement from dock to dolphin with Three Mariner Warning Buoys at Pilot Cap Area (12/19/2019)

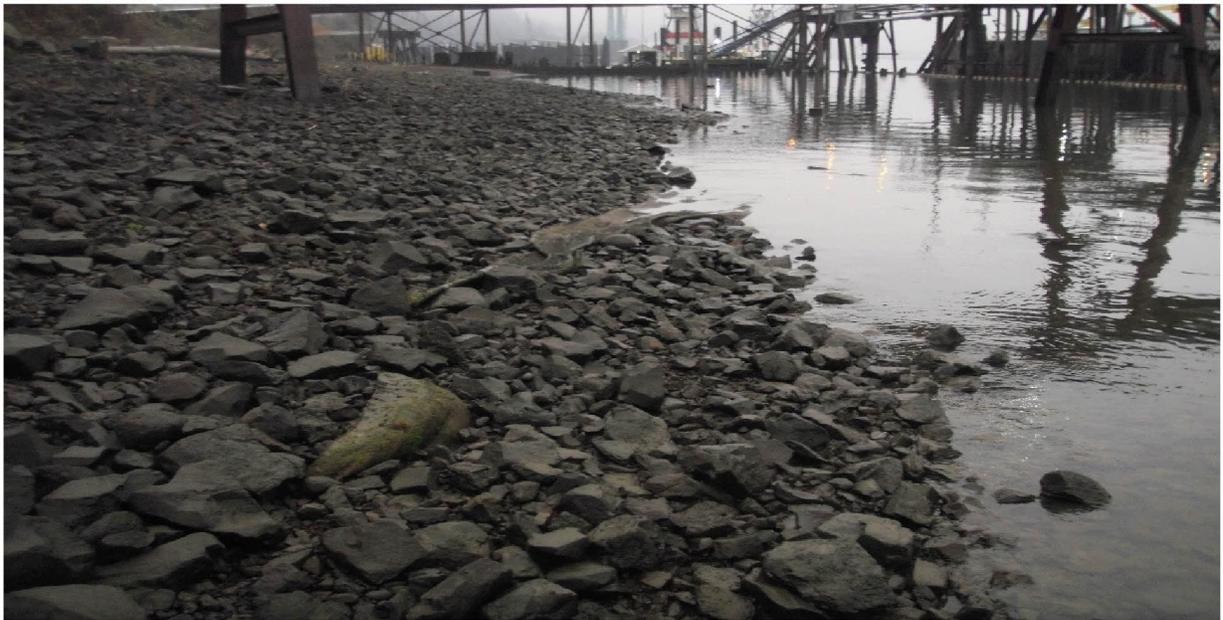
Photo 2

All exposed organo-clay mat material segments are visible. A segment, 5 feet in length, is exposed approximately 10 feet above the water's edge, near the lateral mid-point of the cap area. A 15-foot-long section is exposed at the water's edge, perpendicular to the shoreline at the upriver boundary of the cap area. A section of organo-clay mat material measuring 40 feet in length is exposed along the shoreline, extending from 2 feet in the water to 5 feet landward of the water's edge.

Mat Material Visible In and Out of the Water at the Downriver Extent of the Cap Area (12/19/2019)

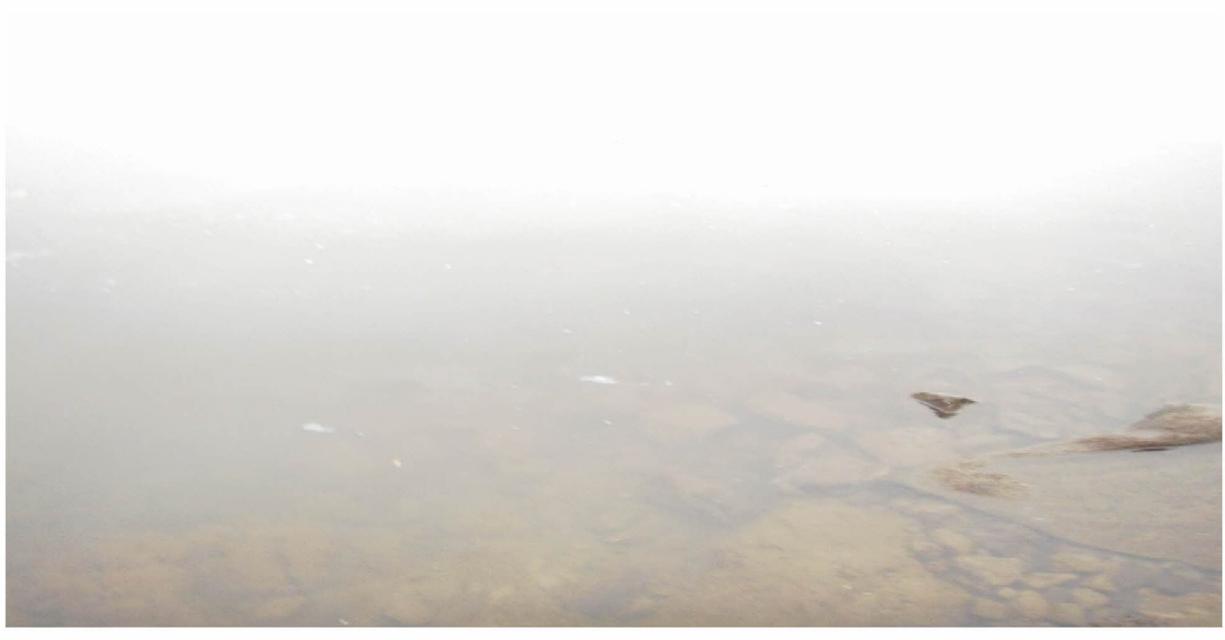
Spots of sheen were observed just riverward to the 40-foot section near the downriver end of the cap (Photo 3). Photo 4 shows the water surface and shoreline immediately downriver of the sediment cap.

Photo 3
Spots of Sheen by Downriver Extent of Cap Area by Mat Material (12/19/2019)

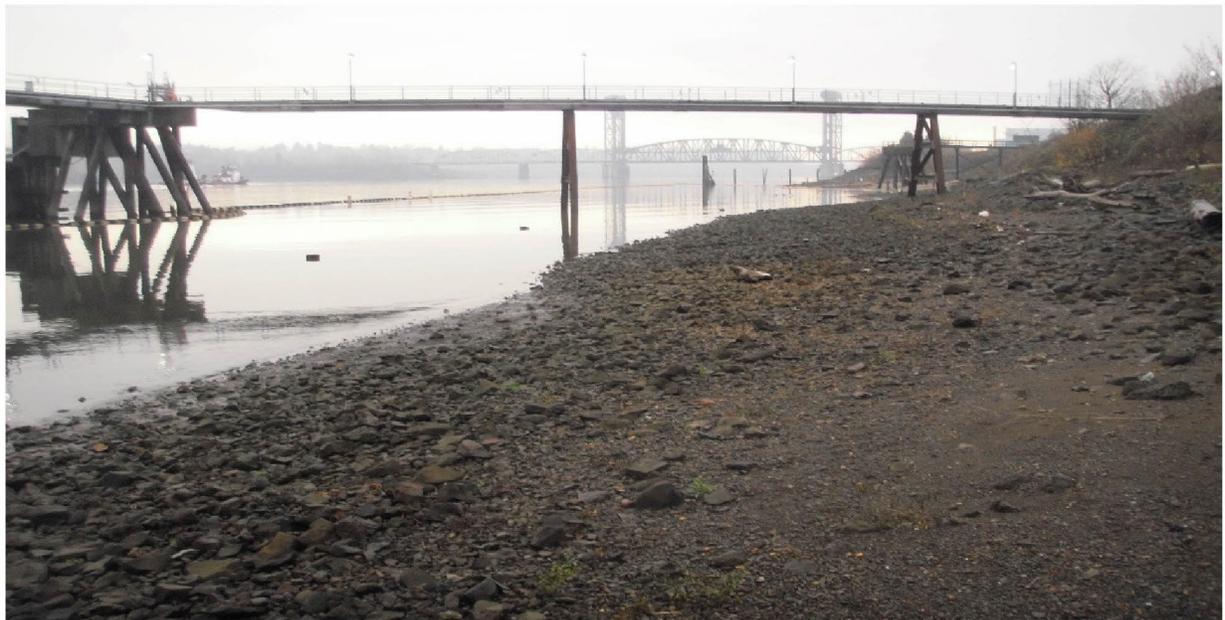
No erosion or deposition is evident along the shoreline.

Photo 4
Conditions Immediately Downriver of Cap Area (12/19/2019)
