Re: January 2020 Monthly Progress Report  
Administrative Settlement Agreement and Order on Consent for Removal Action  
USEPA Region 10 Docket No. CERCLA 10-2009-0255  
Gasco Sediments Site within the Portland Harbor Superfund Site

Attachment A Monthly Visual Monitoring Report for Pilot Cap Vicinity

# Visual Observations Log Form

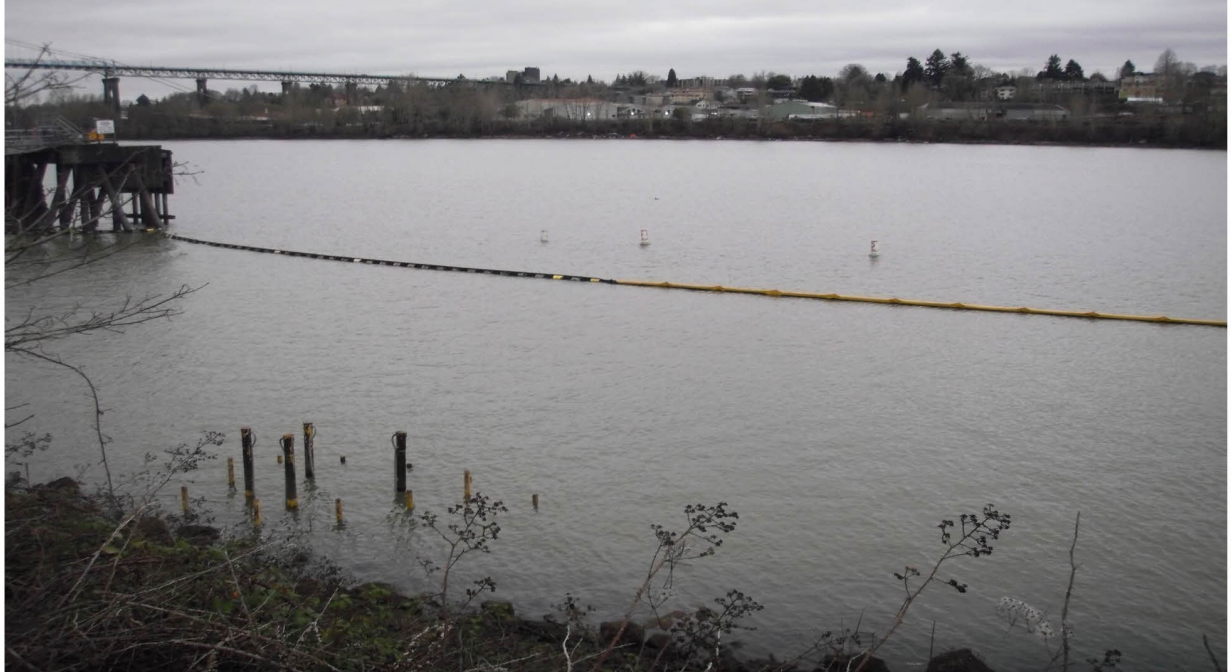
**Photo 1**  
**PacTerm Oil Boom Placement from Dock to Dolphin with Three Mariner Warning Buoys at Pilot Cap Area (1/22/2020)**

During the observation, the PacTerm containment boom was in place from dock to dolphin. The three buoys identifying the cap area to mariners are in place as installed. The positions of the PacTerm oil boom and warning buoys are shown in Photo 1.

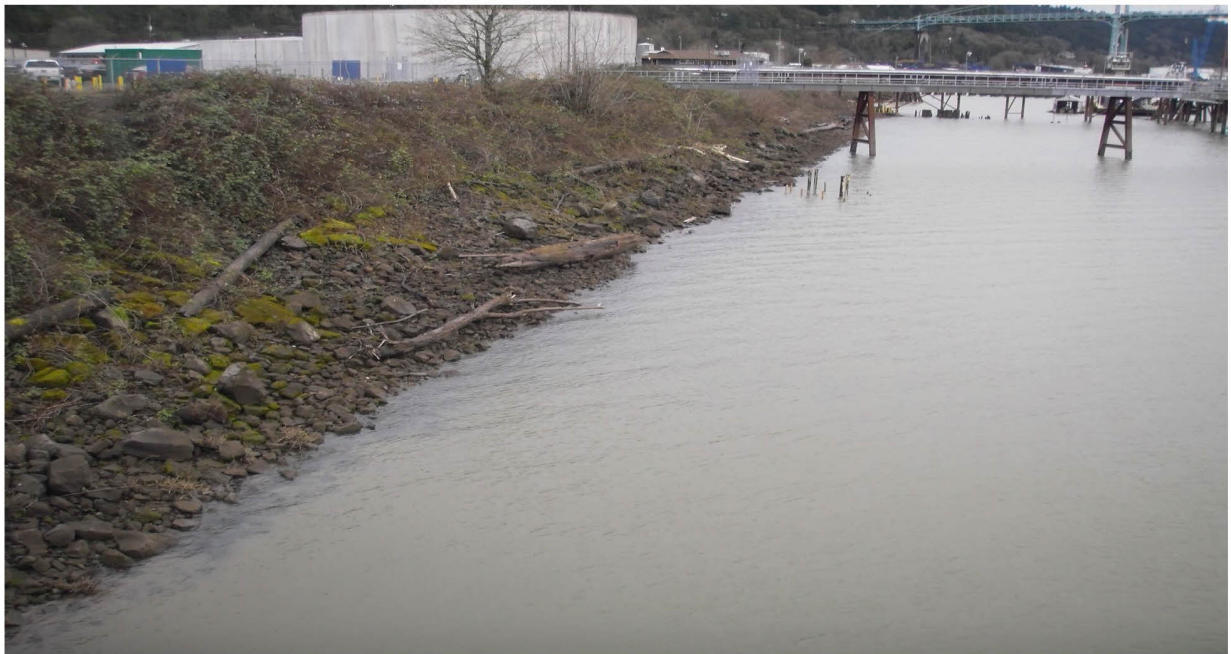
**Photo 2**  
**River Level Currently Above the Extent of Sediment Cap (1/22/2020)**

The shoreward extent of the cap was not visible due to high river water elevation, and the organoclay mat material shoreward of the cap area could not be observed (Photo 2).

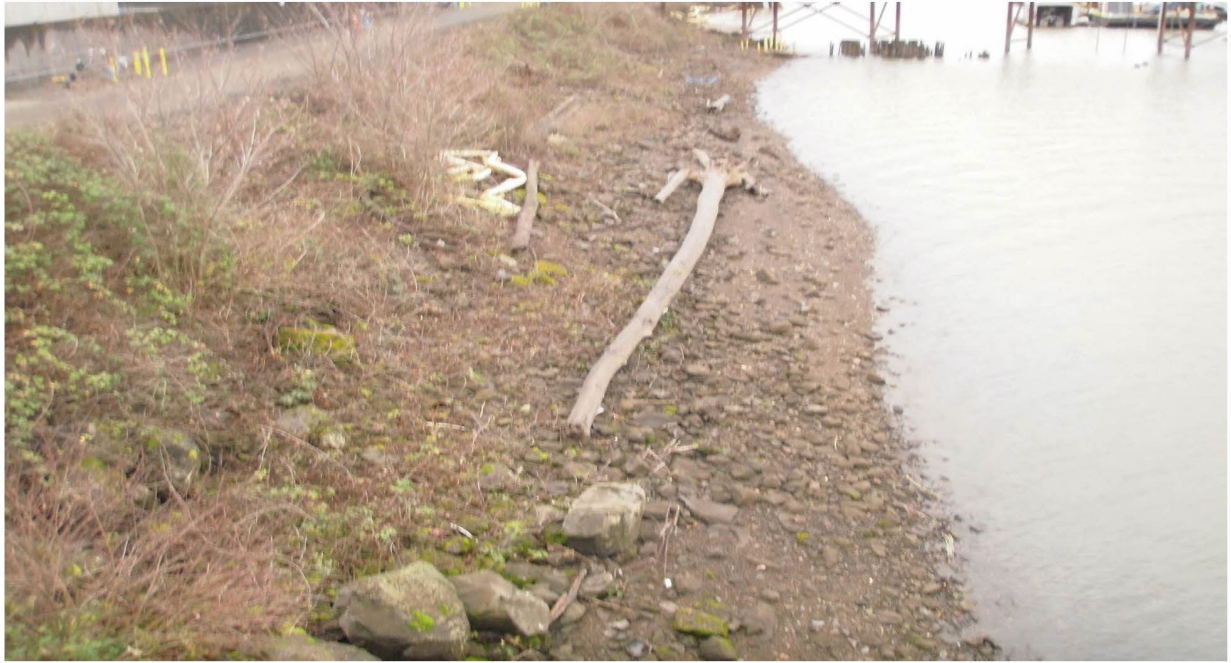
**Photo 3**  
**Conditions Immediately Downriver of Cap Area (1/22/2020)**

No sheen was observed. Photo 3 shows the water surface and shoreline immediately downriver of the sediment cap.
