Re: February 2020 Monthly Progress Report
Administrative Settlement Agreement and Order on Consent for Removal Action
USEPA Region 10 Docket No. CERCLA 10-2009-0255
Gasco Sediments Site within the Portland Harbor Superfund Site

Attachment A Monthly Visual Monitoring Report for Pilot Cap Vicinity

Project: NW Natural – Gasco

Monitoring Period: Monthly (Year 14) —February, 2020

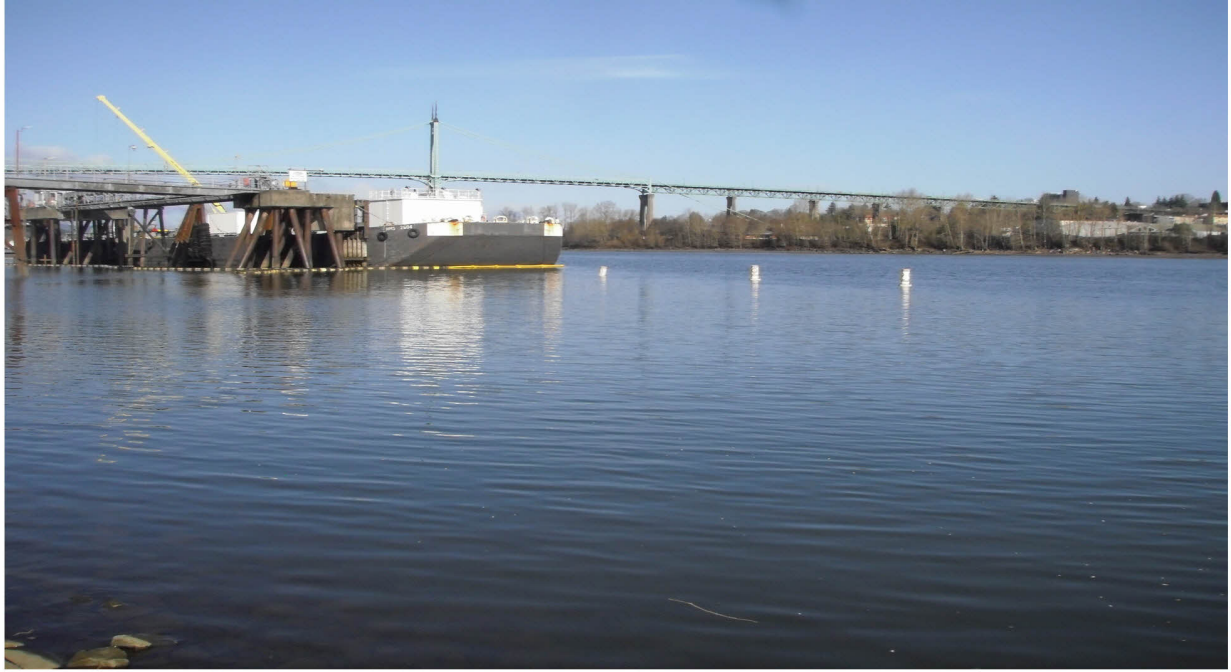
Photo 1

During the observation, a barge was moored at the dock, and the PacTerm containment boom was placed around the barge. The three buoys identifying the cap area to mariners were in place as installed. The positions of the PacTerm oil boom and warning buoys are shown in Photo 1.

PacTerm Oil Boom Placement Around Moored Barge with Three Mariner Warning Buoys at Pilot Cap Area (2/17/2020)

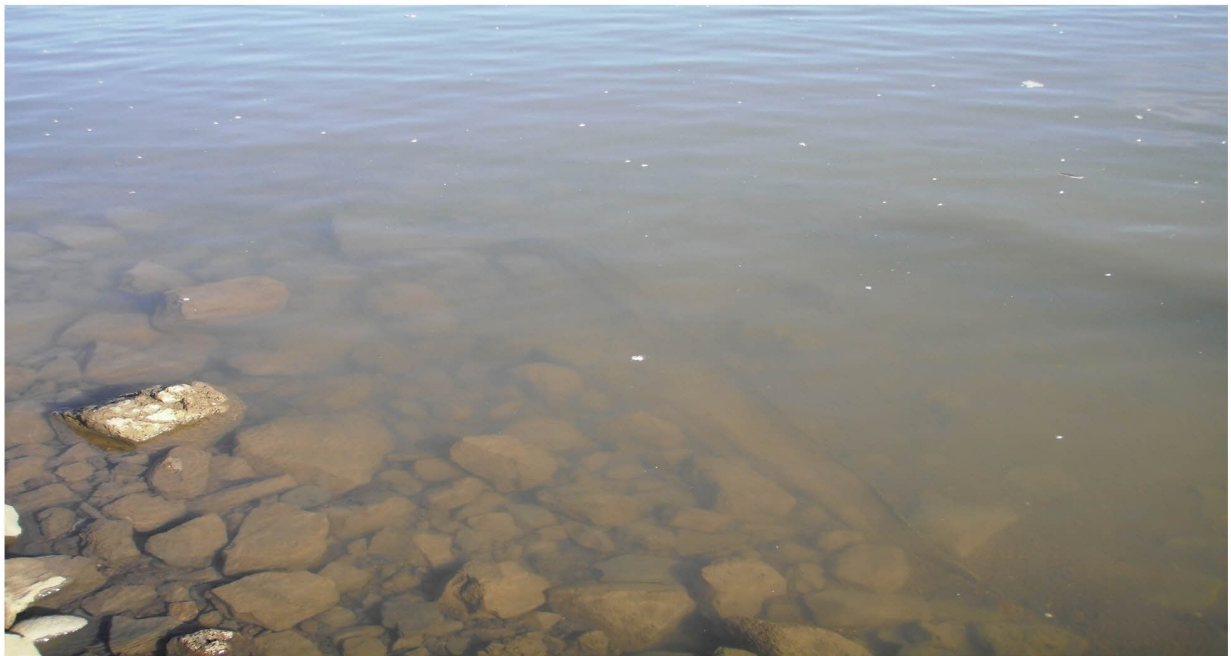
Photo 2

The shoreward extent of the cap was not visible due to high river water elevation, and the organoclay mat material shoreward of the cap area could not be observed. A small section at the lateral midpoint of the cap area was visible (submerged) approximately 5 feet from the shoreline (Photo 2).

Mat Material Visible but Underwater at the Mid-Point of the Cap Area (2/17/2020)

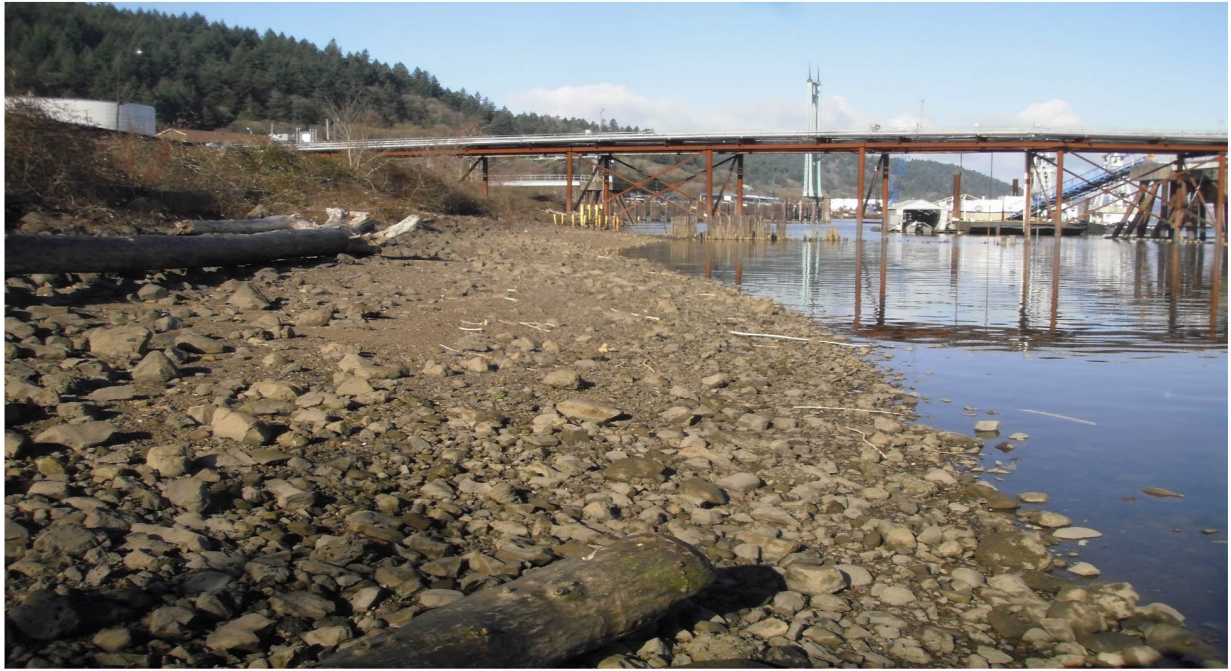
No sheen was observed. Photo 3 shows the water surface and shoreline immediately downriver of the sediment cap.

Photo 3
Conditions Immediately Downriver of Cap Area (2/17/2020)
