Re: March 2020 Monthly Progress Report
Administrative Settlement Agreement and Order on Consent for Removal Action
EPA Region 10 Docket No. CERCLA 10-2009-0255
Gasco Sediments Site within the Portland Harbor Superfund Site

Attachment A Monthly Visual Monitoring Report for Pilot Cap Vicinity

Visual Observations Log Form

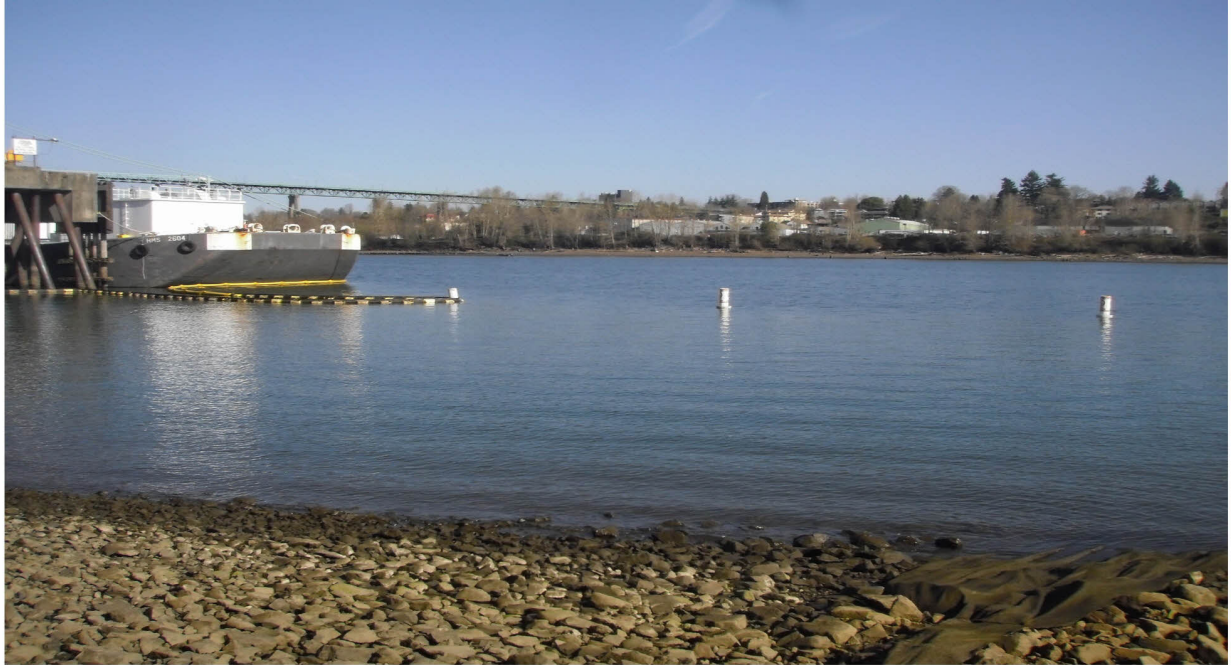
During the observation, a barge was moored at the dock, and the PacTerm containment boom was placed around the barge. The three buoys identifying the cap area to mariners were in place as installed. The positions of the PacTerm oil boom and warning buoys are shown in Photo 1.

Photo 1
PacTerm Oil Boom Placement Around Moored Barge with Three Mariner Warning Buoys at Pilot Cap Area (3/20/2020)

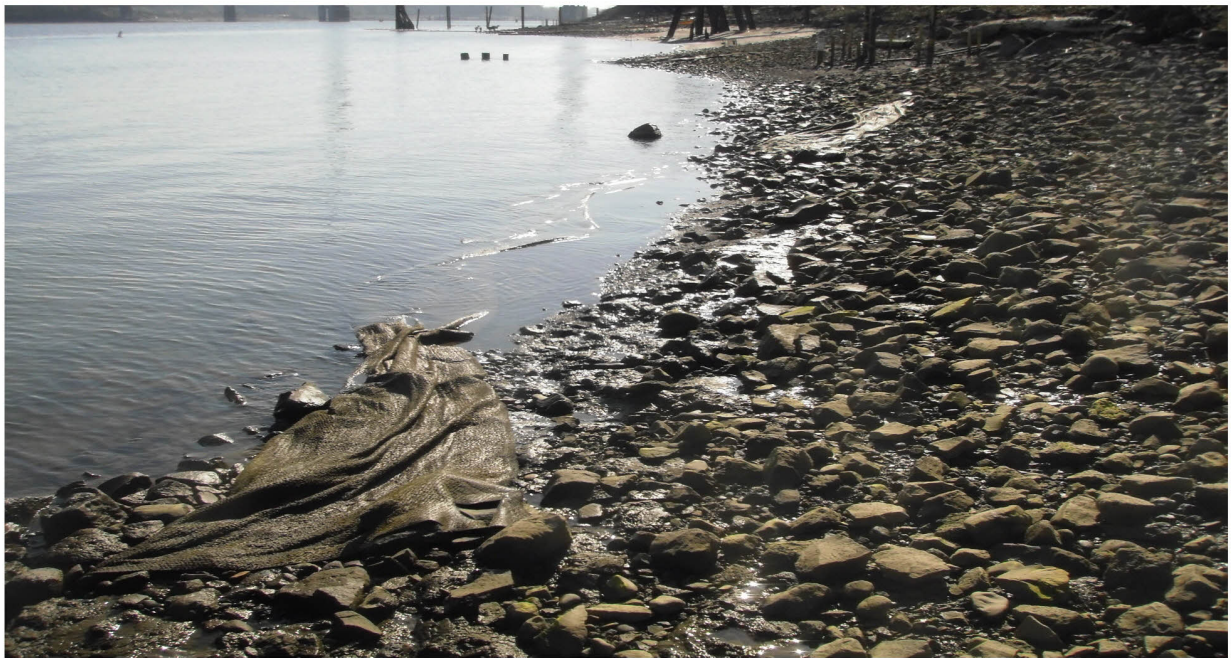
All exposed organoclay mat material segments were visible and partly out of the water. A 5-foot-long segment was exposed approximately 10 feet above the water’s edge, near the lateral mid-point of the cap area. A 15-foot section had 12 feet exposed upgradient of the water’s edge, perpendicular to the shoreline at the upriver boundary of the cap area. A section of organoclay mat material measuring 40 feet long was exposed along the shoreline extending 2 feet into the water and 5 feet upgradient of the water’s edge (Photo 2).

Photo 2
Mat Material Visible at the Downstream End of the Cap Area (3/20/2020)

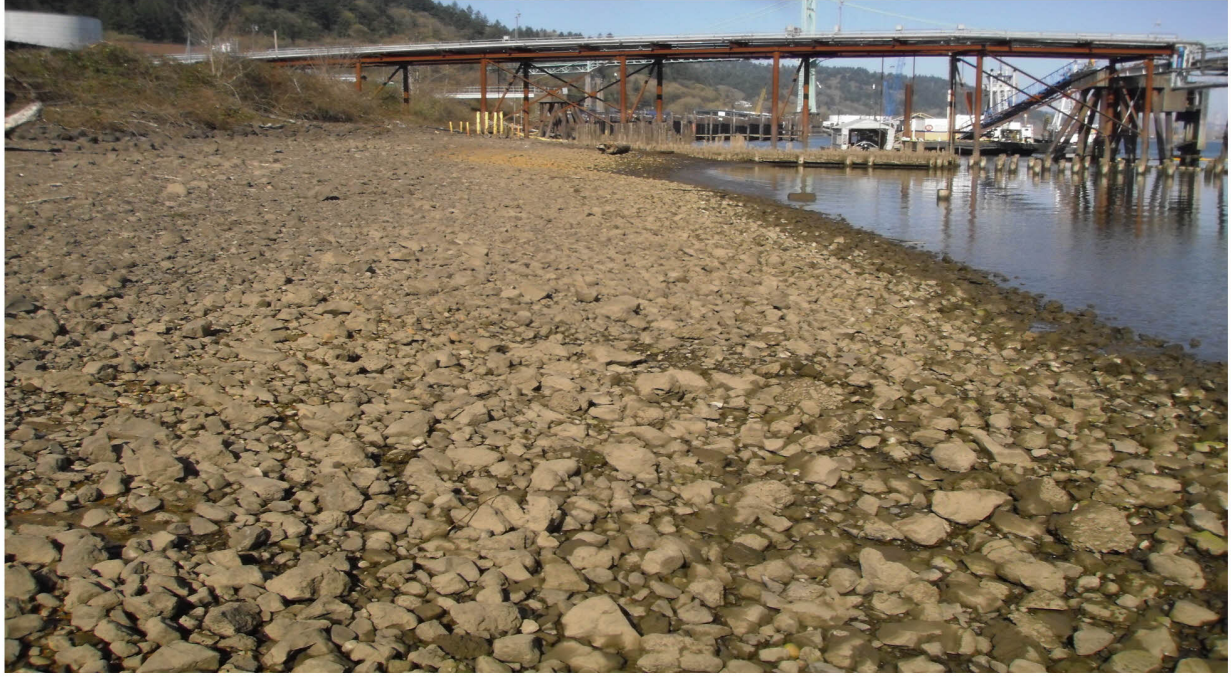
No sheen was observed. Photo 3 shows the water surface and shoreline immediately downriver of the sediment cap.

Photo 3
Conditions Immediately Downriver of Cap Area (3/20/2020)
