Re: April 2020 Monthly Progress Report
Administrative Settlement Agreement and Order on Consent for Removal Action
EPA Region 10 Docket No. CERCLA 10-2009-0255
Gasco Sediments Site within the Portland Harbor Superfund Site

Attachment A Monthly Visual Monitoring Report for Pilot Cap Vicinity

Visual Observations Log Form

Project: NW Natural – Gasco

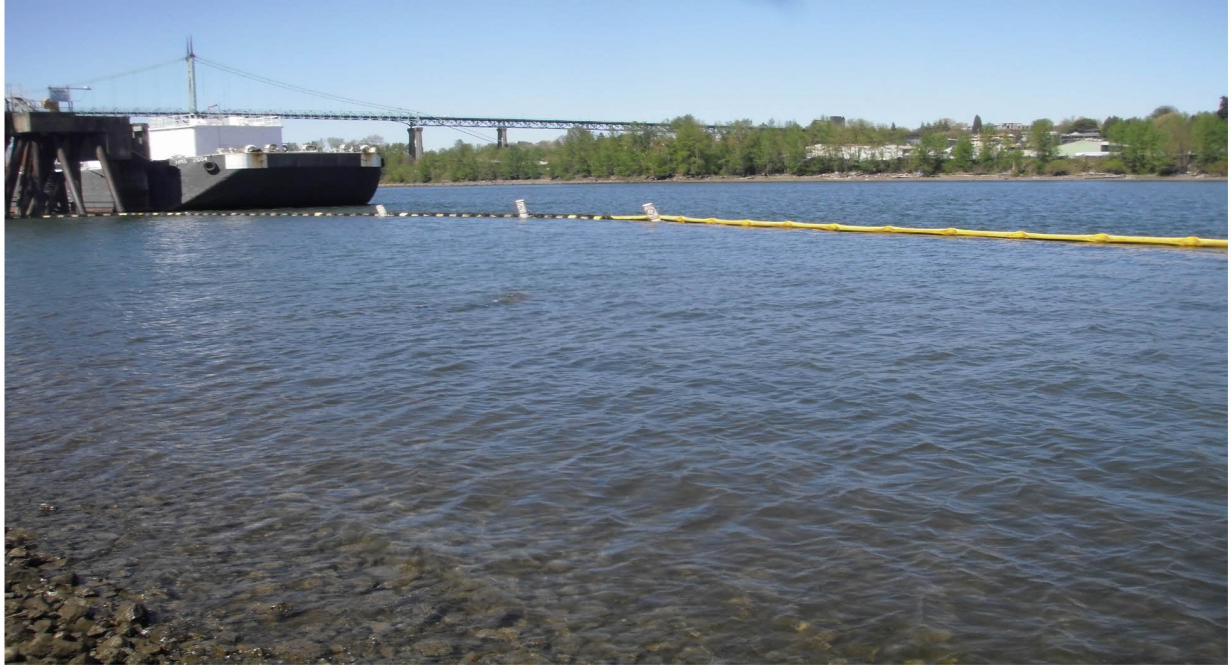
Photo 1

During the observation, a barge was moored at the dock, but the PacTerm containment boom was in place, as normal, from dock to dolphin. The three buoys identifying the cap area to mariners were in place as installed. The positions of the PacTerm oil boom and warning buoys are shown in Photo 1.

PacTerm Oil Boom Placement from Dock to Dolphin with Three Mariner Warning Buoys at Pilot Cap Area with a Barge Moored at the Dock (4/16/2020)

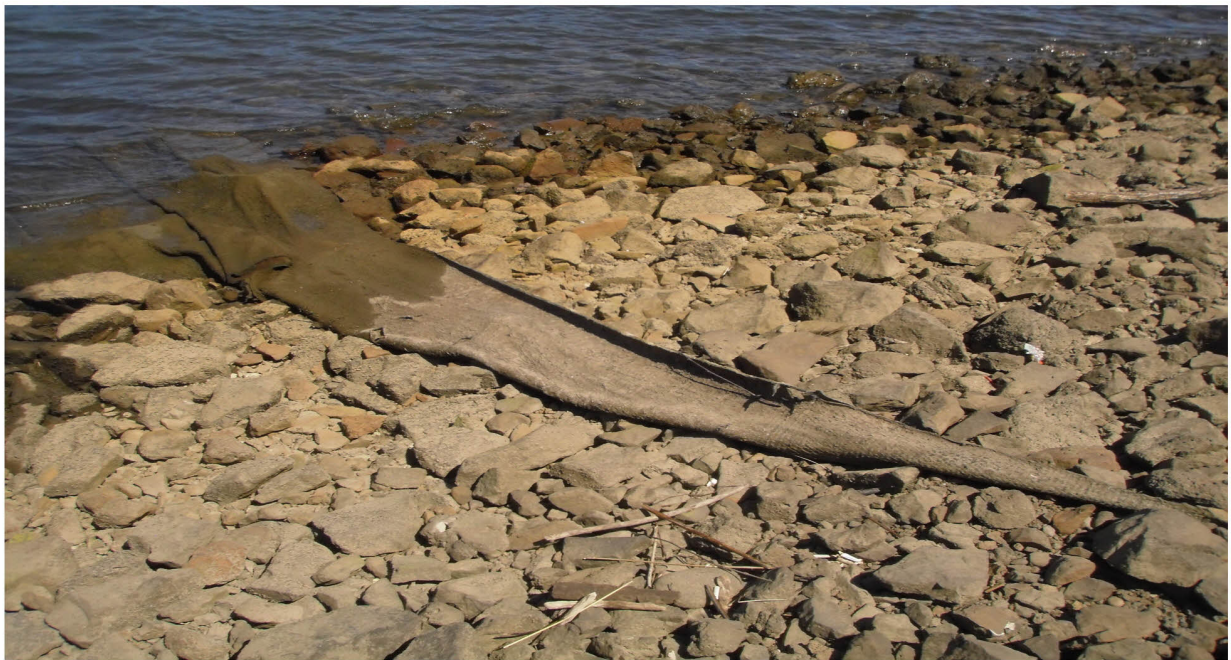
Photo 2

Exposed organoclay mat material segments were visible at the shoreward extent of the cap area. A 5-foot-long segment was exposed to approximately 7 feet above the water’s edge near the lateral mid-point of the cap area. A 15-foot section was exposed at the upriver boundary of the cap area perpendicular to the shoreline. A section of organoclay mat material measuring 40 feet long was exposed along the shoreline extent of the cap extending from the waterline to approximately 5 feet riverward of the waterline (Photo 2).

Mat Material Visible at the Upriver End of the Cap Area (4/16/2020)

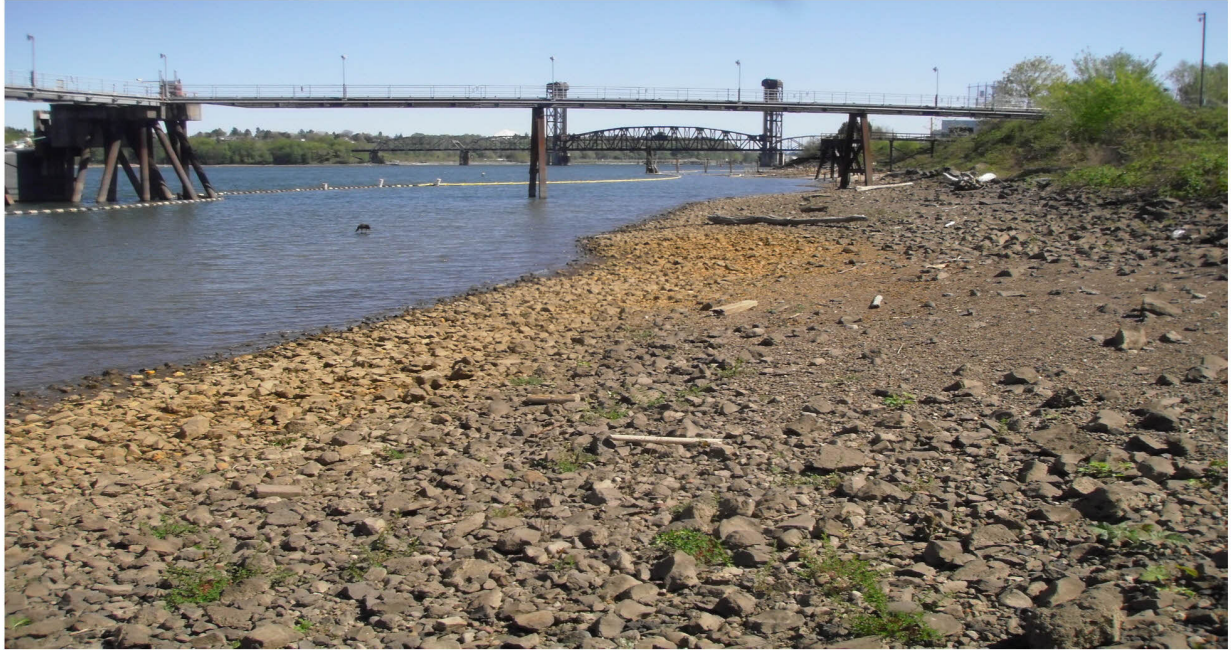
No sheen was observed. Photo 3 shows the water surface and shoreline immediately downriver of the sediment cap.

Photo 3
Conditions Immediately Downriver of Cap Area (4/16/2020)
