**BEFORE THE WASHINGTON
UTILITIES & TRANSPORTATION COMMISSION**

Avista Supplemental Response to Public Counsel Data Request No. 108, Attachment A

Distribution Feeder

Management Plan

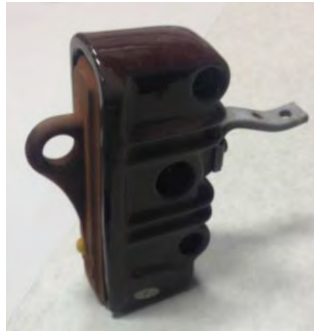
Figure 4: Porcelain Box

- Porcelain cutouts in operational condition may be changed out at the discretion of the Designer.
 - If the transformer is being replaced, the porcelain cutout shall also be replaced.
- Replace cracked porcelain cutouts and butyl rubber cutouts with signs of chalking.
- Do not replace cutouts based only on age.
- Design Fuse Marking Signs on all poles with a trunk, lateral, riser, or fuse.²⁶
- Replace all of the cutouts on a cross arm if one or more require replacement.
 - If cutout(s) located on an equipment arm are identified for replacement, relocate the cutouts to the primary cross arm.
- If replacing cutouts on an existing pole:
 - Install a fiberglass standoff bracket for a cutout on single phase armless overhead construction.²⁷
- Replace the following types of cutouts:
 - Chance brand porcelain
 - Porcelain Box
 - Grasshopper
 - Open Link
 - Q-Q

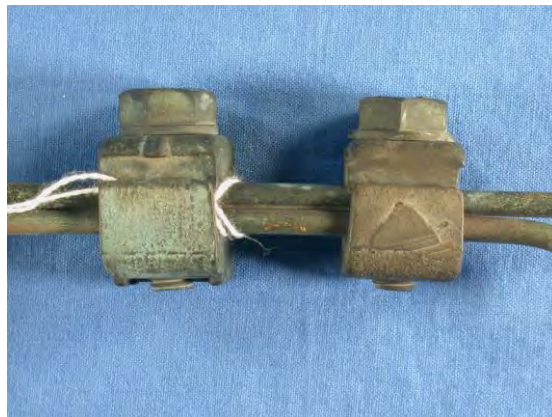
Figure 15: Newer Style Small Bolt

- Copper Conductor
 - Replace primary and neutral overhead conductors if:
 - The wire has the older style small bolt (Fargo connectors). These will be some of the oldest installations (see pictures below).
 - There are physical signs of annealing. Physical signs of annealing include:
 - If a span has obvious kinks and bends caused by previous physical and electrical current damage is observed.
 - If wire sags greater than expected because it has been damaged or a section may have been spliced.
 - If more complete verification is needed, a service man can check various sections of the #6 copper wire by attaching a hot tap to the wire and twisting to determine if the wire has been annealed (softened).⁷²

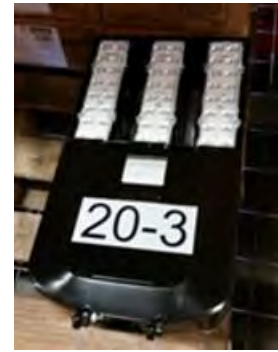
Figure 26: 200W equivalent-
Type 3

- Install LEDx00Tx in non-residential street and area light applications only, such as major roadway arterials, streets, and intersections. These lights come in both 100 and 200 W equivalents, and in both Types 3 and 5.⁸⁶
- Install the LED fixtures with the correct distribution light type.⁸⁷
 - Type 2 or 3 LED fixtures are for mid-block applications only, and are ideal for residential streets scenarios.
