# Native Link

MARCH 1, 2012

## Confederated Tribes of the Colville Reservation

### CenturyLink Damaged Pedstal Pictures

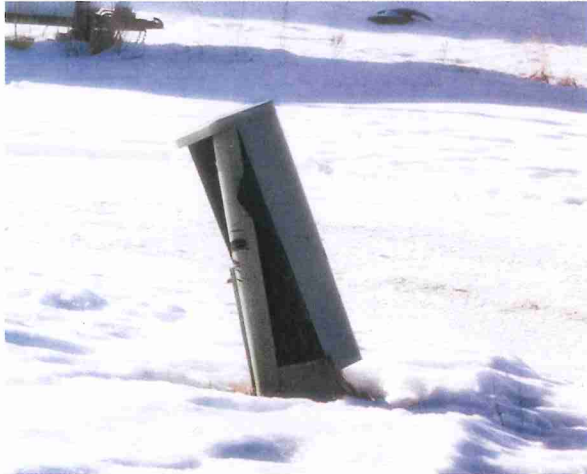
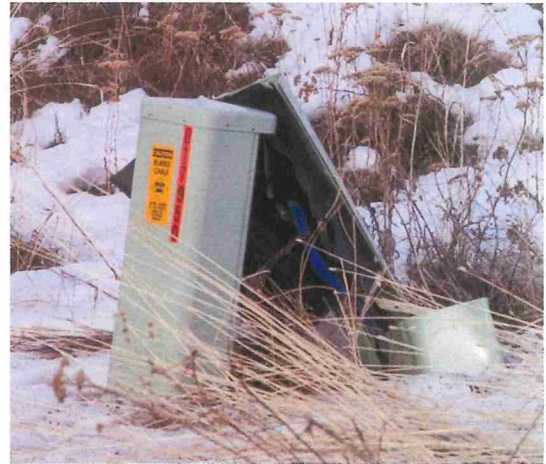
CenturyLink Damaged PEDs located less than ½ Mile from their Nespelem Central Office and one by the Nespelem Community Center.

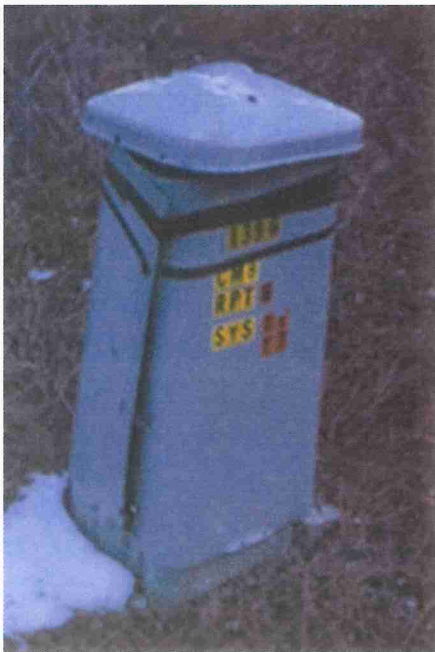
CenturyLink Damaged PED on Highway 21 – State Route in the Keller reservation district.

Located between Keller Park and the Mt. Tolman, Peter Dan Road.
