Final Report No. 605601

Development of Delineator Material/Impact Testing Specific to Managed Lane Use for Optimization of Service Life

Test Nos.: 605601-1-6

TEXAS A&M TRANSPORTATION INSTITUTE PROVING GROUND

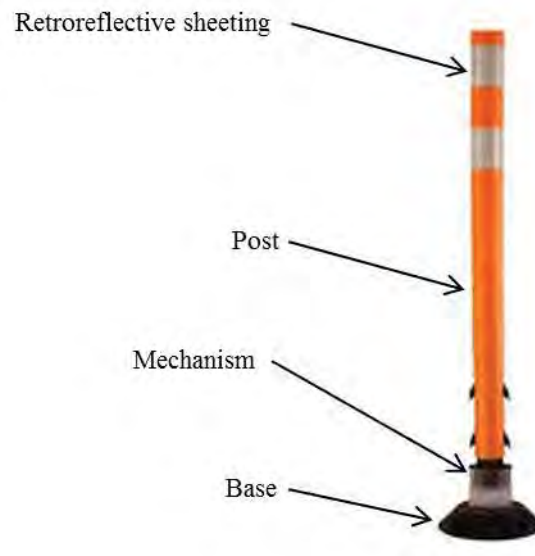
Figure 1. Delineator Parts

Delineators have four main parts: the retroreflective sheeting (required for nighttime use), the post (can be various colors), the mechanism that connects the post and the base (typically a proprietary component), and the base. Figure 1 shows these parts that compose one delineator.

When installed, there are two additional parts to consider: the epoxy (which connects the base to the pavement) and the pavement itself. Any of these parts may fail when the delineator is struck. Based on past efforts, the researchers developed a list of failure modes, which are described below:

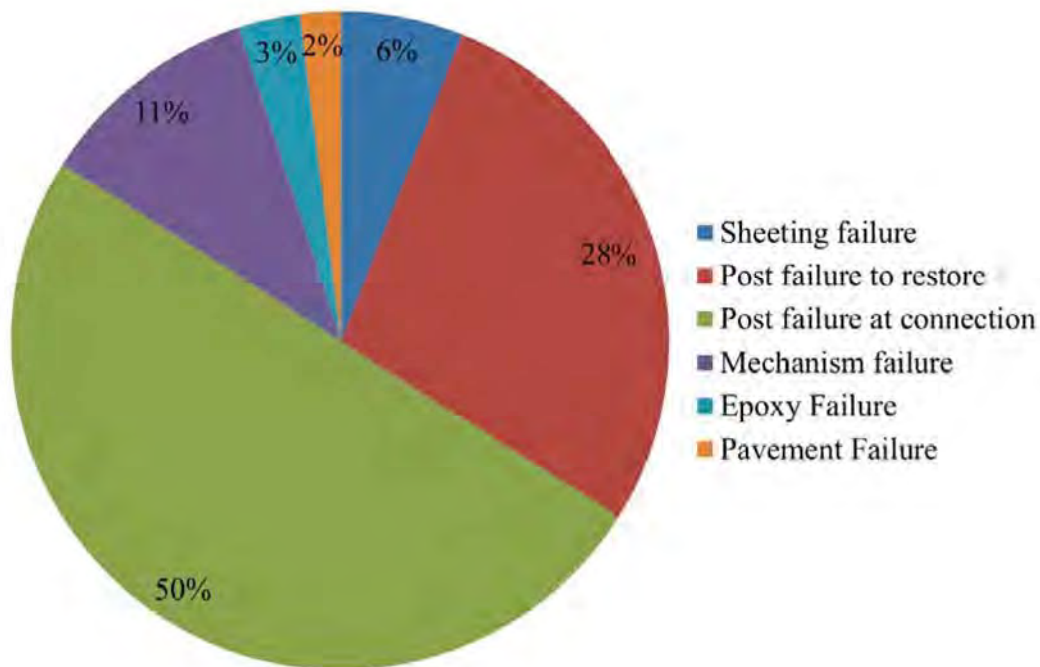
Figure 2. Distribution of Failure Modes in Phase 1 of I-95 Express Lanes.

In Phase 1, the researchers followed a two man crew tasked with repairing and/or replacing failed (damaged) delineators in the northbound direction of I-95 at night. The researchers followed the crew while they replaced 100 delineators. For each delineator, the failure mode was noted. There were no data available to identify the type of impact(s) (i.e., vehicle tire or bumper) that likely caused each failure. The time required for the crew to repair or replace the delineator was documented for a sampling of the failures. Figure 2 shows the distribution of failure modes seen in Phase 1. Notice that no base failures were documented in the field.

The first three failure modes (sheeting failure, post failure to restore, and post failure at connection) comprised 84 percent of the repair/replace activities witnessed in Phase 1. All of these failures required replacement of the post to correct. The workers used a cutting tool to remove any portions of the failed posts (as shown in Figure 3) and attached the new post by shoving it down onto the connector. Each of these repairs took about 15 seconds for one worker to perform.

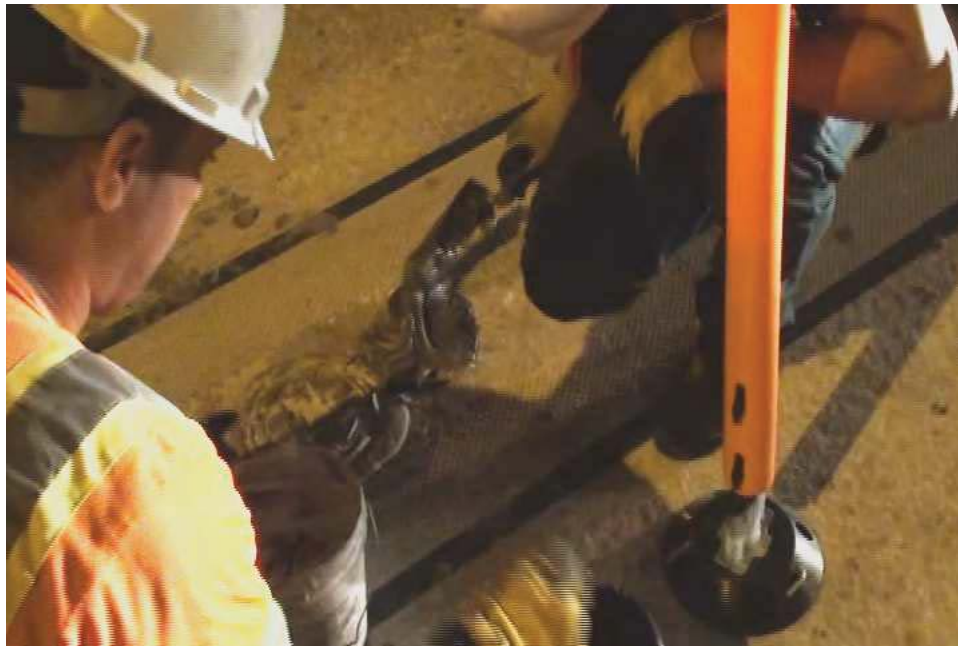
Figure 5. Epoxy Failure and Pavement Failure Replacement.

When the epoxy or the pavement has failed, a new delineator was installed. The workers swept a small area of the pavement by hand and mixed a small batch of two-part epoxy directly on the pavement (as shown in Figure 5). A new delineator was placed and the workers set the

delineator by rotating it in the wet epoxy, checking for proper alignment, and stepping on the top of the base to force the epoxy up into the pockets in the bottom of the base. This process took about 4 minutes for two workers to perform.

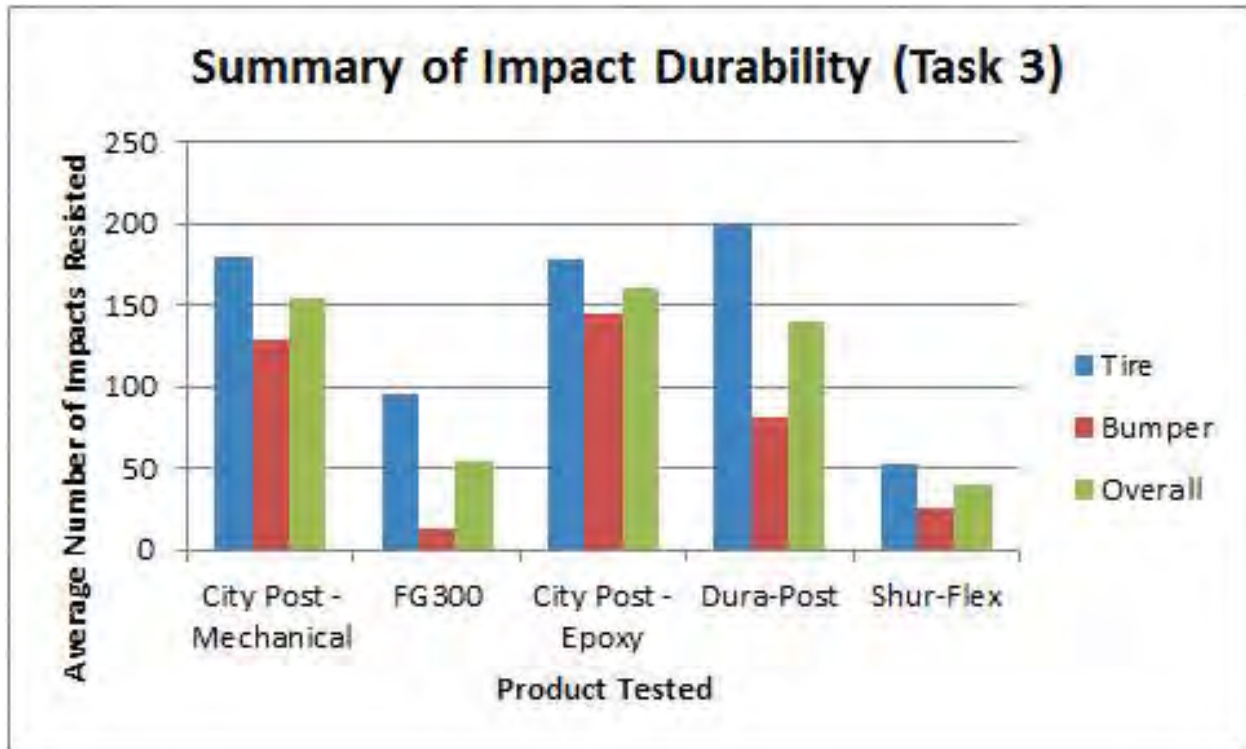
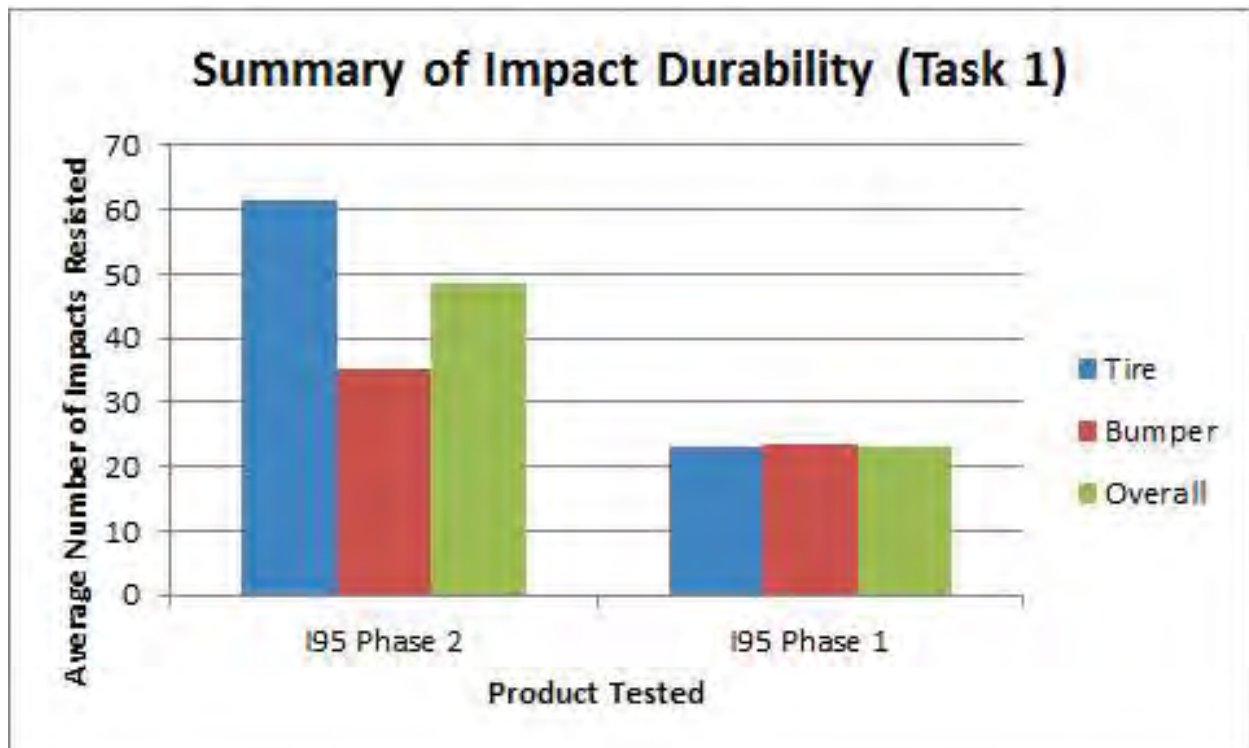
After an extensive evaluation of the data, the researchers recommend setting a minimum average of 150 tire impacts and a minimum average of 45 bumper impacts resisted. These minimum values would serve as an additional requirement that a product must meet in order to be considered for a managed lane marker application. These recommended values come directly from the data obtained while testing the products under Task 3 and represent the state of the possible.

Figure 32. Summary of Impact Durability (Task 3).

Figure 33. Summary of Impact Durability (Task 1).

When determining the minimum average number of tire impacts, the researchers looked at the performance of the test samples under Task 1 and Task 3. After looking at the data, there was a large gap between product performances. This created a reasonable and scientific reason to set a minimum performance level for tire impacts that separates the two performance levels. The researchers recommend that a minimum value of 150 impacts be used as a minimum average number of impacts to be resisted by an impacting vehicle tire. Figure 34 shows the average number of tire impacts resisted for each delineator compared to the recommended minimum value. The City Post (mechanically anchored), City Post (epoxy anchored), and Dura-Post (epoxy and mechanically anchored) samples all meet the minimum. The FG300, Shur-Flex, I95 Phase 1, and I95 Phase 2 products do not meet the minimum requirement.

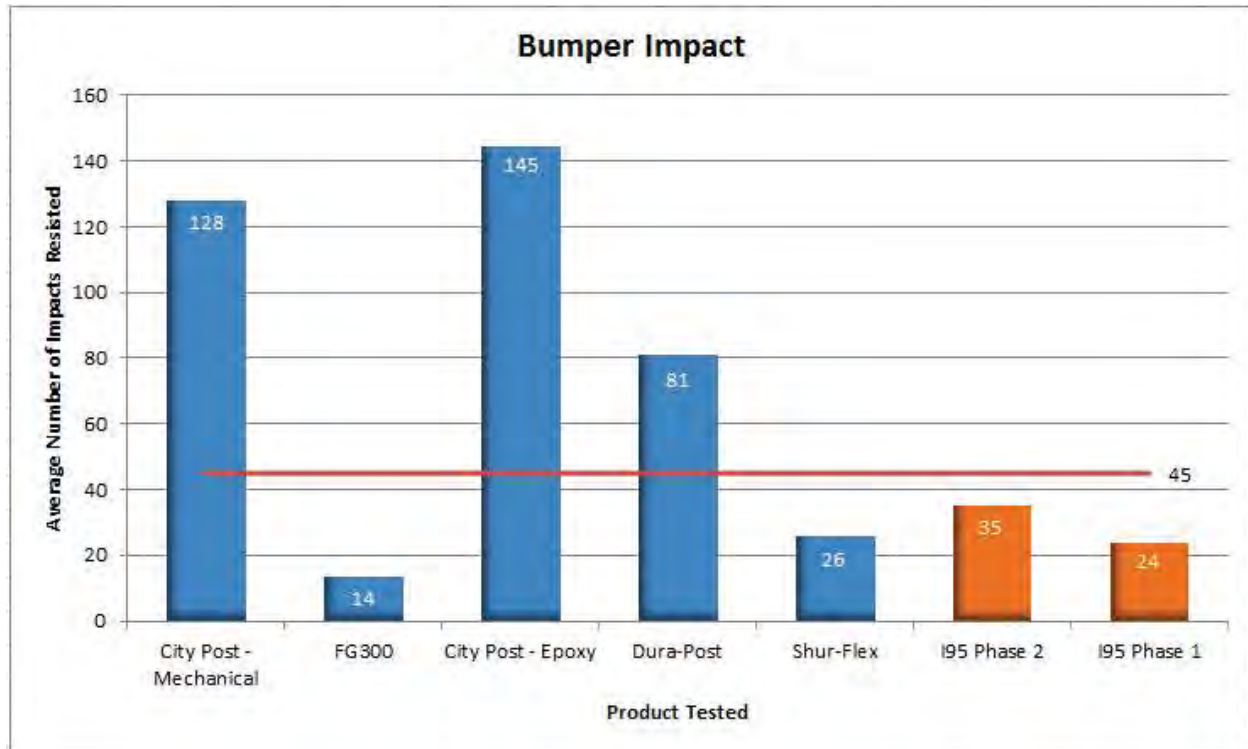
Figure 35. Average Number of Bumper Impacts Resisted.

each product compared to the recommended minimum value. Again the City Post (mechanically anchored), City Post (epoxy anchored), and Dura-Post (epoxy and mechanically anchored) samples all meet the minimum requirement. The FG300, Shur-Flex, I95 Phase 1, and I95 Phase 2 products do not meet the minimum requirement.

When evaluating impacts with the front bumper, a trend was witnessed. This time three rather than two groups of product performance were noticed. The best performing group included two products from Pexco and had a minimum impact performance of 128 impacts resisted. The third lowest performing group included the FG300, Shur-Flex, and I95 Phase 1 and 2 products. The third and final group was comprised by only 1 product, the Dura-Post. While the product did perform significantly better than the products found in the third group, it did not perform as well as the City-Post products.

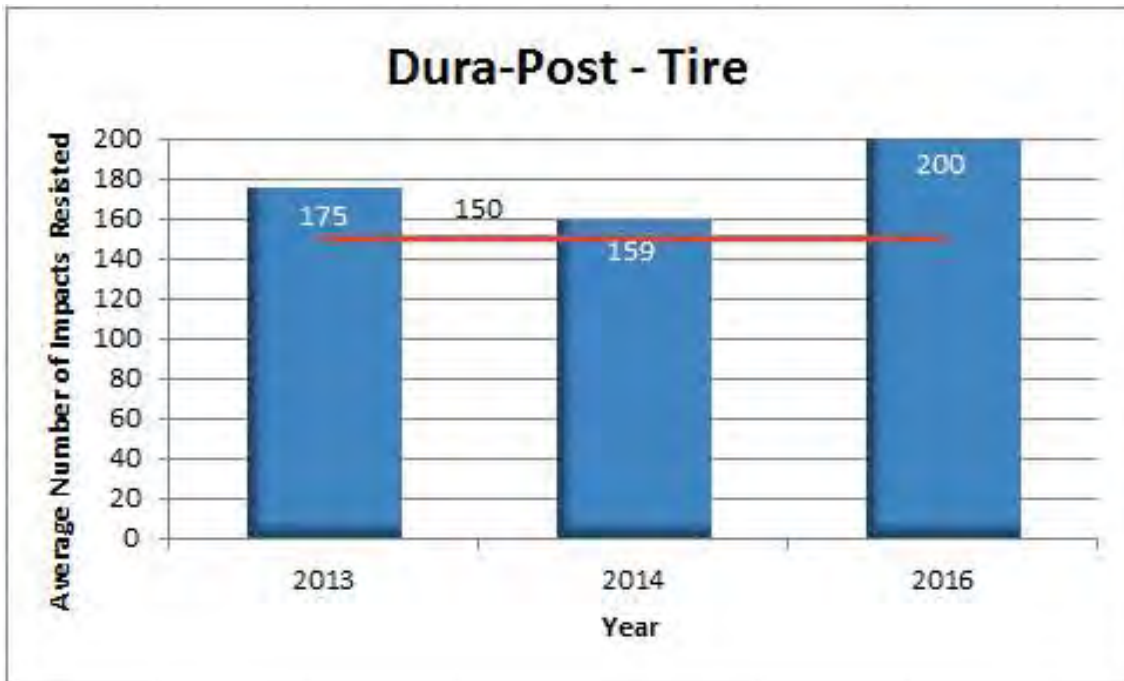
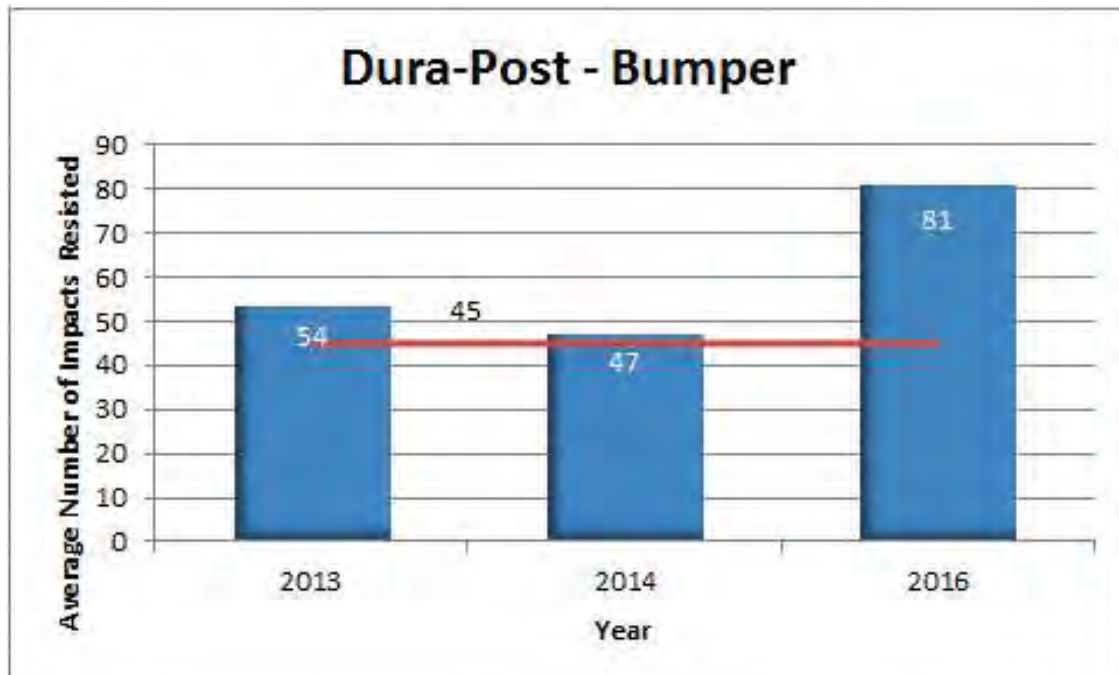
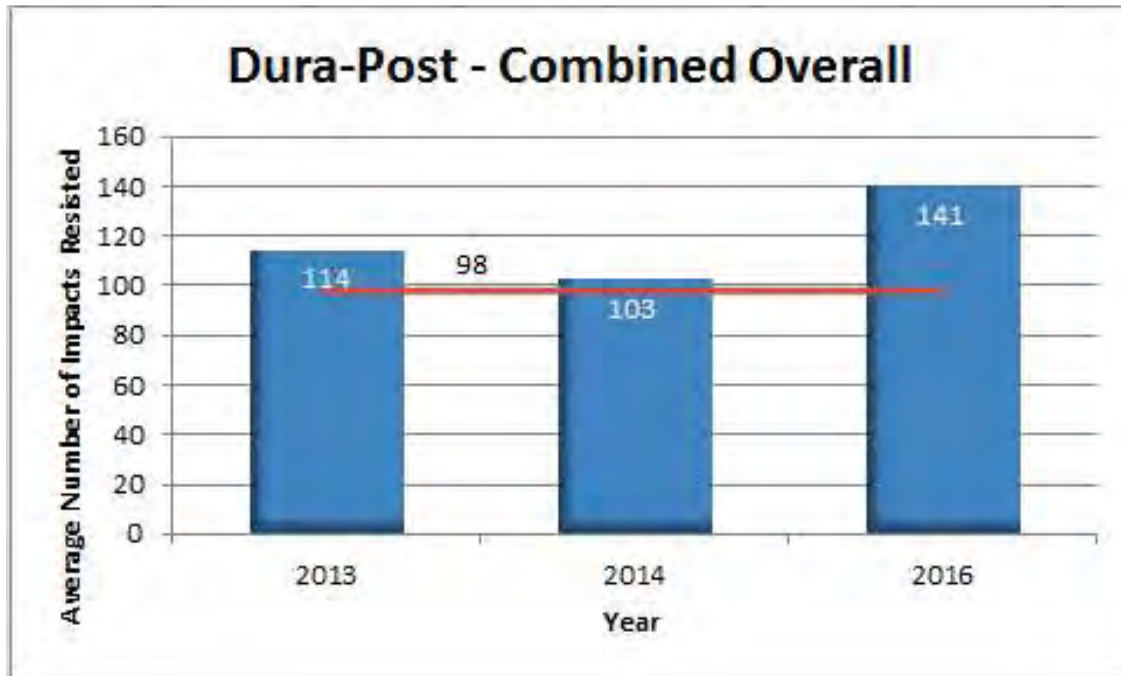
To address this inherent variability, the minimum average number of impacts resisted was shifted lower to accommodate the variability in testing conditions. Figure 37 through Figure 39 indicate how the minimum values were selected to ensure that the Dura-Post and City-Post meet the minimum requirement within a reasonable temperature range for testing under this standard. Additionally, Figure 39 indicates why the minimum value for the average number of bumper impacts resisted is recommended to be much lower than the values witnessed in the 2016 testing.

Figure 37. Average Number of Tire Impacts Resisted.

Figure 38. Average Number of Bumper Impacts Resisted.

Figure 39. Combined Overall Average Number of Impacts Resisted.

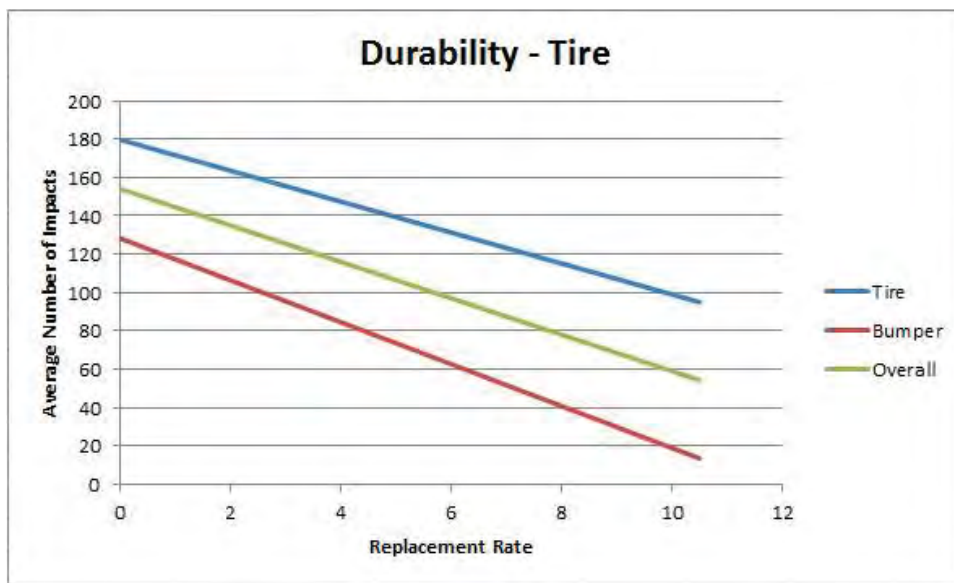
Figure 40. Durability of Delineators.

Product	Distance of Installation (miles)	Total Number of Posts Installed	Spacing (feet)	Average Number of Posts Replaced	Average Annual Cost to Replace	365-Day (Annual) Replacement Rate (%)	Speed Limit (MPH)
Pexco FG300 UR 36"	9	15840	6	1667	\$75,000.00	10.5	65
Pexco EFX 36"	10	13200	8	750	\$65,000.00	5.7	65
Pexco City Post Surface Mount	0.5	405	10	0	\$0.00	0.0	70

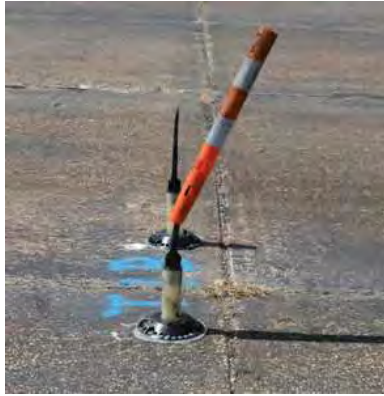
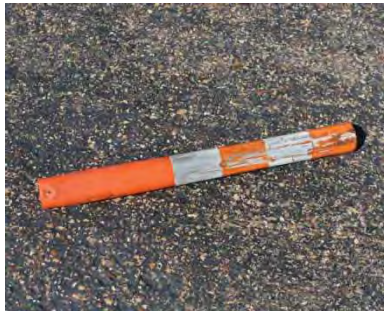
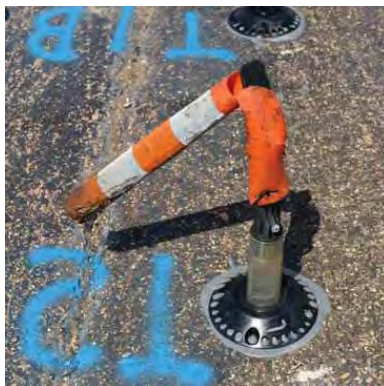
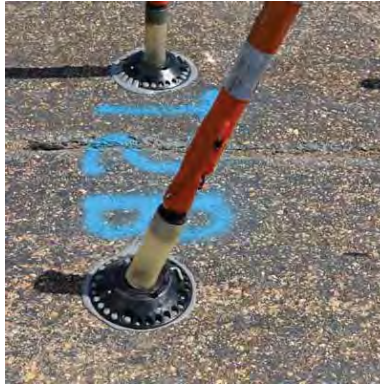
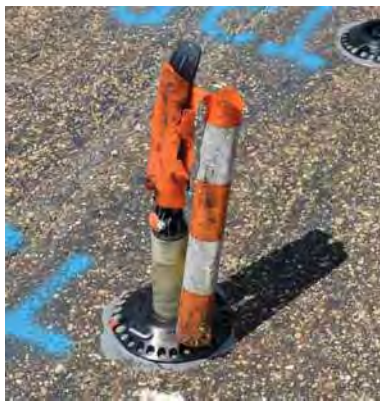
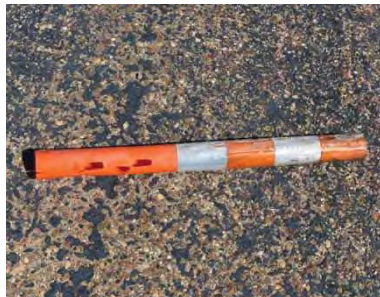
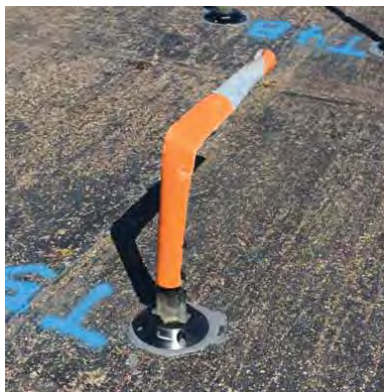
Figure A-1 through Figure A-16 show each delineator sample at failure.

Figure A-1. Sample 1T Failure at 53 Impacts.

Figure A-2. Sample 1B Failure at 27 Impacts.

Figure A-3. Sample 2T Failure at 66 Impacts.

Figure A-4. Sample 2B Failure at 44 Impacts.

Figure A-5. Sample 3T Failure at 71 Impacts.

The testing was performed on September 24, 2015. Table 2 summarizes the test results, including the measured list and lean, number of impacts to failure, and failure mode. For reference, photographs taken at failure for each of the 16 samples are provided in Appendix A.
