DEVELOPMENT OF DELINEATOR TESTING STANDARD

Test Report No. 0-6772-1

**TEXAS A&M TRANSPORTATION INSTITUTE
COLLEGE STATION, TEXAS**

Project Title: Development of New Delineator Material and Impact Testing Standard to Prevent
Premature Failures Specific to Installation Application

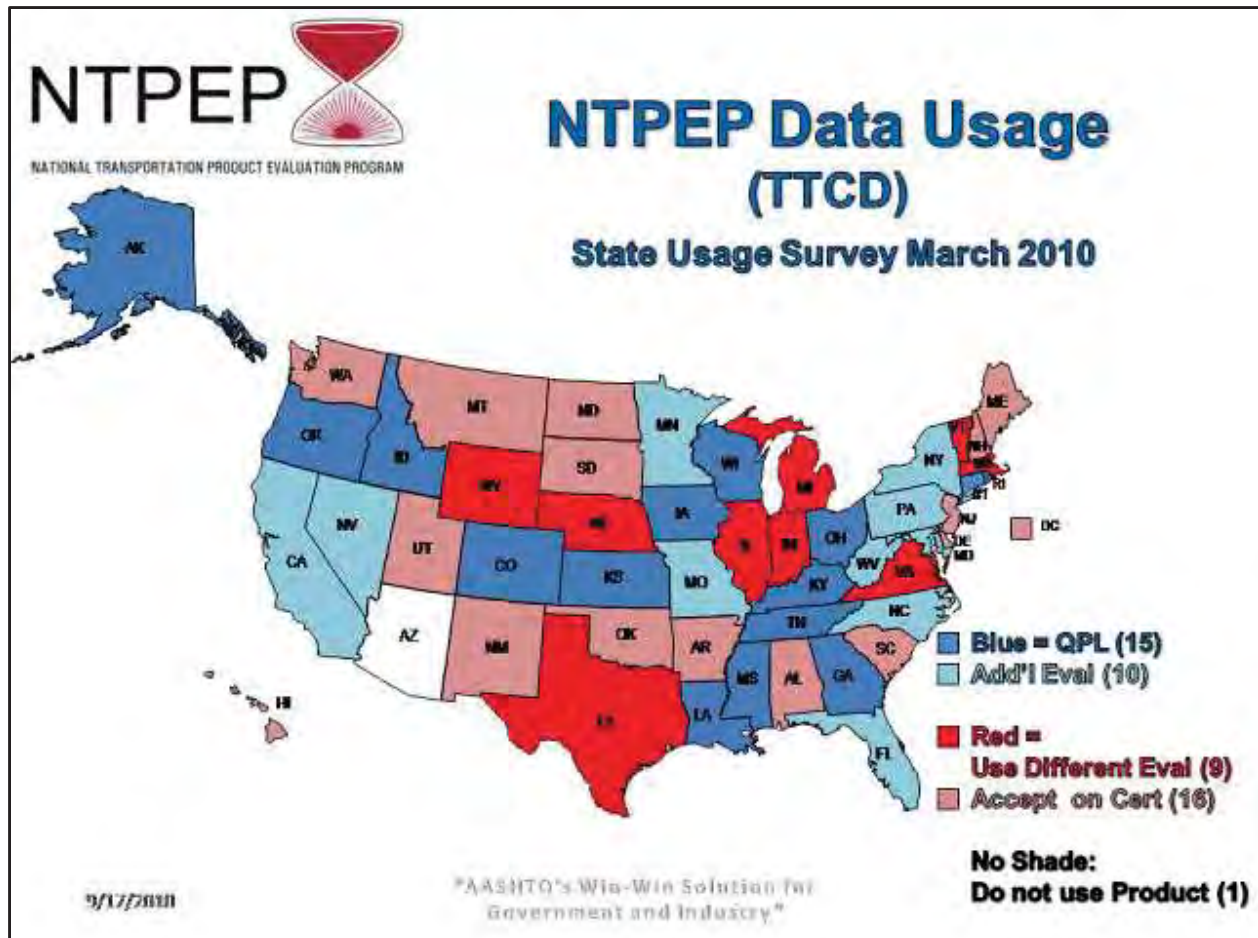
Figure 1.1. NTPEP's Summary Map of State Delineator Testing Requirements.

Many states who have additional requirements simply increase the number of impacts and keep the same testing protocol. As manufacturers strengthen their designs to resist an increased number of impacts, it is expected that the likelihood of failures in the field would decrease. This method is not necessarily the most efficient solution to the problem. The standard may in fact be driving up the cost of delineators without actually addressing failures in the field. These testing standards may result in a delineator design that will perform well in a test, but may perform poorly in the field. An example of this may be a result of using the wrong test vehicle (different test vehicles result in different impact delineator performance). Some states, shown in red, have developed their own independent specifications, which can be less stringent than the NTPEP impact standard.

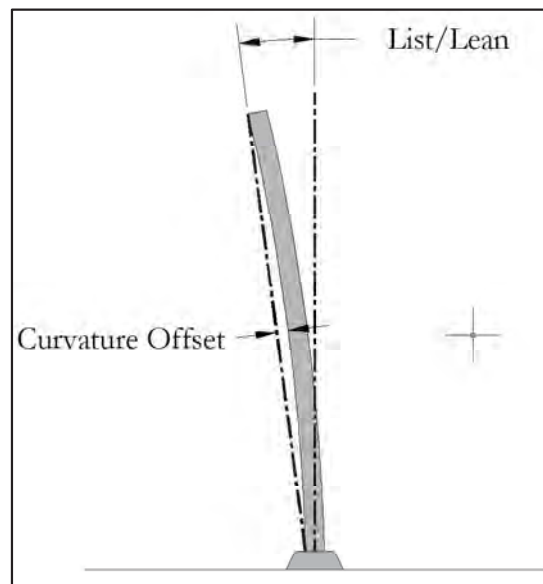
Figure 5.3. Diagram of Measurement Methods.

For this reason, the researchers developed a standard method for measuring list/lean and curvature offset shown in [Figure 5.3](#). The list and lean are measured from the base of the delineator to the top edge of the delineator using a digital level that reads degrees. The curvature offset is measured at the maximum offset from the level in inches. These measurements were taken after the following impact numbers:

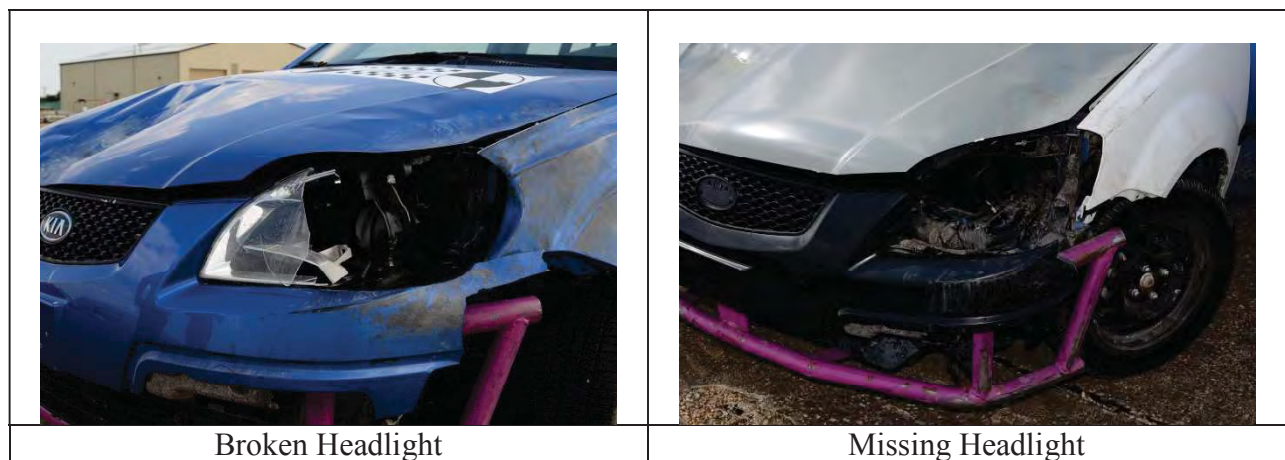
Figure 7.2. Headlamp Damage.

Two different failure modes of the headlamp were witnessed during the impact testing of delineators. The first was the failure of the lens itself due to repeated delineator impacts. The second was the failure of the mounting points for the headlamp. In this case, the intact headlamp was ripped from the vehicle by the repeated delineator impacts. Images of both failure modes can be found in [Figure 7.2](#). The researchers felt this was a significant change in the geometry of the impacting vehicle and felt that this problem needed to be addressed to prevent it from occurring in future testing.
