**GRADE CROSSING PROTECTIVE FUND  
2009 – 2011 GRANT APPLICATION  
OPEN CALL FOR PROJECTS**

1. Summary of Hazard

## 2. Proposed hazard mitigation

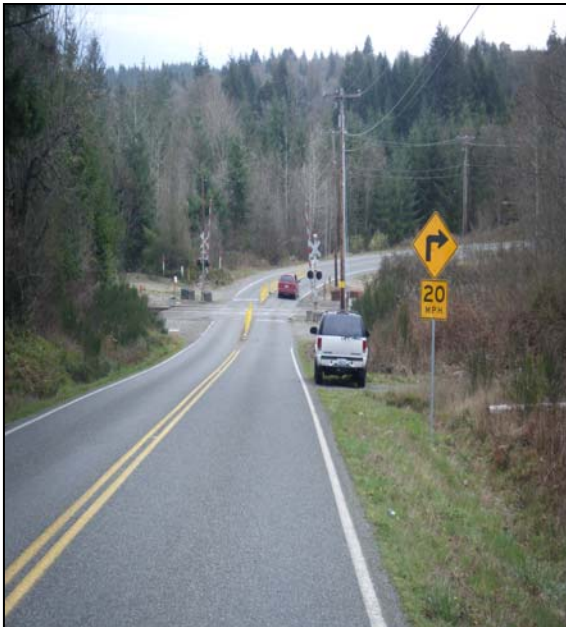
Eastbound 143<sup>rd</sup> Ave SE

The area being investigated is on 143<sup>rd</sup> Ave SE that is a two lane rural county road (see vicinity map below). The railroad crossing sits at the bottom of a vertical curve and beginning of a horizontal curve. Furthermore there is an intersection just south of the crossing and vegetation and an earth berm affect sight distance around the horizontal curve. BNSF has expressed concern regarding this crossing and the sight distance for westbound traffic. They mentioned at an on-site meeting that the gates had been hit before which is the reason BNSF placed ecology blocks in front of each gate. These incidents appear to be un-reported crashes and have caused damage to the gates. These

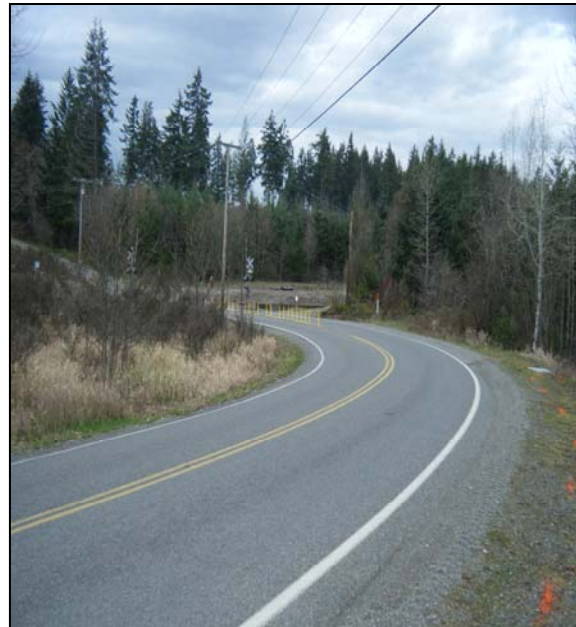
Westbound 143<sup>rd</sup> Ave SE

The concerns at this location are three-fold one is driver awareness of the crossing (especially for westbound traffic), roadway departures and the continued deterioration of the median barrier. They are interrelated at this location need to be addressed enhance and maintain the safety of this crossing. We evaluated several different types of improvements and those include flashing beacon on advanced warning sign, traverse rumble bars, shoulder widening, enhanced signing and sight distance enhancement along the horizontal curve. A summary of the possible safety benefit of each is below:

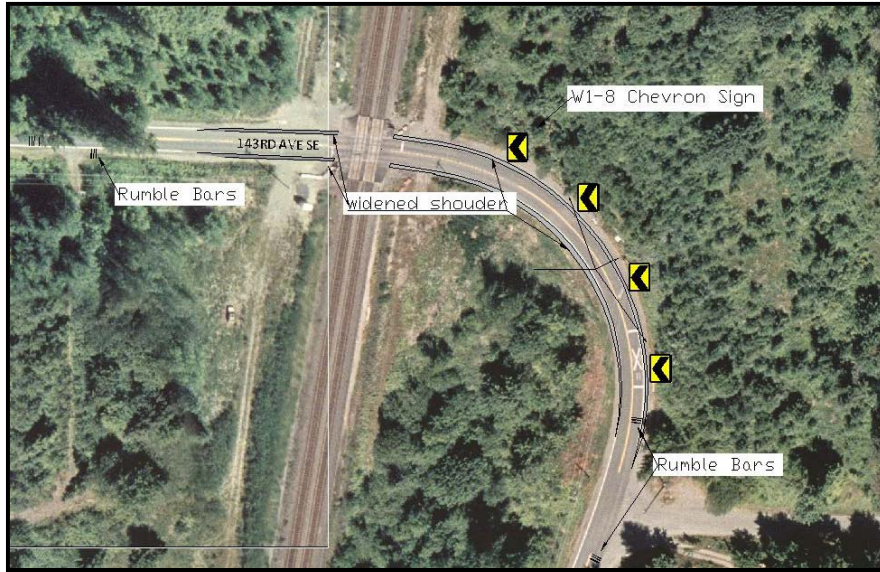
Sample Project Layout<sup>6</sup>

- Providing paved shoulders through crossing<sup>5</sup>
- Replacing the mountable median barrier (100' each side of crossing)
- Adding delineation to the curve (i.e., chevron signs)
- Adding rumble bars at the approach to the curve and railroad crossing signs

<sup>6</sup> Note median replacement is not shown

We evaluated providing paved shoulders for a couple reasons. Shoulder widening is a proven measure to reduce roadway departure crashes and also will help reduce long-term maintenance of the median barrier. Currently the roadway is narrow and vehicles do not have much room to shy away from the median as such this median is damaged by vehicles more than others we have in Thurston County. The widened shoulder will provide additional room for vehicles to shy away from the median and we hope will reduce damage and reduce the frequency of the delineator post replacement.
