Rail Incident Investigation Report

Docket No: TR-180581

Road name, yard name, bridge identifier: Perkins Rd. 7572

A westbound freight train struck a vehicle that drove around the crossing gate arm at Perkins Road. Witness statements indicate that the crossing gate arms were in the down position and the driver attempted to drive around the crossing gate arm which resulted in the vehicle leaving the roadway and becoming high-centered on the railroad tracks at the crossing. Witnesses stated that the driver was struck after she was attempting to exit the car. A statement by the investigating officer indicated the lights, bell and gate arms were functioning at the time of the collision. The officer's statement also indicated that there was a strong odor of intoxicants coming from the driver of the vehicle.

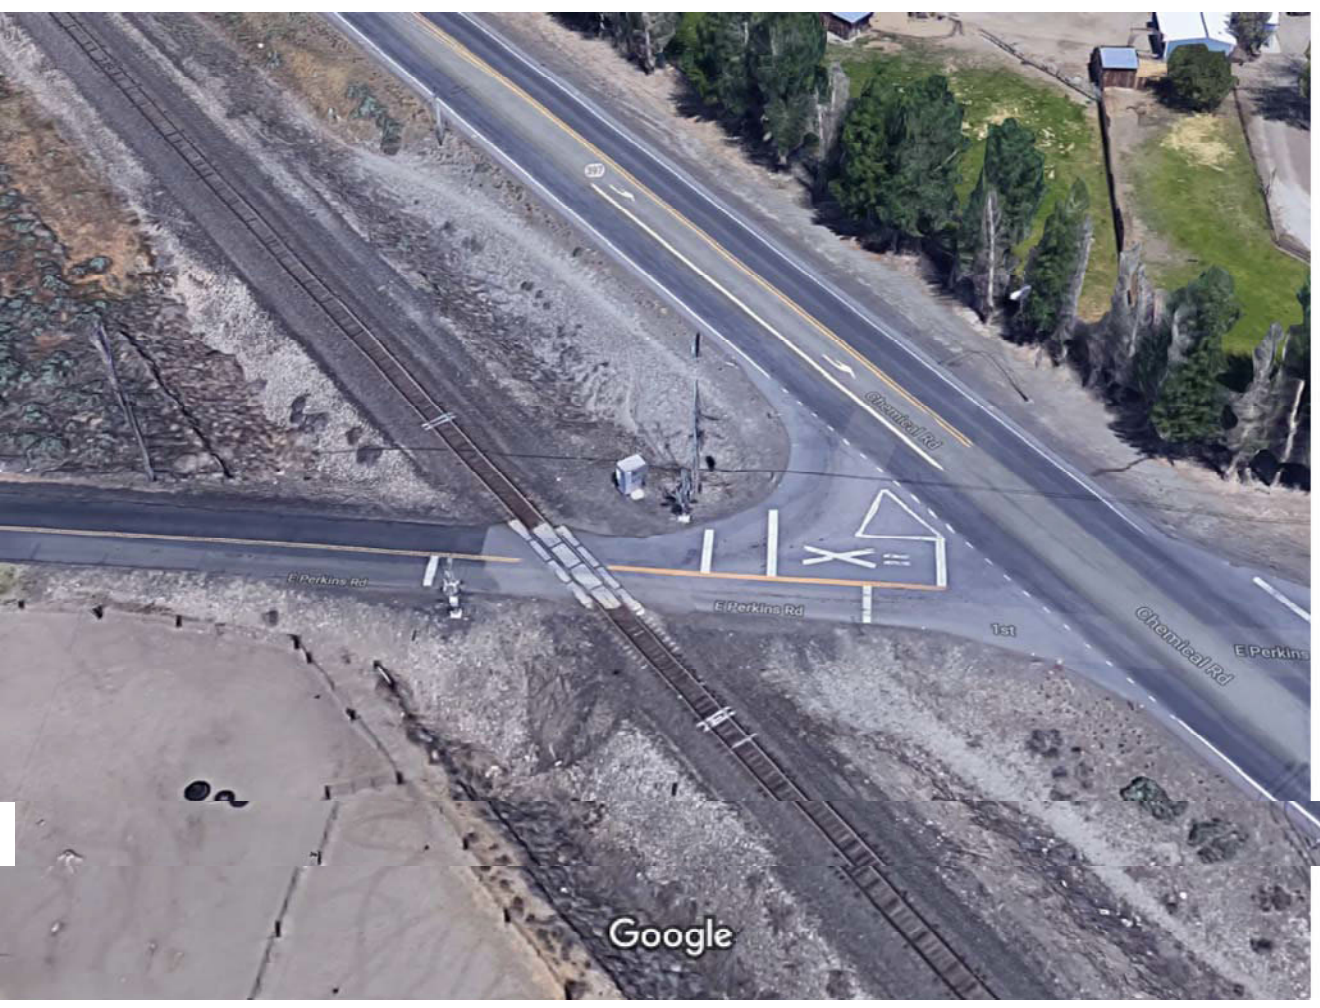
The view of the sight distance to the northwest at the stop line The train was coming from this direction

The view of the sight distance
to the southeast at the stop
line

S ght distance to the northwest s 1500' or greater on a tangent section of track

Sight distance to the southeast is 1500' or greater on a tangent section of track

Accident site

Describe: Tangent section of track with 1500' sight distance in both directions. The 1500' sight distance to the Northwest is partially obstructed by the crossing signal bungalow.

This is a public railroad crossing equipped with active and passive warning devices which consist of advance warning signs, pavement markings, crossbucks, flashing lights, gates, and a bell. The tangent section of track has adequate sight distance to the southeast. When facing west at the stop line on Perkins Road a portion of the sight distance to the northwest is partially obstructed by the crossing signal bungalow.

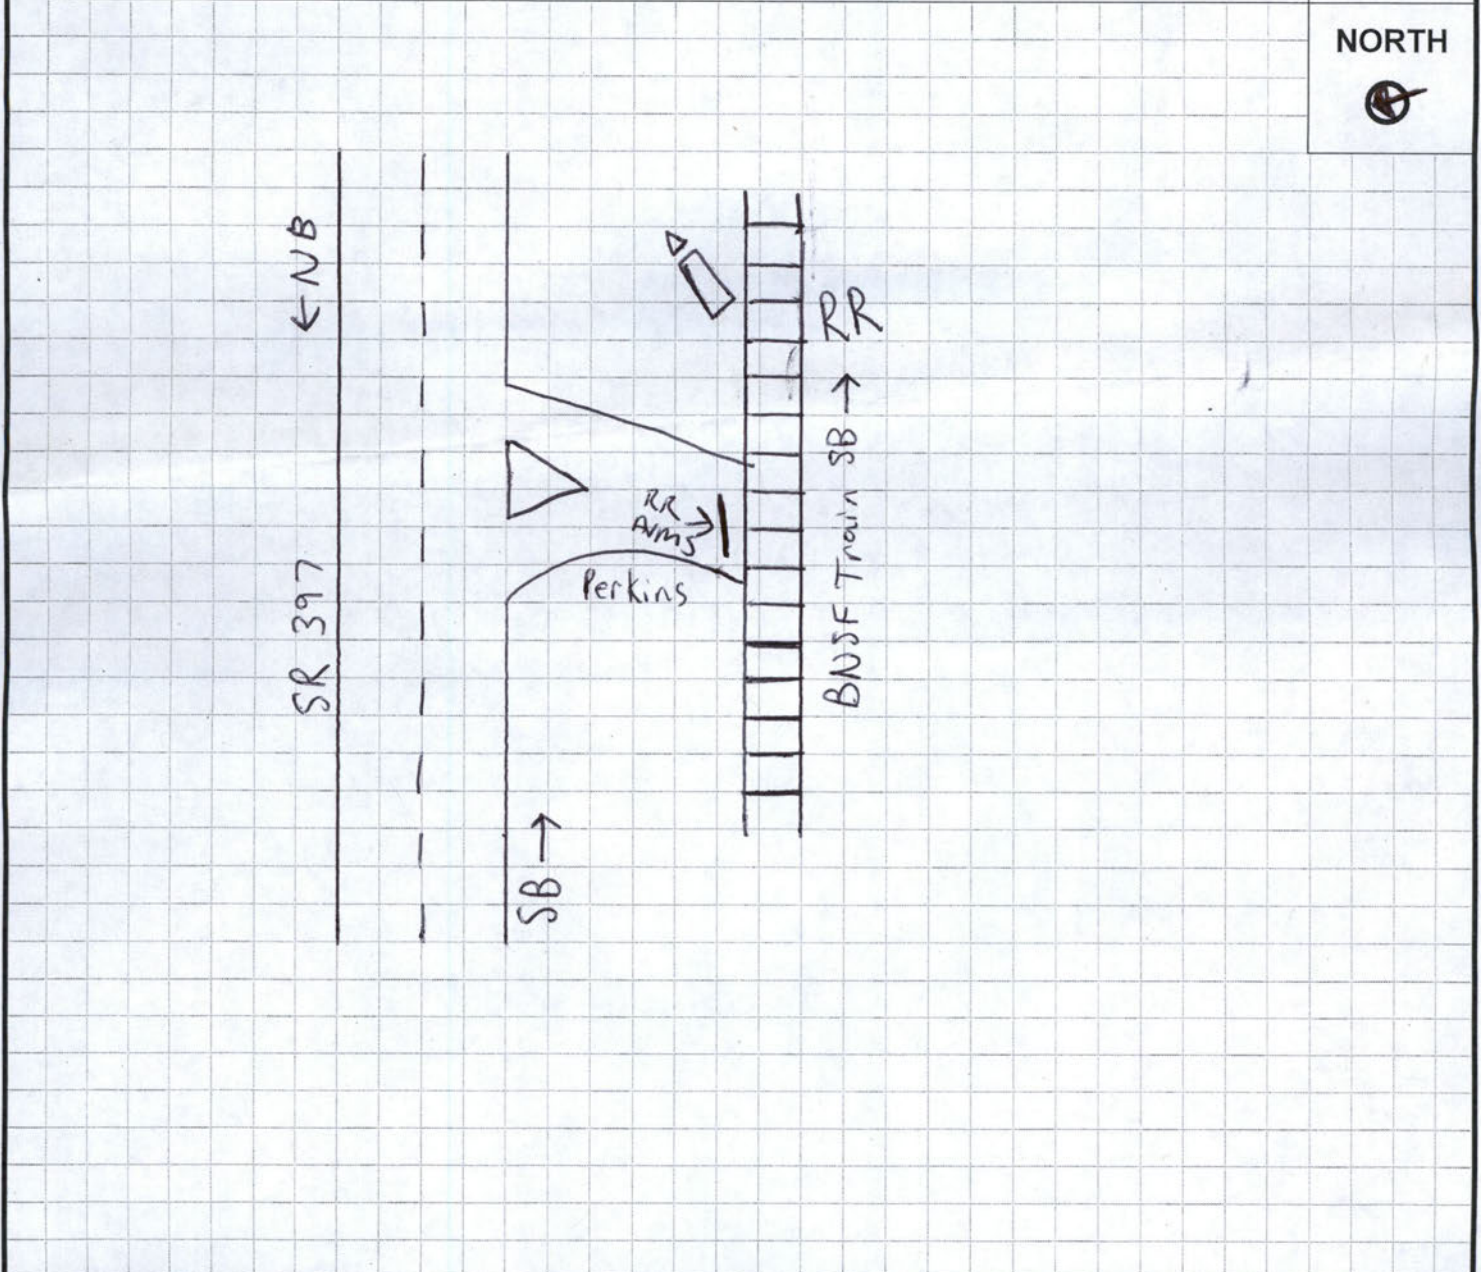
LOCATION SR 397/Perkins			COUNTY Benton
# OF LANES EACH DIRECTION 1	GRADE OF ROADWAY Level	SUPERELEVATION -	STRIPING Double yellow
LIGHTING Street lights	VISIBILITY Clear	COEFFICIENT OF FRICTION f= f= f=	HOW OBTAINED -
TYPE ROAD SURFACE Pavement Blacktop			
WEATHER Clear			TEMP 66 F

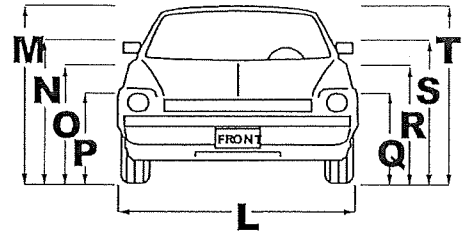
A Length Overall L	5'6"
B Top of Bumper Front	1'9"
C Front to Front Axle L	4'1"
D Wheelbase L	7'11"
E Rear Axle to Rear L	3'5"
F Track Width Rear	5'1"
G Top of Bumper Rear	2'3"
H Rear Axle to Rear R	3'4"
I Wheelbase R	8'7"
J Front to Front Axle R	3'0"
K Length Overall R	14'10"
L Track Width Front	5'7"
M Roof Height R	5'0"
N Mirror Height R	3'3"
O Fender Height R	3'2"
P Headlight Height R	2'3"
Q Headlight Height L	2'8"
R Fender Height L	3'0"
S Mirror Height L	3'7"
T Roof Height L	4'4"

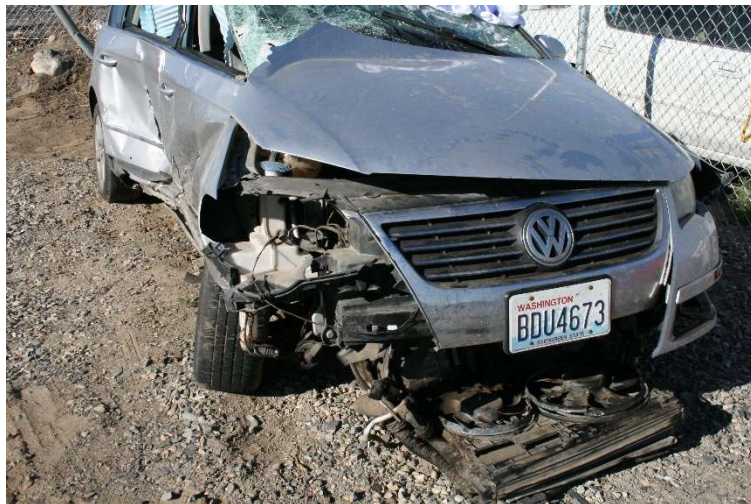
2007 Volkswagen Passat- WA BDU 4673

VEHICLE ONE-

I began to photograph the Passat starting from the rear and working counter-clockwise around the vehicle. I observed the vehicle registration to be Washington BDU4673. I observed the rear right quarter panel sustained almost no damage. The passenger side contact damage started at the rear passenger door with the center of the engine impacting the front, "A pillar," of the vehicle. I was able to determine this due to a large square gouge in the frame of the vehicle that matched a metal spike on the front coupling assembly on the lead engine. The top frame rail on the passenger side of the vehicle began to buckle due to the force of the impact. There were dents along the entire passenger frame rail from the vehicle's frame bending post impact.

There was severe contact damage with intrusion to the front right quarter panel of the vehicle. I observed the bumper area of the front of the vehicle sustained contact damage underneath the bumper. The front windshield was broken starting from the passenger side. The hood of the vehicle was canted with the front passenger side higher than the driver's side. The front left quarter panel of the vehicle sustained damage from the front tire being broken away from the vehicle and pushed out to the left. The rest of the driver's side was largely undamaged other than induced damage to the top frame rail. I observed the driver's door to be open with the vehicle keys inside the door pocket. Inside of the vehicle I observed the dashboard began to buckle upwards in the center of the vehicle, exposing the inside of the dash.

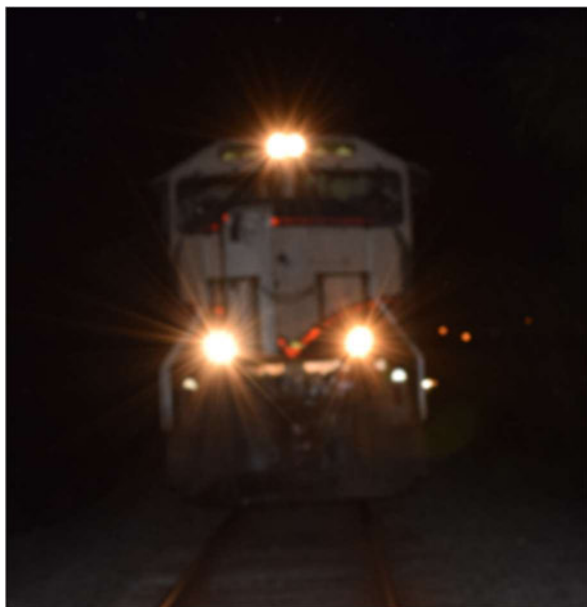
BNSF Locomotive

VEHICLE TWO

The front of the engine had a coupling assembly and a metal guard around the bottom of the engine. The metal is approximately 1/4 - 1/2" thick and designed to clear debris from the tracks rather than going under the train. I observed the bottom of the metal coupling assembly has a

metal spike sticking out and it matched the damage to the front, "A pillar," area of the vehicle. I observed the bottom of the metal guard around the engine was bent back. I observed scrapes across the coupling assembly, metal guard and contact damage to the metal stairs on the west side of the engine. There was glass debris strewn throughout the front of the engine and down the east side of the engine.

I then walked up to the front of the train. I observed the coupler knuckle on the front of the locomotive had multiple scrapes and scratches on it, as well as silver paint transfer. I could see the cattle guard on both sides of the locomotive and it matched the imprint on the rear passenger door of the Passat. I could see that the impact damaged the steps on the left side of the locomotive that leads into the cab. Trooper Trombley briefly spoke with the train conductor, Nick McLachlan and engineer, Justin Haines. Both stated that they observed the silver passenger car try to go around the train crossing arms on got high centered on rail. They both observed the driver attempt to get out of the vehicle prior to impact. Justin stated he put the train into "Emergency" stop as soon as he realized the car was stuck on the tracks. I spoke with a BNSF track crewman who told me that they would be pulling the video from the front of the train and that I could contact BNSF Police next week to view it. I will get ahold of BNSF Police to set up an appointment.

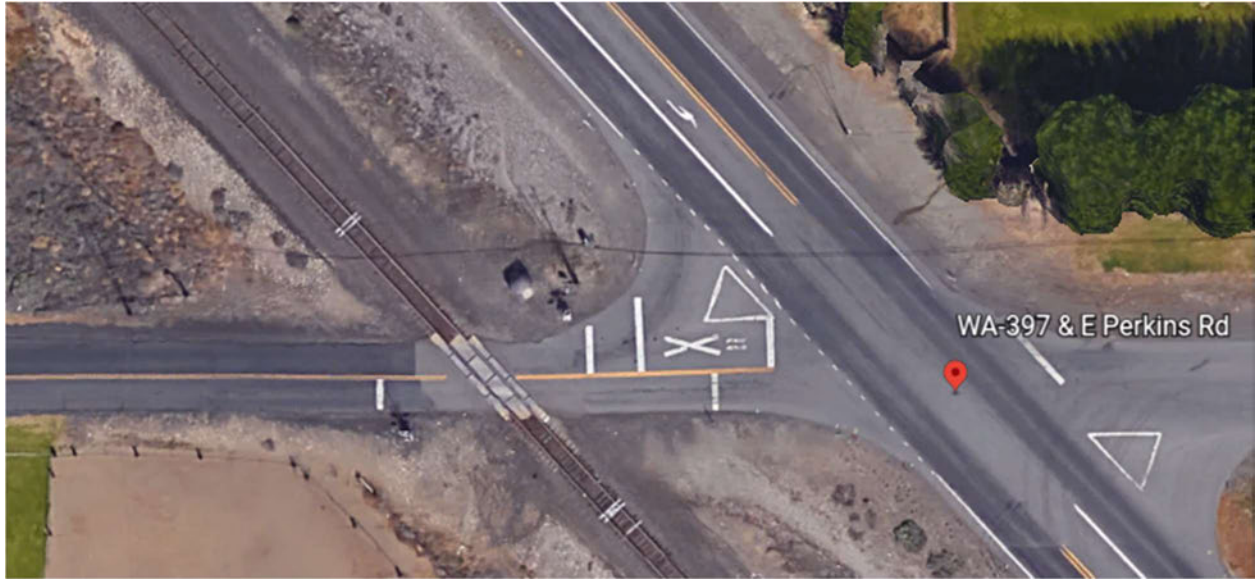
Figure 1- North is Up

East Perkins Road is a paved, east to west road with one lane in each direction marked with double yellow stripe down the center at the train crossing. Heading south on SR397, the turn west onto E Perkins is an acute angle intersection. Heading west there is a slight incline onto the crossing platform and then a sharper decline moving west. The pavement is travel worn but in good condition.

SR 397 and Perkins Road is an acute angled intersection traveling south on SR 397. I believe Madison felt she had more room to go around the crossing gates like you would at a 90-degree intersection. The vehicle's front left tire left the paved surface of the road and Madison was not able to regain the traction she needed to get through the crossing. Based on the damage to the vehicle and the train speed at impact, I feel that Madison may have survived the collision if she remained in the vehicle with her seatbelt on.
