WA COMPLAINT 18-063

SUMMARY: Locate ticket number 18189511 was for a sewer line replacement for the home at 535 SE South St in Pullman, WA. The work to Begin Date was 5/12/18. Avista's locator completed marking the pipeline on 5/11/18. Roach Construction damaged Avista's plastic pipeline with a backhoe at approximately 9:00 am on 6/4/18. Excavator did not begin work within 10 days after request of locate per 19.122.030 (2). Because of the extended delay between when the locate marks were completed and when Roach Construction began excavation, the yard on South St was mowed reducing the visibility of the gas locate marks.

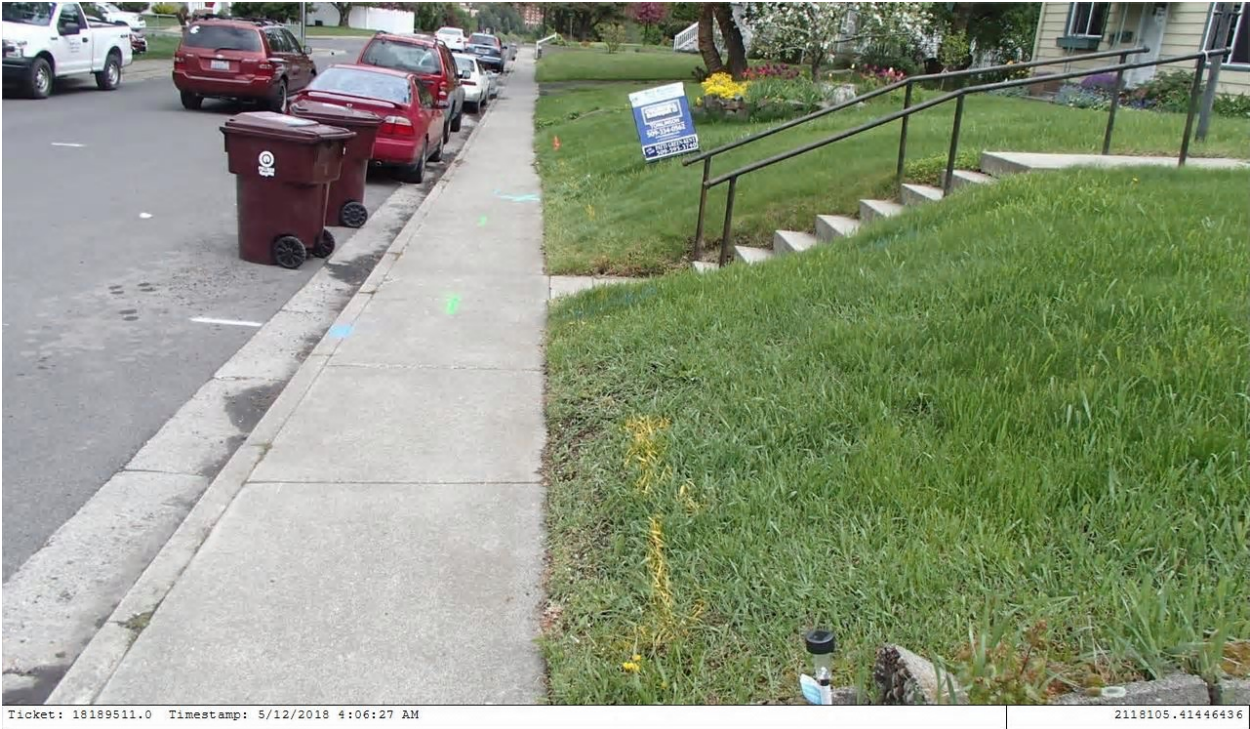
Picture #1 Original locate marks showing the gas pipeline locate marks looking east down the property.

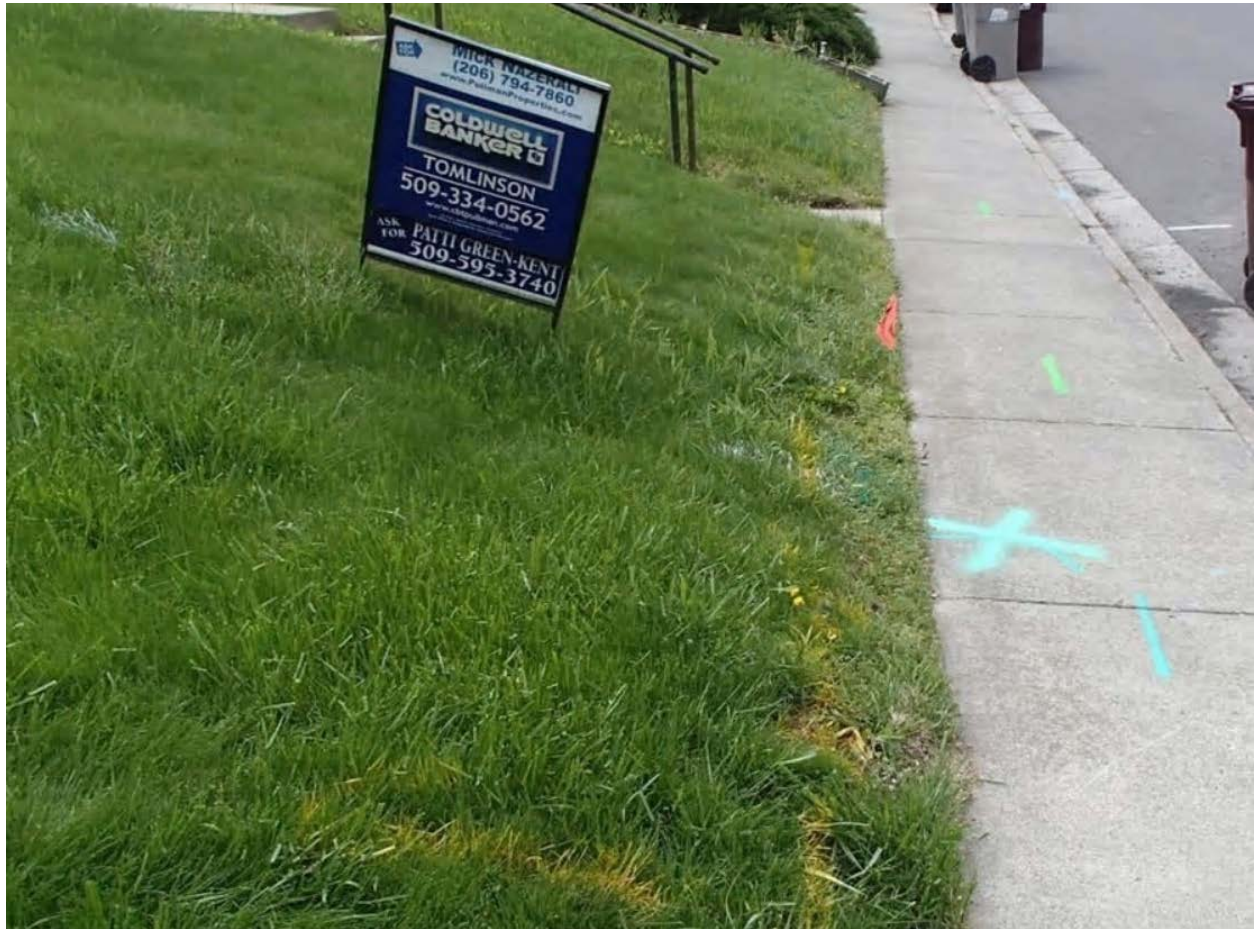
Picture #2 Original locate marks showing the gas pipeline marks looking west down the property. Damage occurred just south of green X mark and where white marks just visible in picture show going south towards the house.

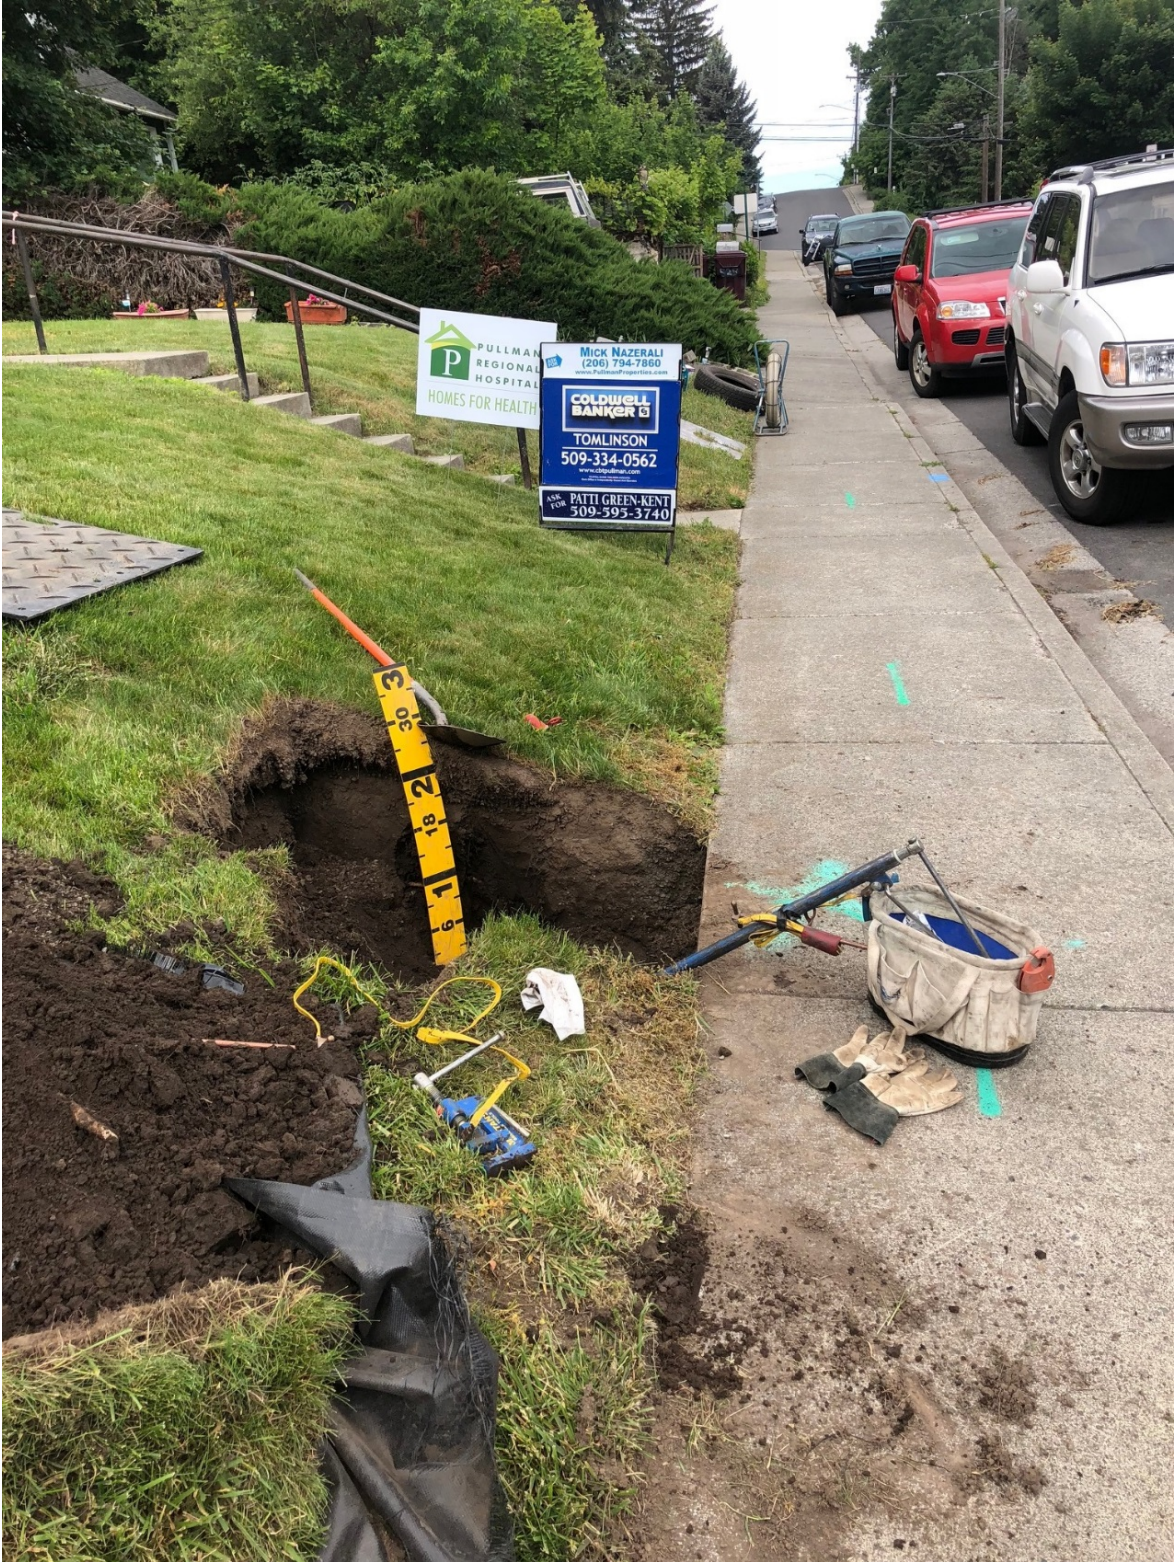
According to Avista's serviceman that responded to the damage, the locate marks that were somewhat visible were accurate. Faded locate marks were still visible just to the east of where the damage occurred and also on the other side of the damage location. Avista's serviceman said that the excavator said he did not see the marks.

Picture #3 dated 6/4/18 showing where damage occurred. Picture also shows yellow gas line marks faded as compared to Picture #2

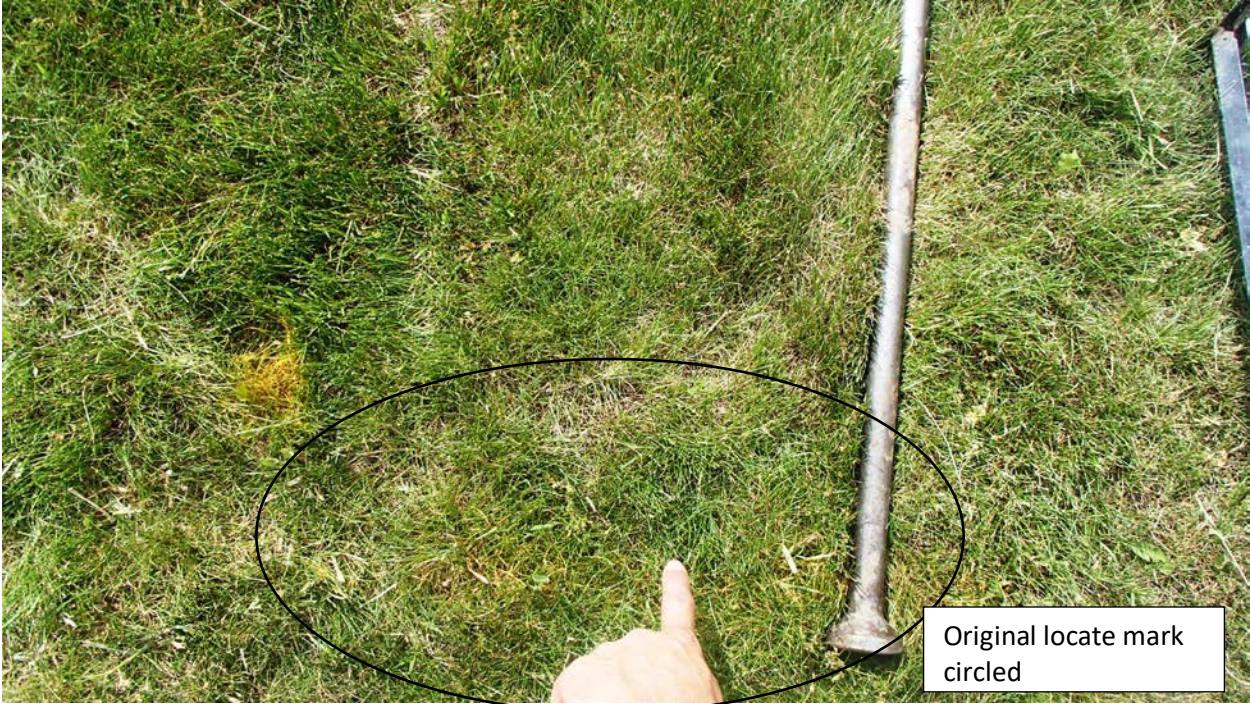
Picture #4 Faded locate marks west of damage location near for sale sign.

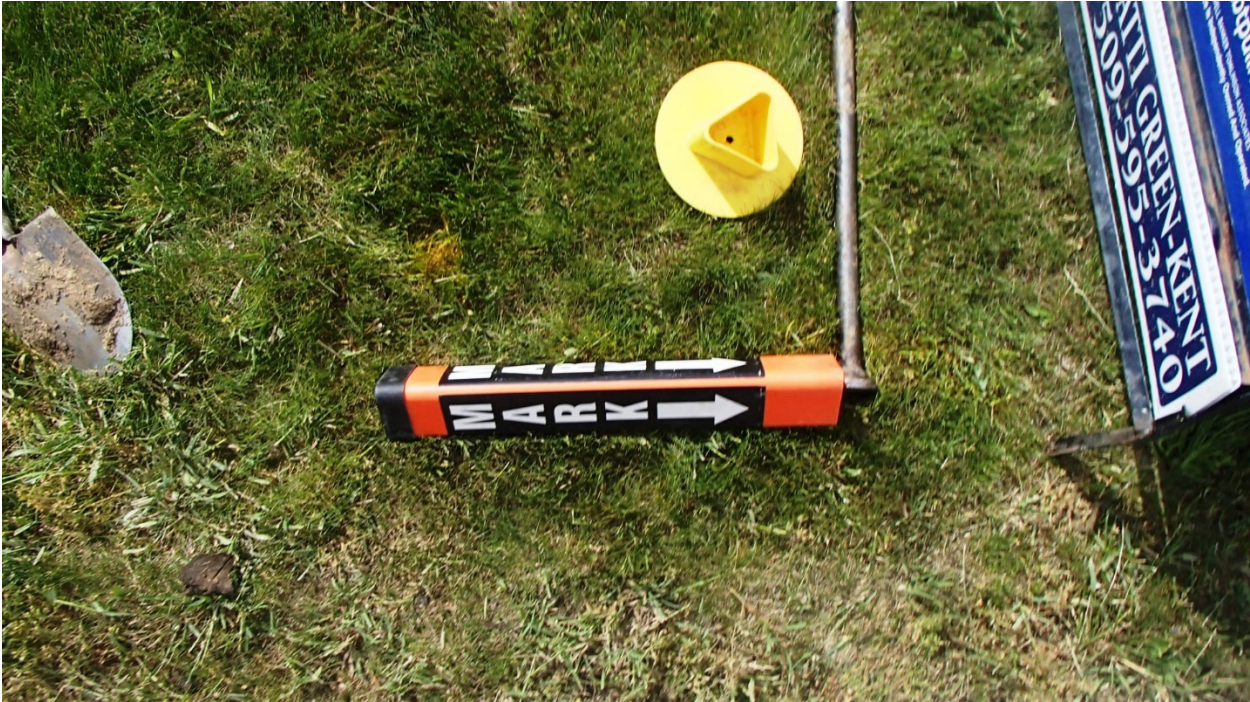
Picture #5 Another view of the faded locate mark west of the damage in relation to the for sale sign.

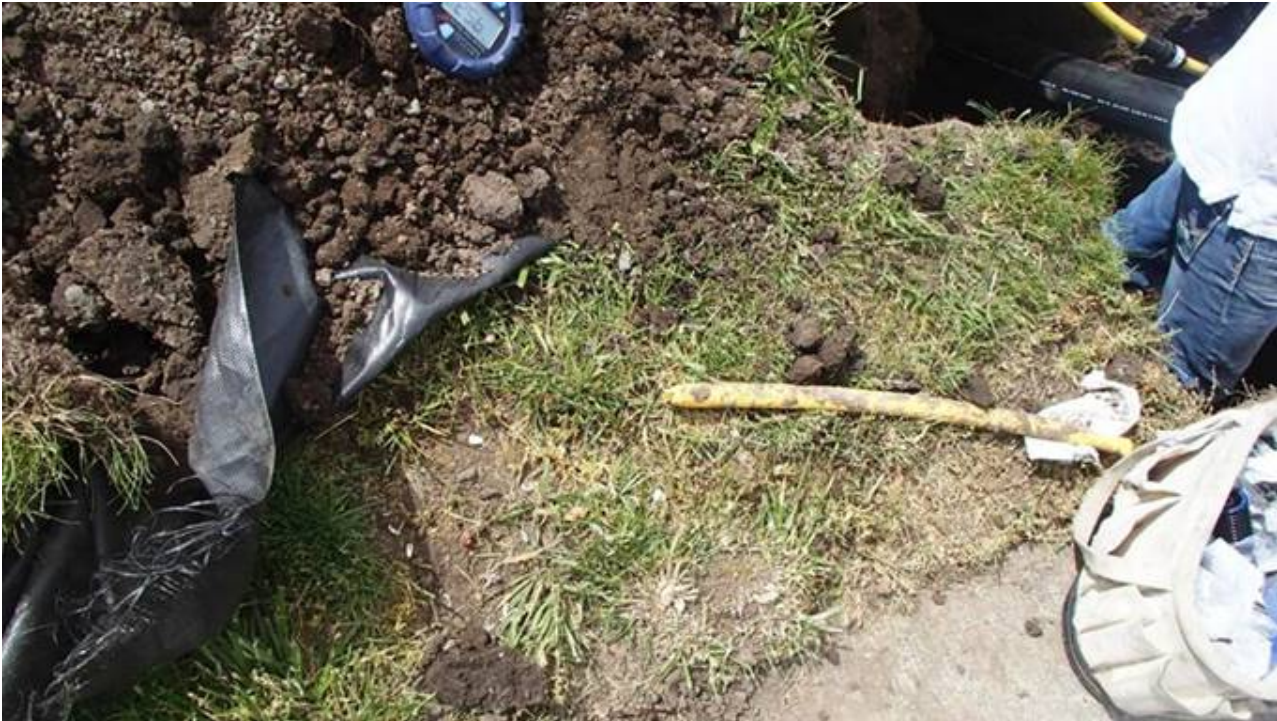
Picture #6 Faded locate marks just east of the damage location

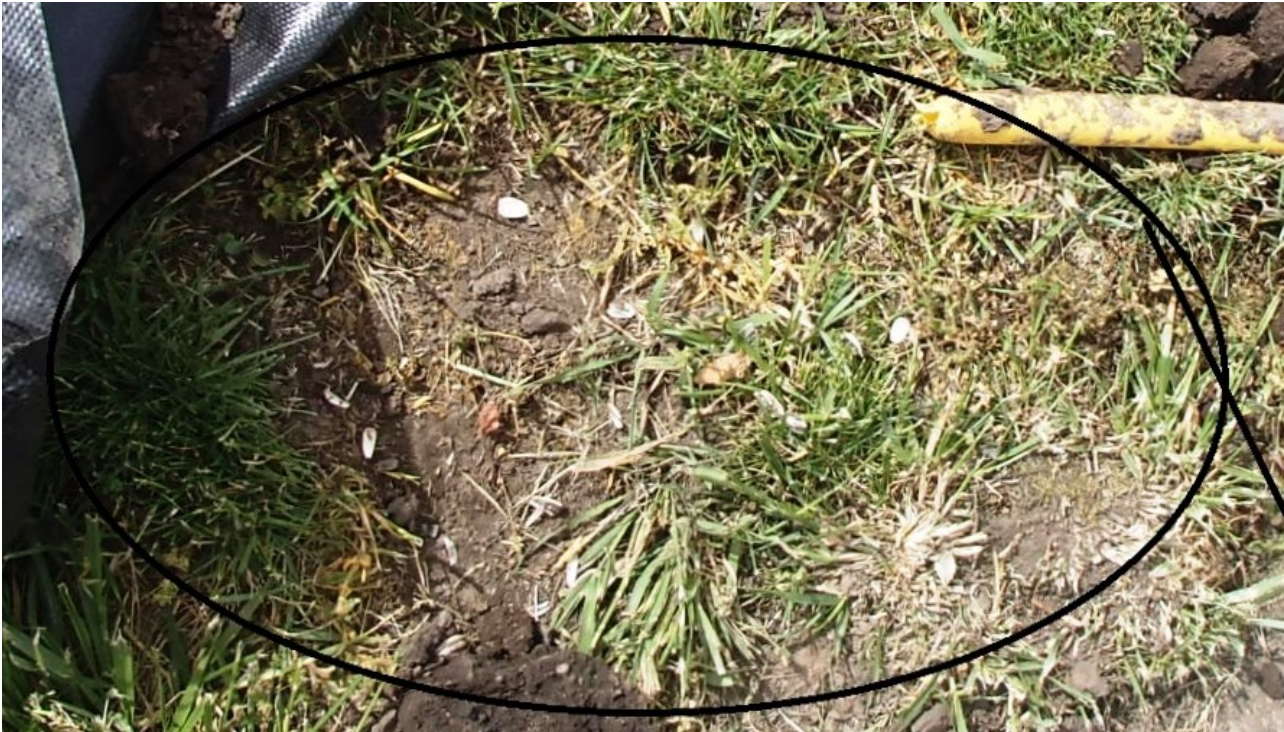
Picture #7 Close up of faded locate mark just to the east of the damage location.

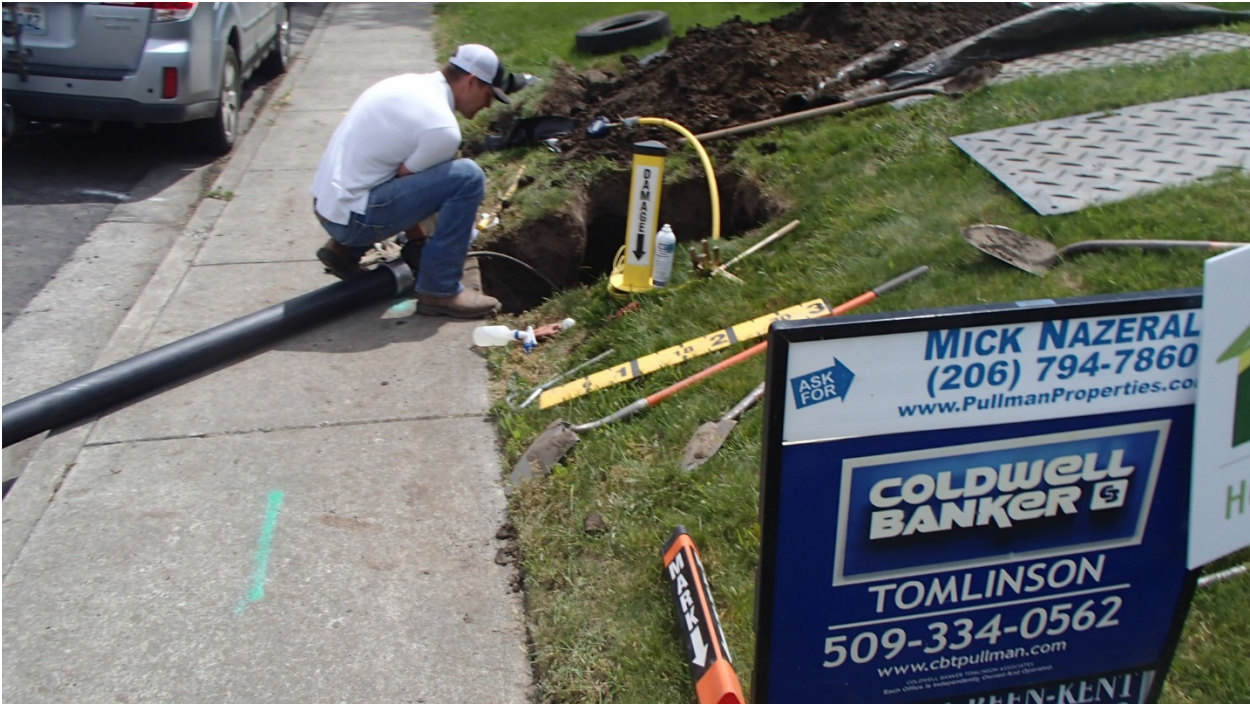
Picture #8 Looking east toward the damage location

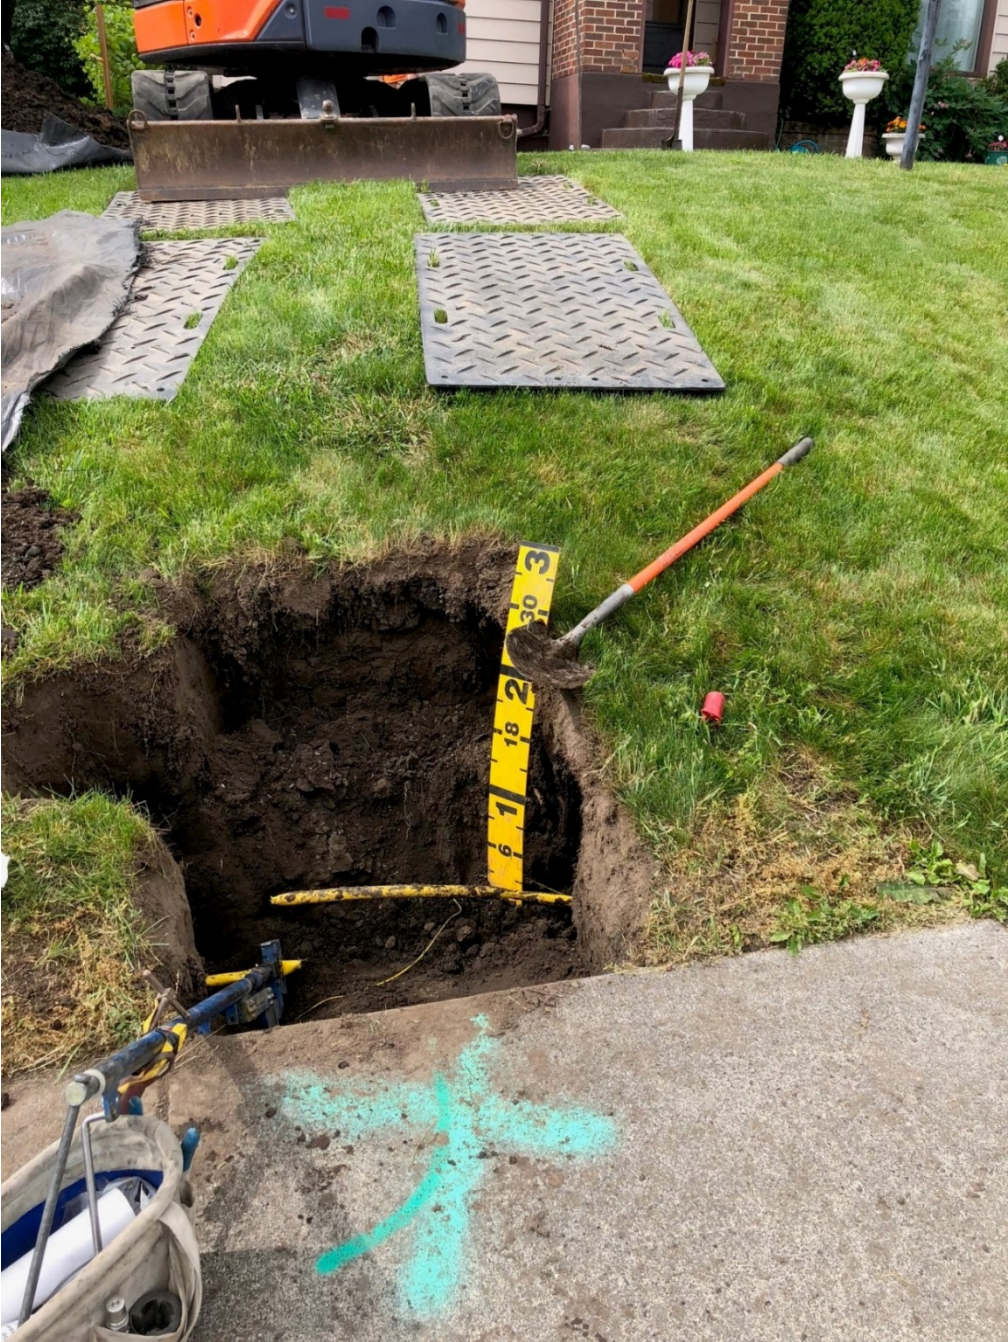
Picture #9 Looking south towards the house at 353 SE South St showing damage to pipe and where backhoe was located at the time of the damage on skid plates.

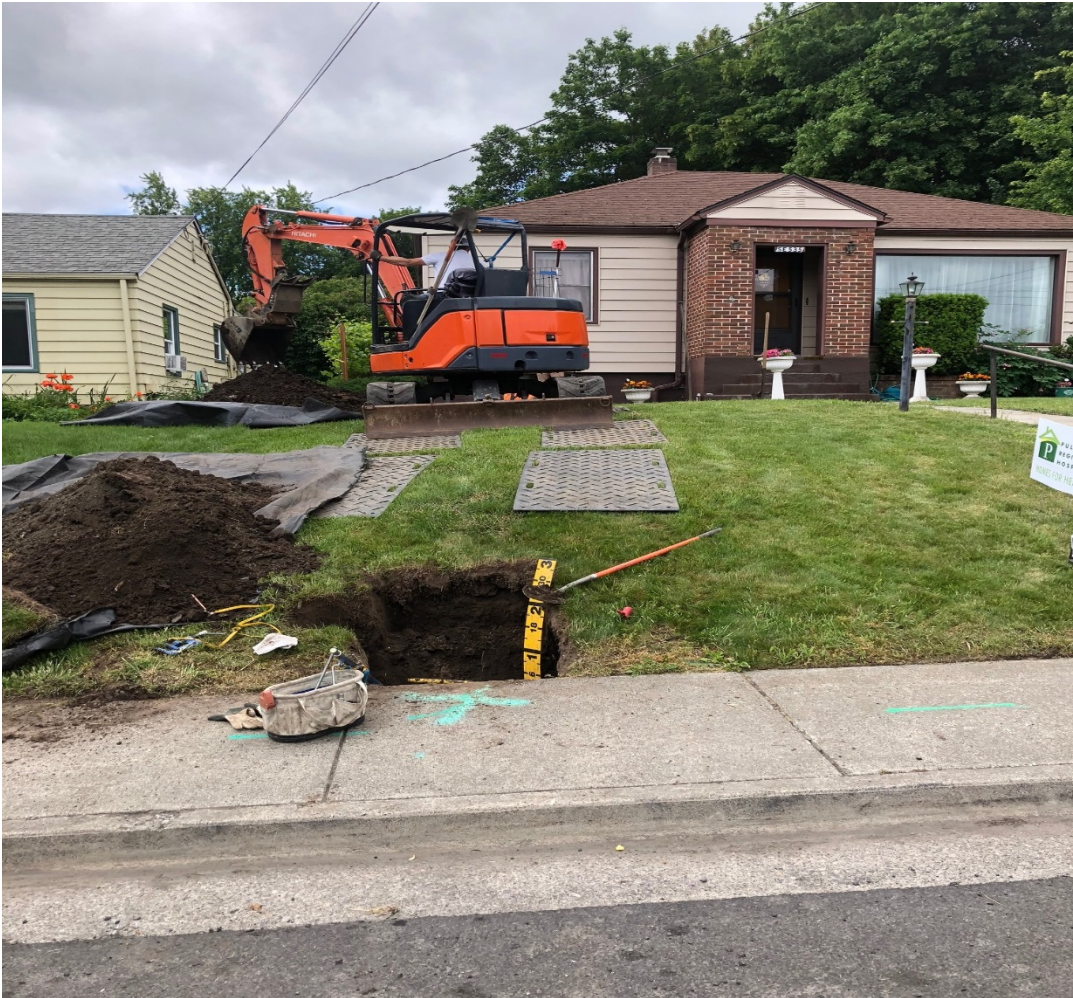
Picture #10 View of damage location looking south towards house.

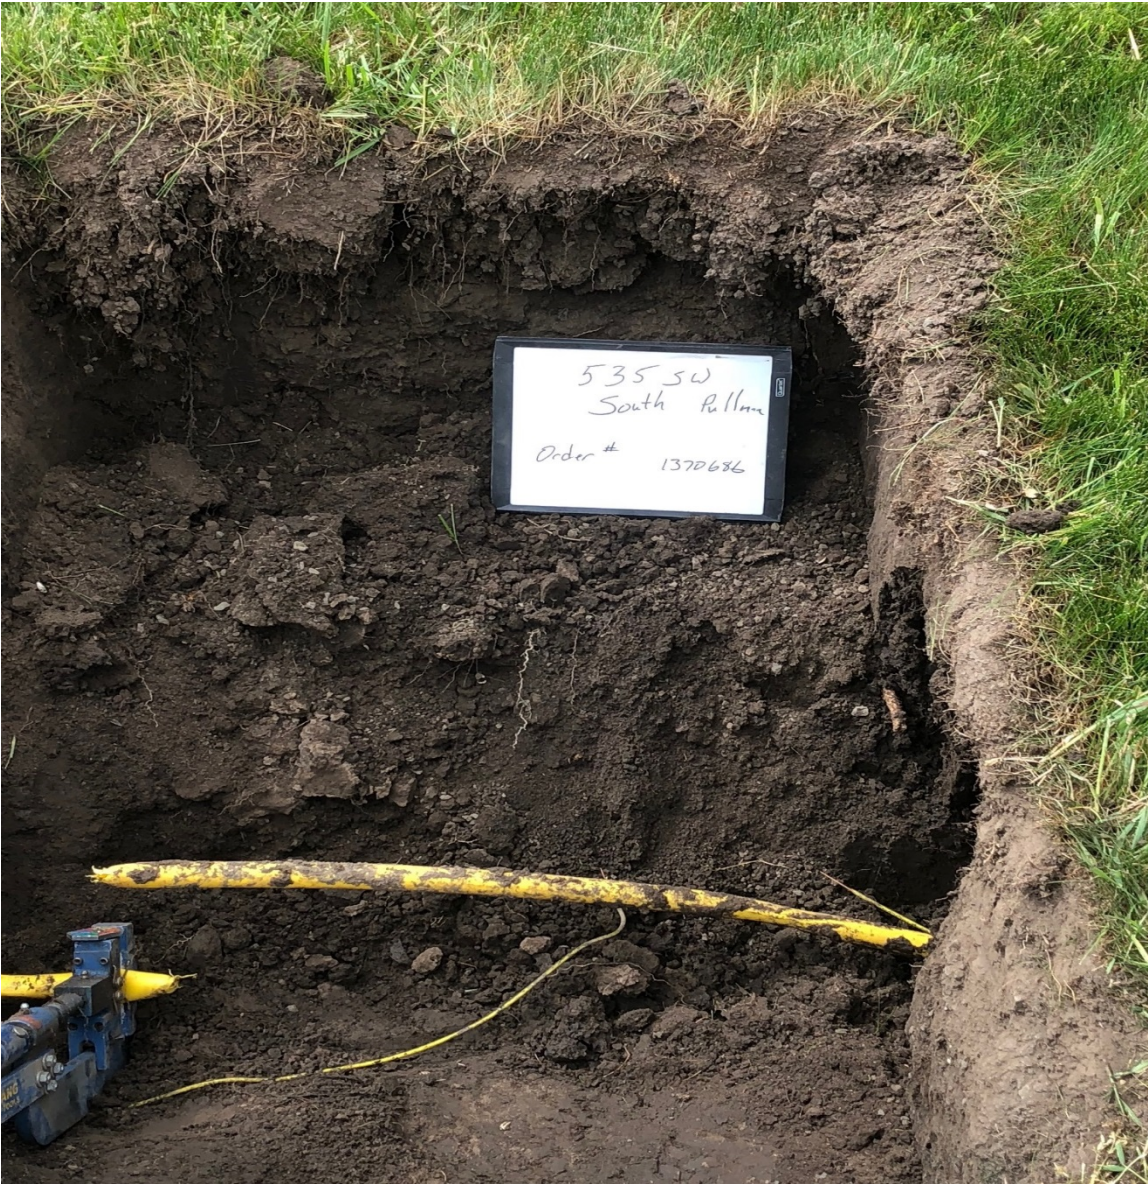
Picture #11 Showing location of damage and trouble order number
