Complaint Form Request

Re: Complaint Case 20-013 City of Enumclaw Gas vs. Quality Fence Builders

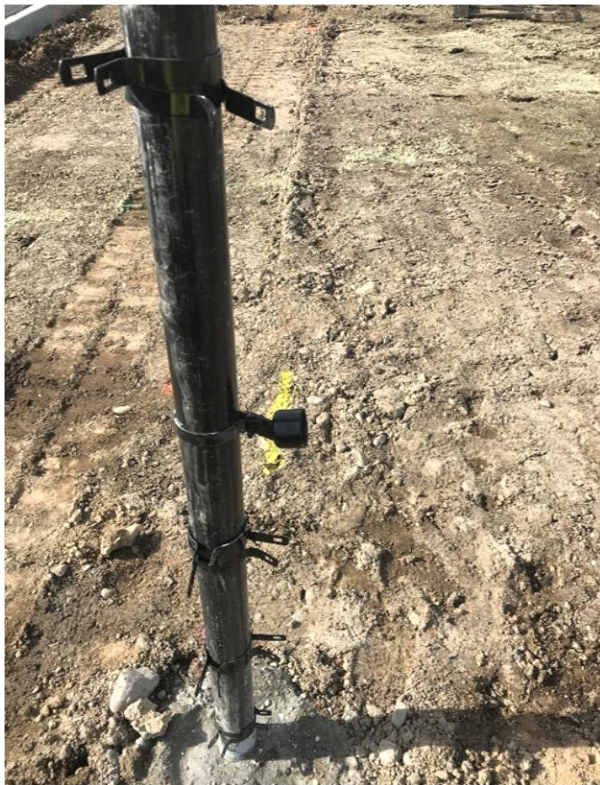
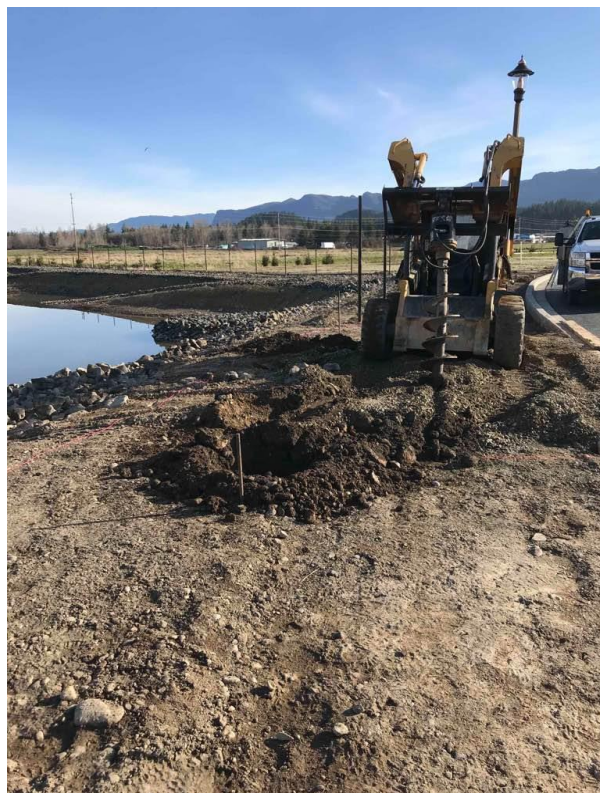
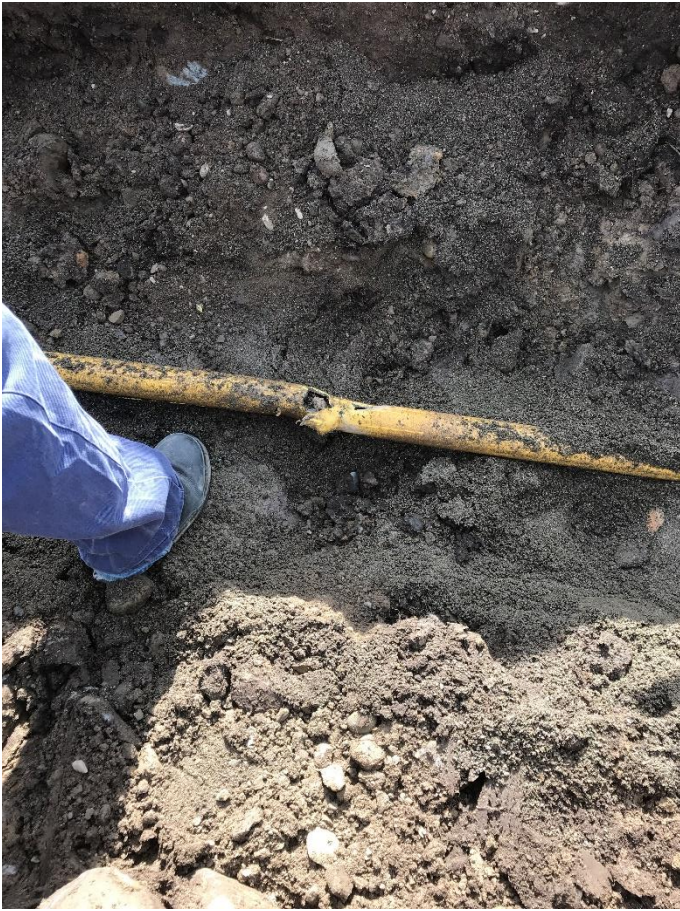
Violation RCW: RCW 19.122.030
Violation Section: Did not call for locate prior to excavation
Violation Description: While auguring a fence post hole, the contractor damaged a 2 inch gas main resulting in the uncontrolled release of gas. When the operator was questioned why he was excavating without a locate, he responded "what is a locate". The operator had no idea of what a locate is or when it should be called.
Violation Address: Becky Ave between 477 and 489
Violation Date: 03/17/2020

On March 17, 2020, City of Enumclaw Gas responded to an emergency 911 call reporting blowing gas at Suntop Division 5, a new plat on the east side of town. Mark VanWieringen, the Gas Supervisor responded 15 minutes after receiving the call finding that Quality Fence Builders had damaged a 2-inch gas main operating at 35 psi while auguring a fence post hole. The contractor was utilizing a skid steer with augur attachment to excavate for a future fence being placed around a storm water facility. The primary cause of this accident was due to the contractor failing to call in locates prior to excavation, this action resulted in the uncontrolled release of natural gas, placing the contractor, public, and City of Enumclaw Gas workers in danger. Mark VanWieringen reported that the two persons operating the augur claimed to not know what a locate was or understand why it was required. After locating the line, the contractor had placed multiple post directly on top of the main.

Below are photos showing the damaged pipe, equipment, and location of fence in reference to the gas main.
