**Supporting Documentation
Avista vs Neighborhood Fence Complaint
May 13, 2020**

Date of Violation: April 24, 2020

Location of Damage: 4015 S Crestline Spokane, WA 99

Locate Ticket Number: 20148862

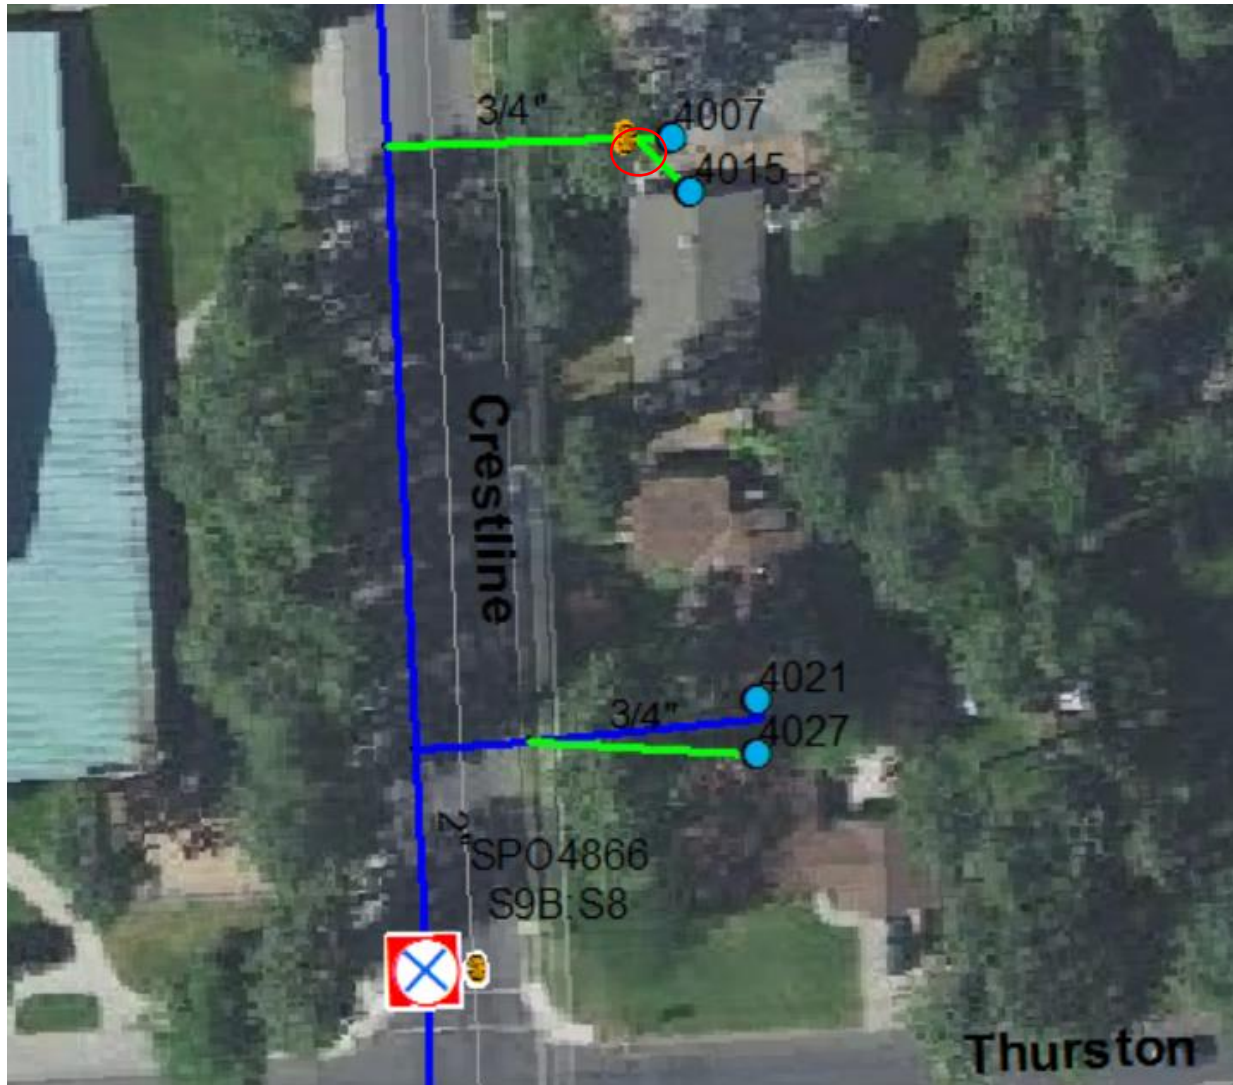
Exhibit #1 – Vicinity map showing location of damaged pipe in red circle. This 3/4" pipe is a split service that feeds both 4007 and 4015 S Crestline.

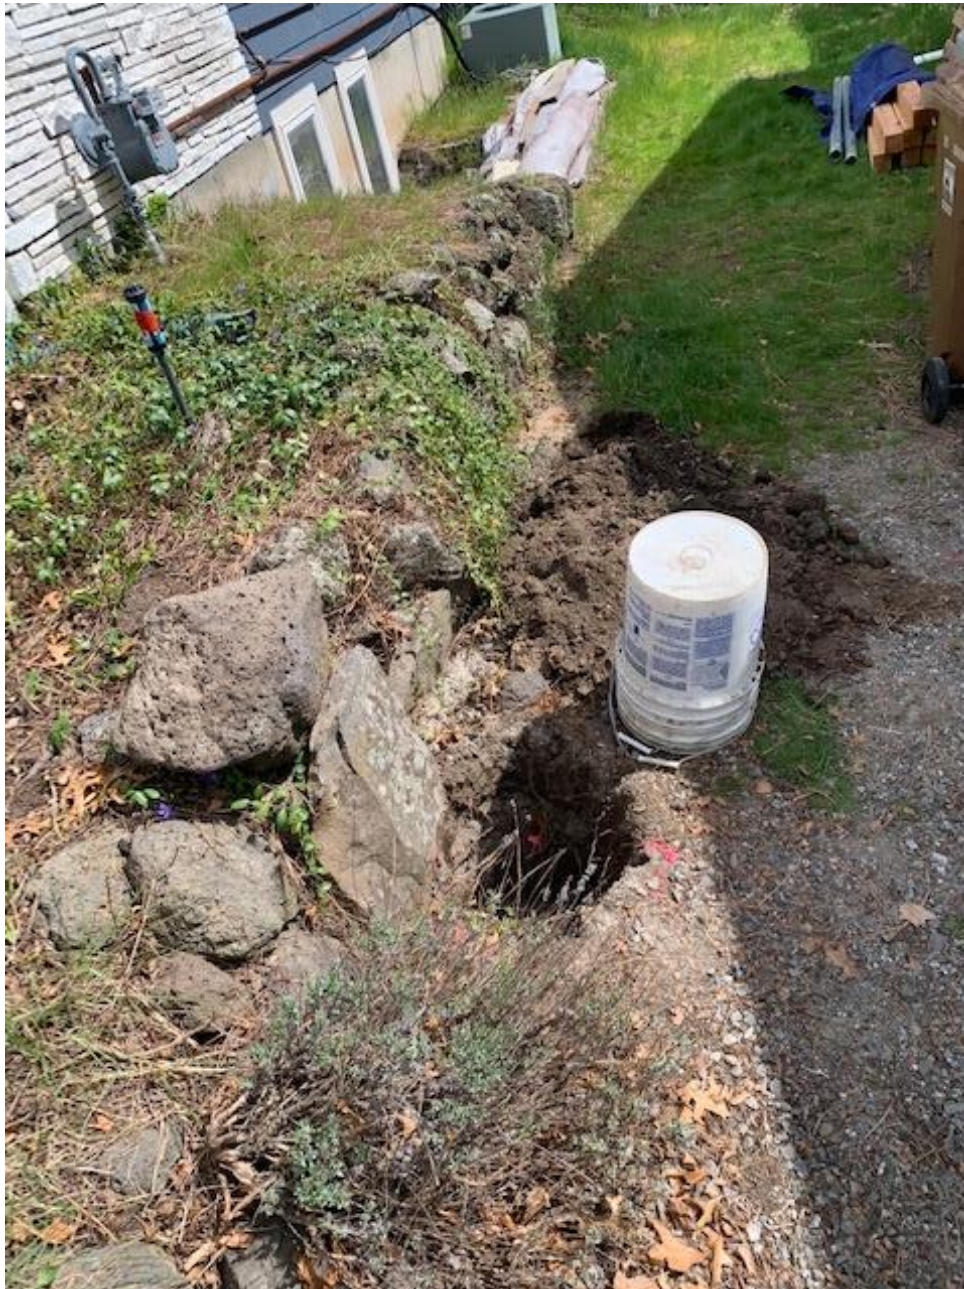
Exhibit #4 - Photo taken on 4/24 by Avista's serviceman showing the location of the damaged pipe and no evidence of locate marks.

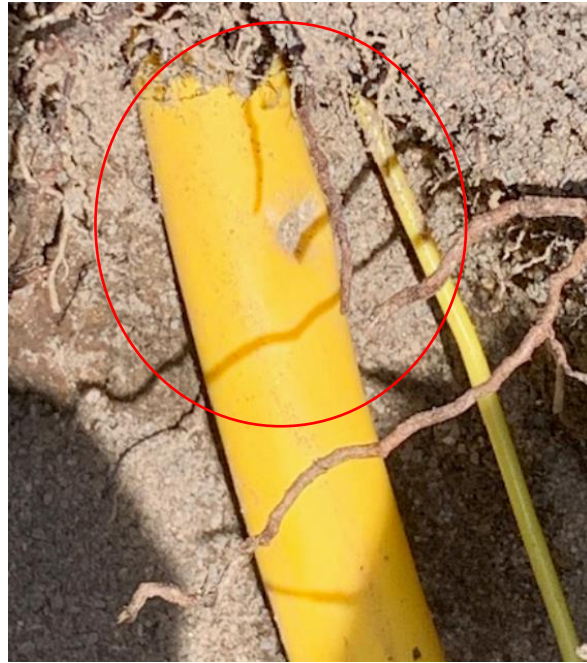
On 4/24/20 Ray Spies of Neighborhood Fence called Avista about a damage to Avista's ¾" plastic pipe at 4015 S Crestline. When Avista's serviceman arrived on site he found that Neighborhood Fence had gouged Avista's ¾" plastic pipe with a digging bar while digging a post hole for the installation of a fence. The serviceman did not see any locate marks on the ground and determined that Neighborhood Fence did not wait the two business days required by 19.122.030 (2) of Chapter 19.122 RCW Underground Utilities. There was no one from Neighborhood Fence on-site when Avista's serviceman arrived.

Exhibit #5 - Photo shows gouge damage to the plastic pipe by digging bar, photo taken by Avista serviceman on 4/24.

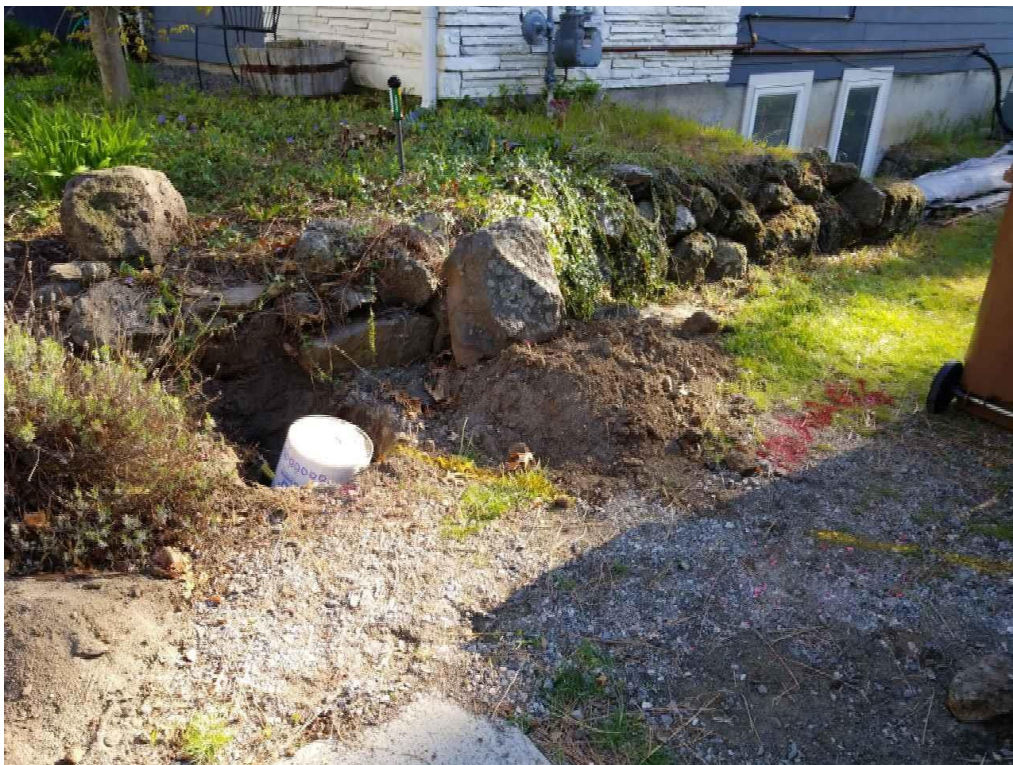
Ticket: 20148862.0 Timestamp: 4/27/2020 8:06:15 AM

Exhibit #6 - Photos from locate technician when they arrived on 4/27/20. Shows damaged pipe location (bucket over pipe) when locate technician showed up to locate Avista's pipe for ticket 20148862.

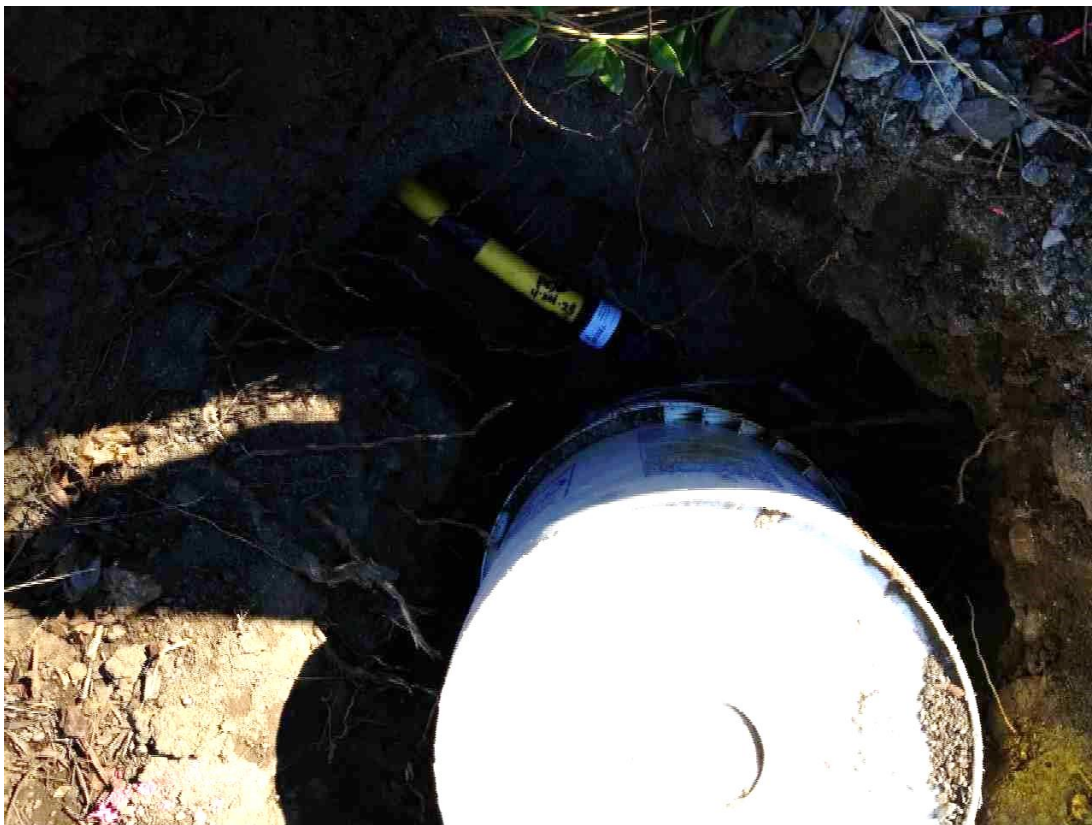
Ticket: 20148862.0 Timestamp:4/27/2020 8:06:26 AM

Exhibit #7 – Photo by locating technician showing repaired pipe in open post hole upon their arrival on 4/27.
