Case 19-087 PSE Gas

On 9/18/2019 JCC crews discovered that a PSE gas main was insufficiently located at the intersection of 8th and S L Street in Tacoma Washington. As JCC crews began to excavate for a catch basin at the NE corner of the intersection, the ground man noticed that there was an unknown un-located 6" steel line in conflict with the structures location after further exposing it by hand digging. JCC previously requested locate tickets through 811 and received ticket #19372927 to dig under.

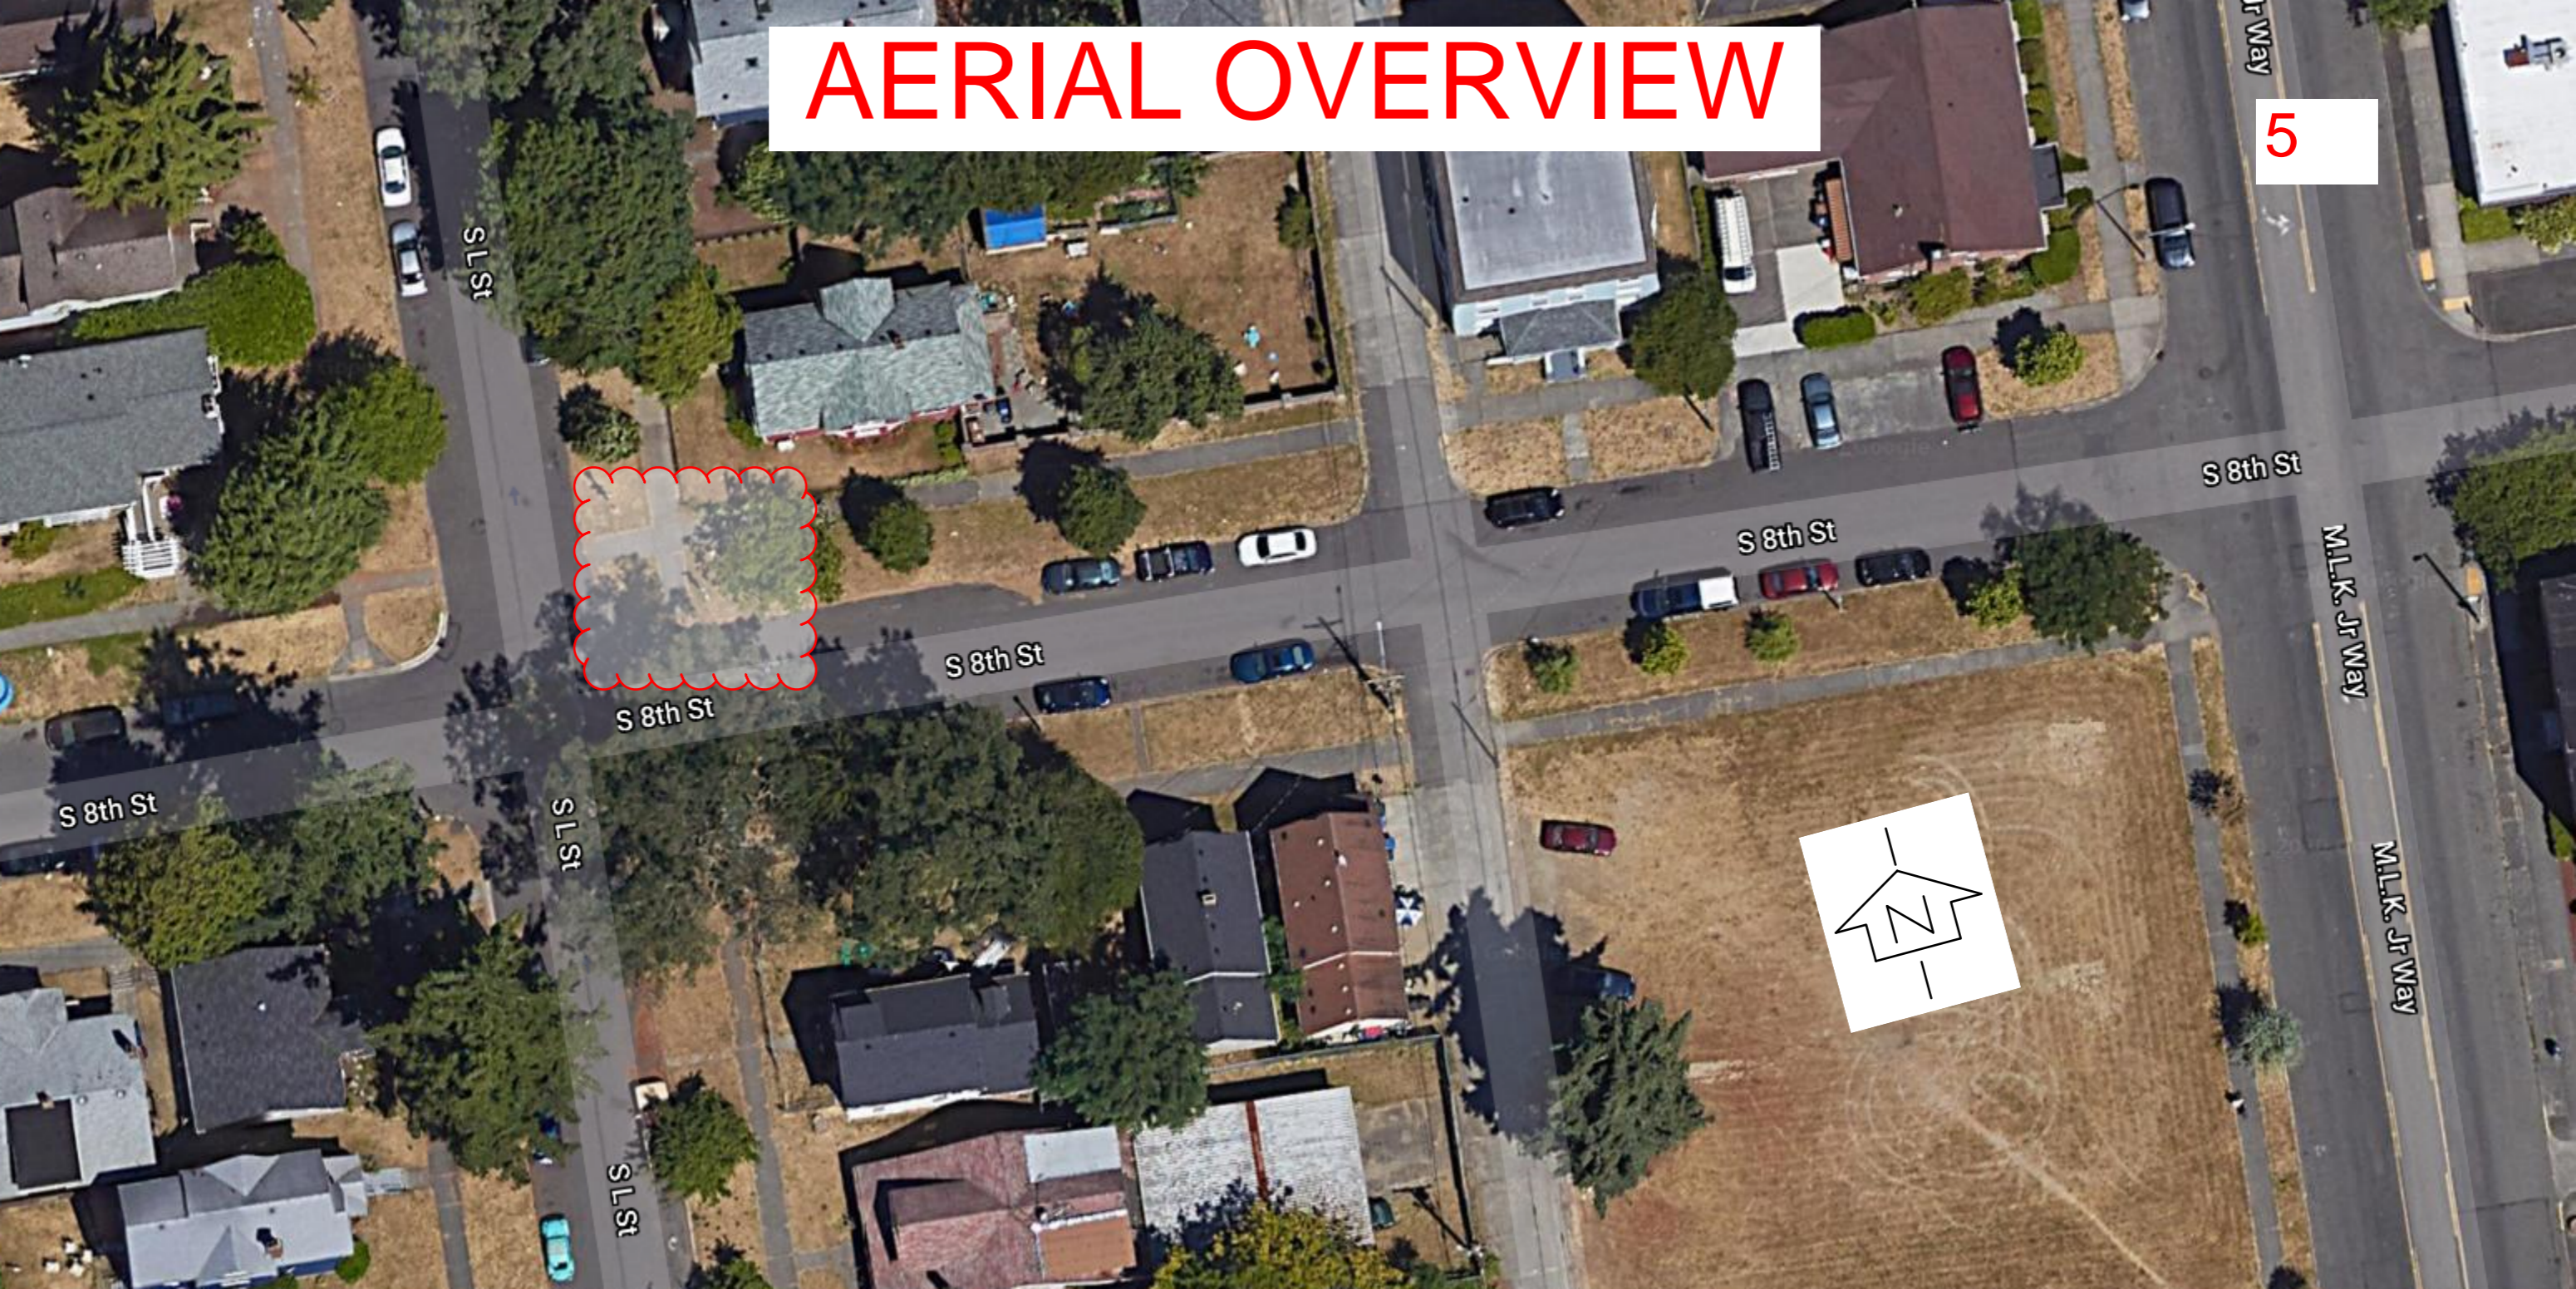
AERIAL OVERVIEW

GAS LOCATE

ACTUAL
LOCATION OF
LIVE 6" PSE
MAIN 4.5' OFF

PICTURE
TAKEN HERE,
LOOKING
THIS
DIRECTION

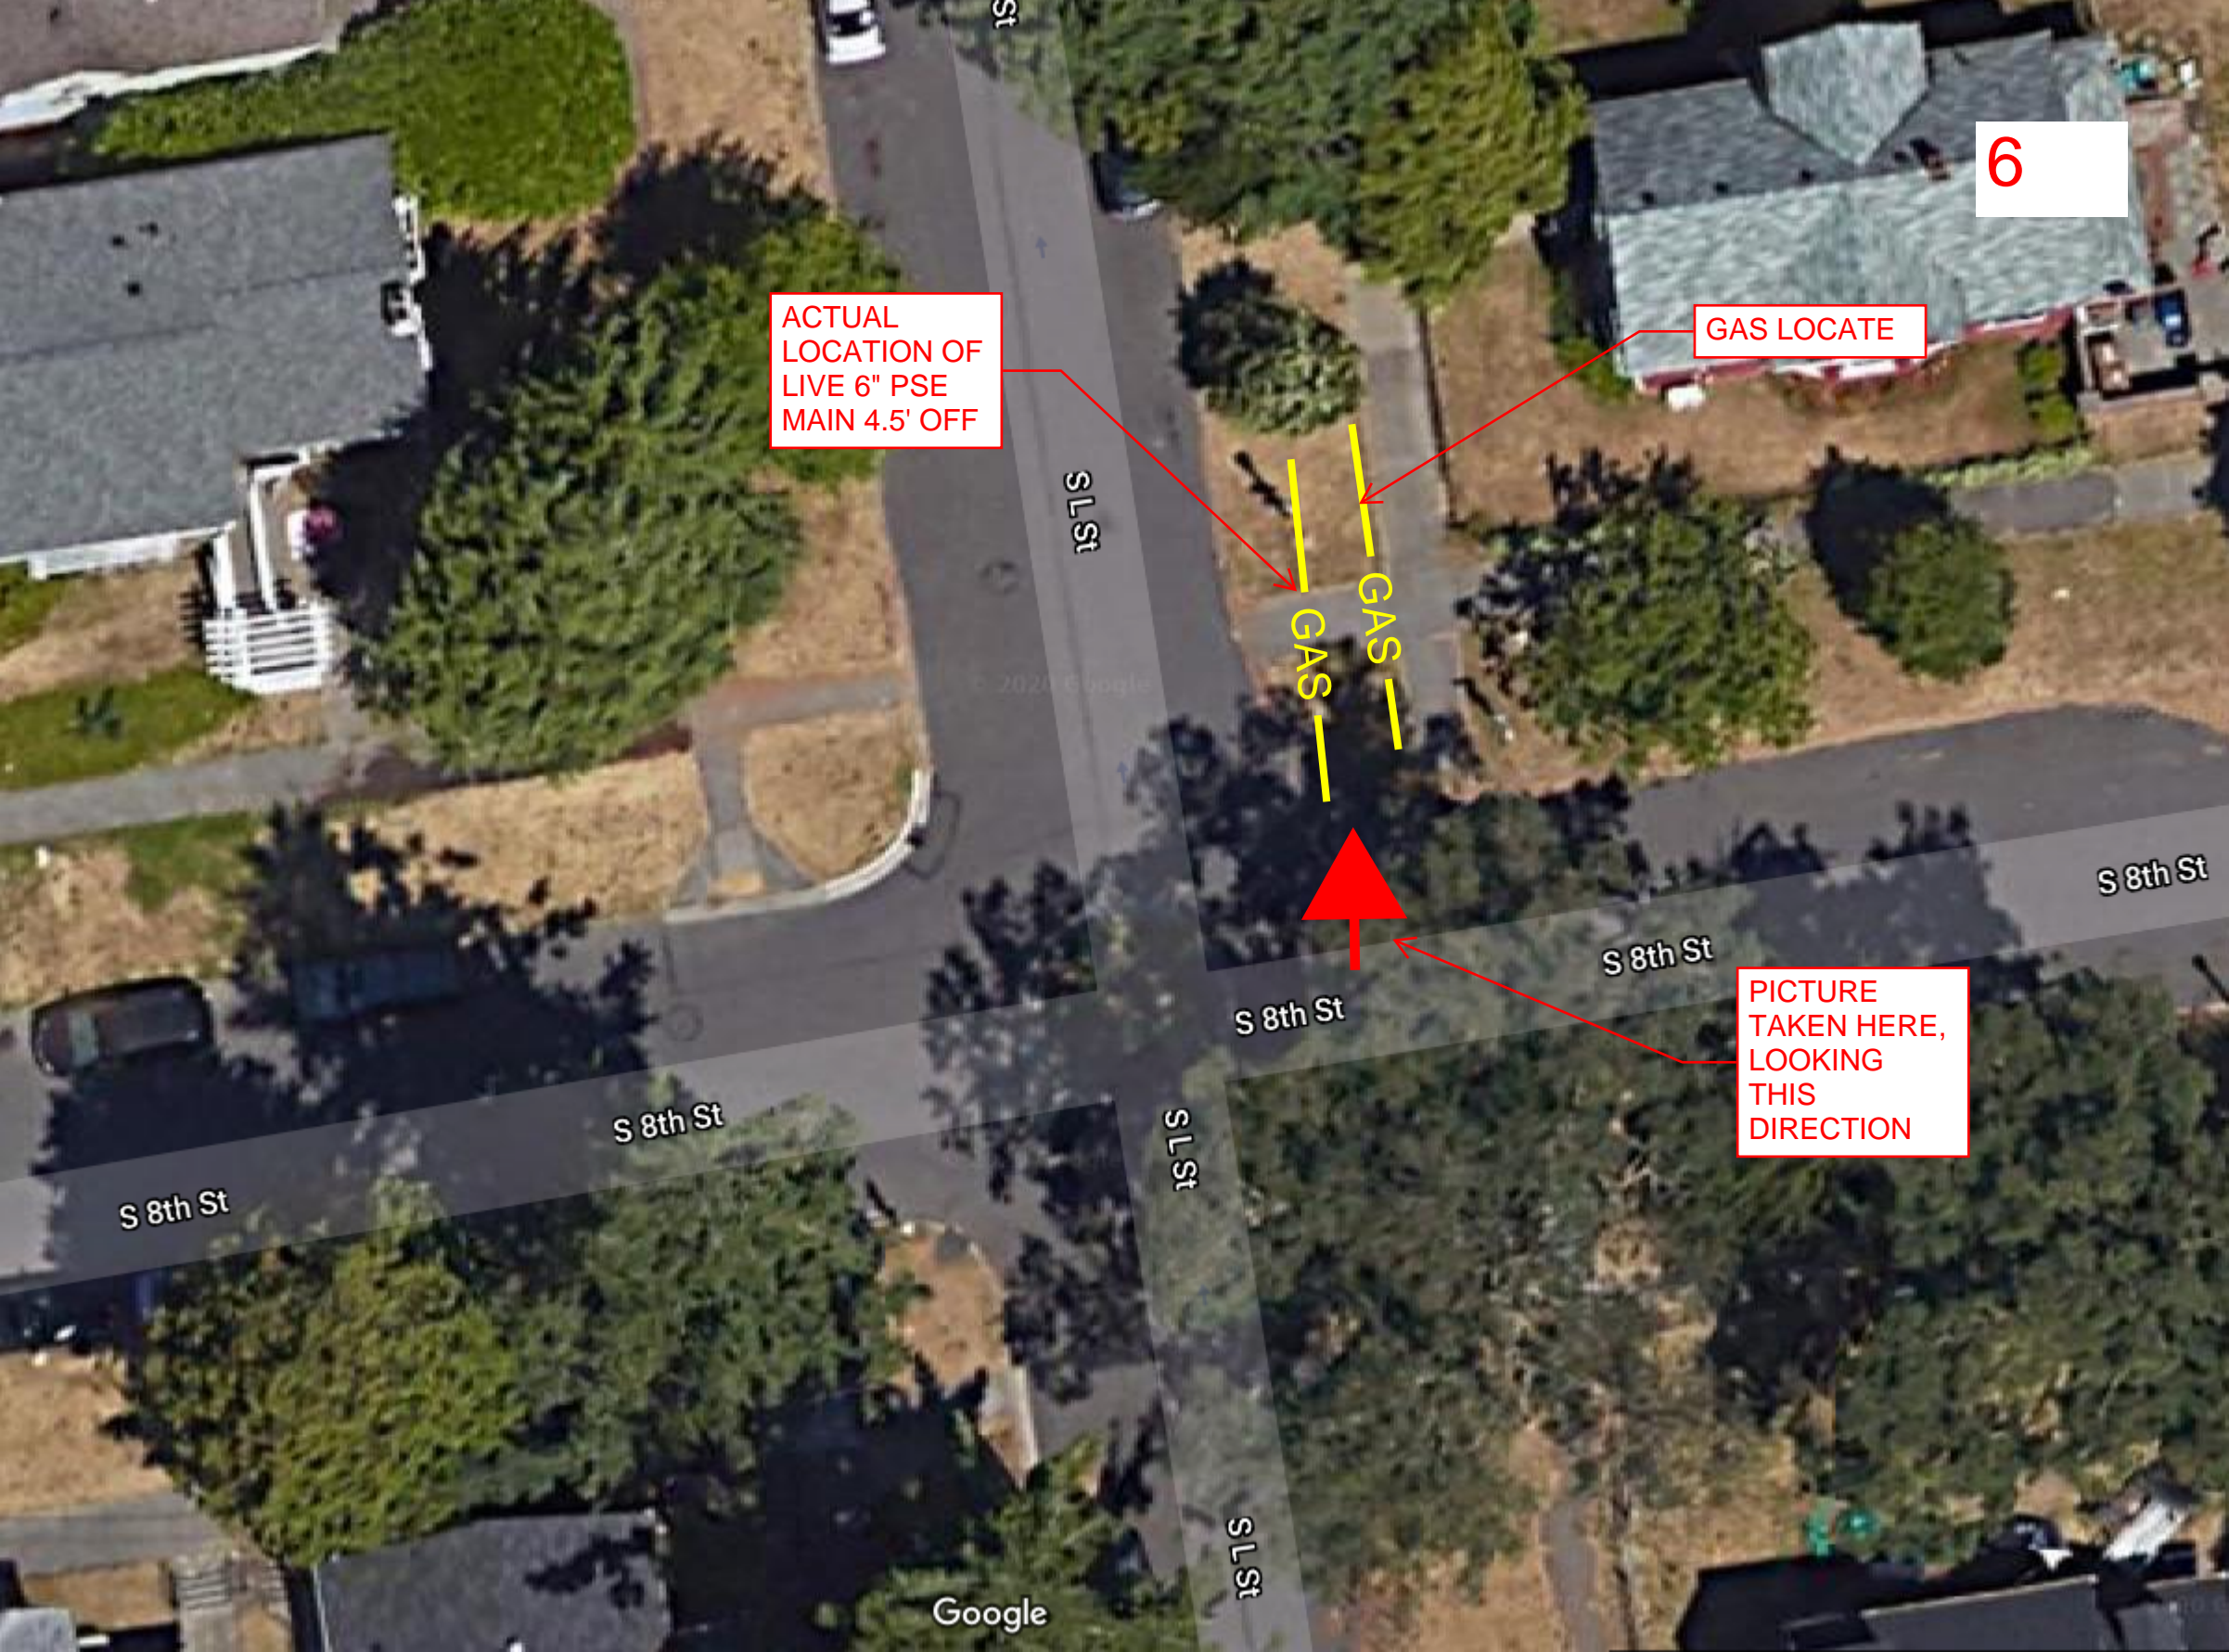
**GAS LOCATE MARK
(4.5') OFF ACTUAL
PIPE**

The live gas line was insufficiently located by 4.5'.

6" Gas line was found to be 4.5' off of locate marks when discovered. PSE confirmed this was their live main when they came on site and the locates were inaccurate. NO DAMAGE OCCURRED.

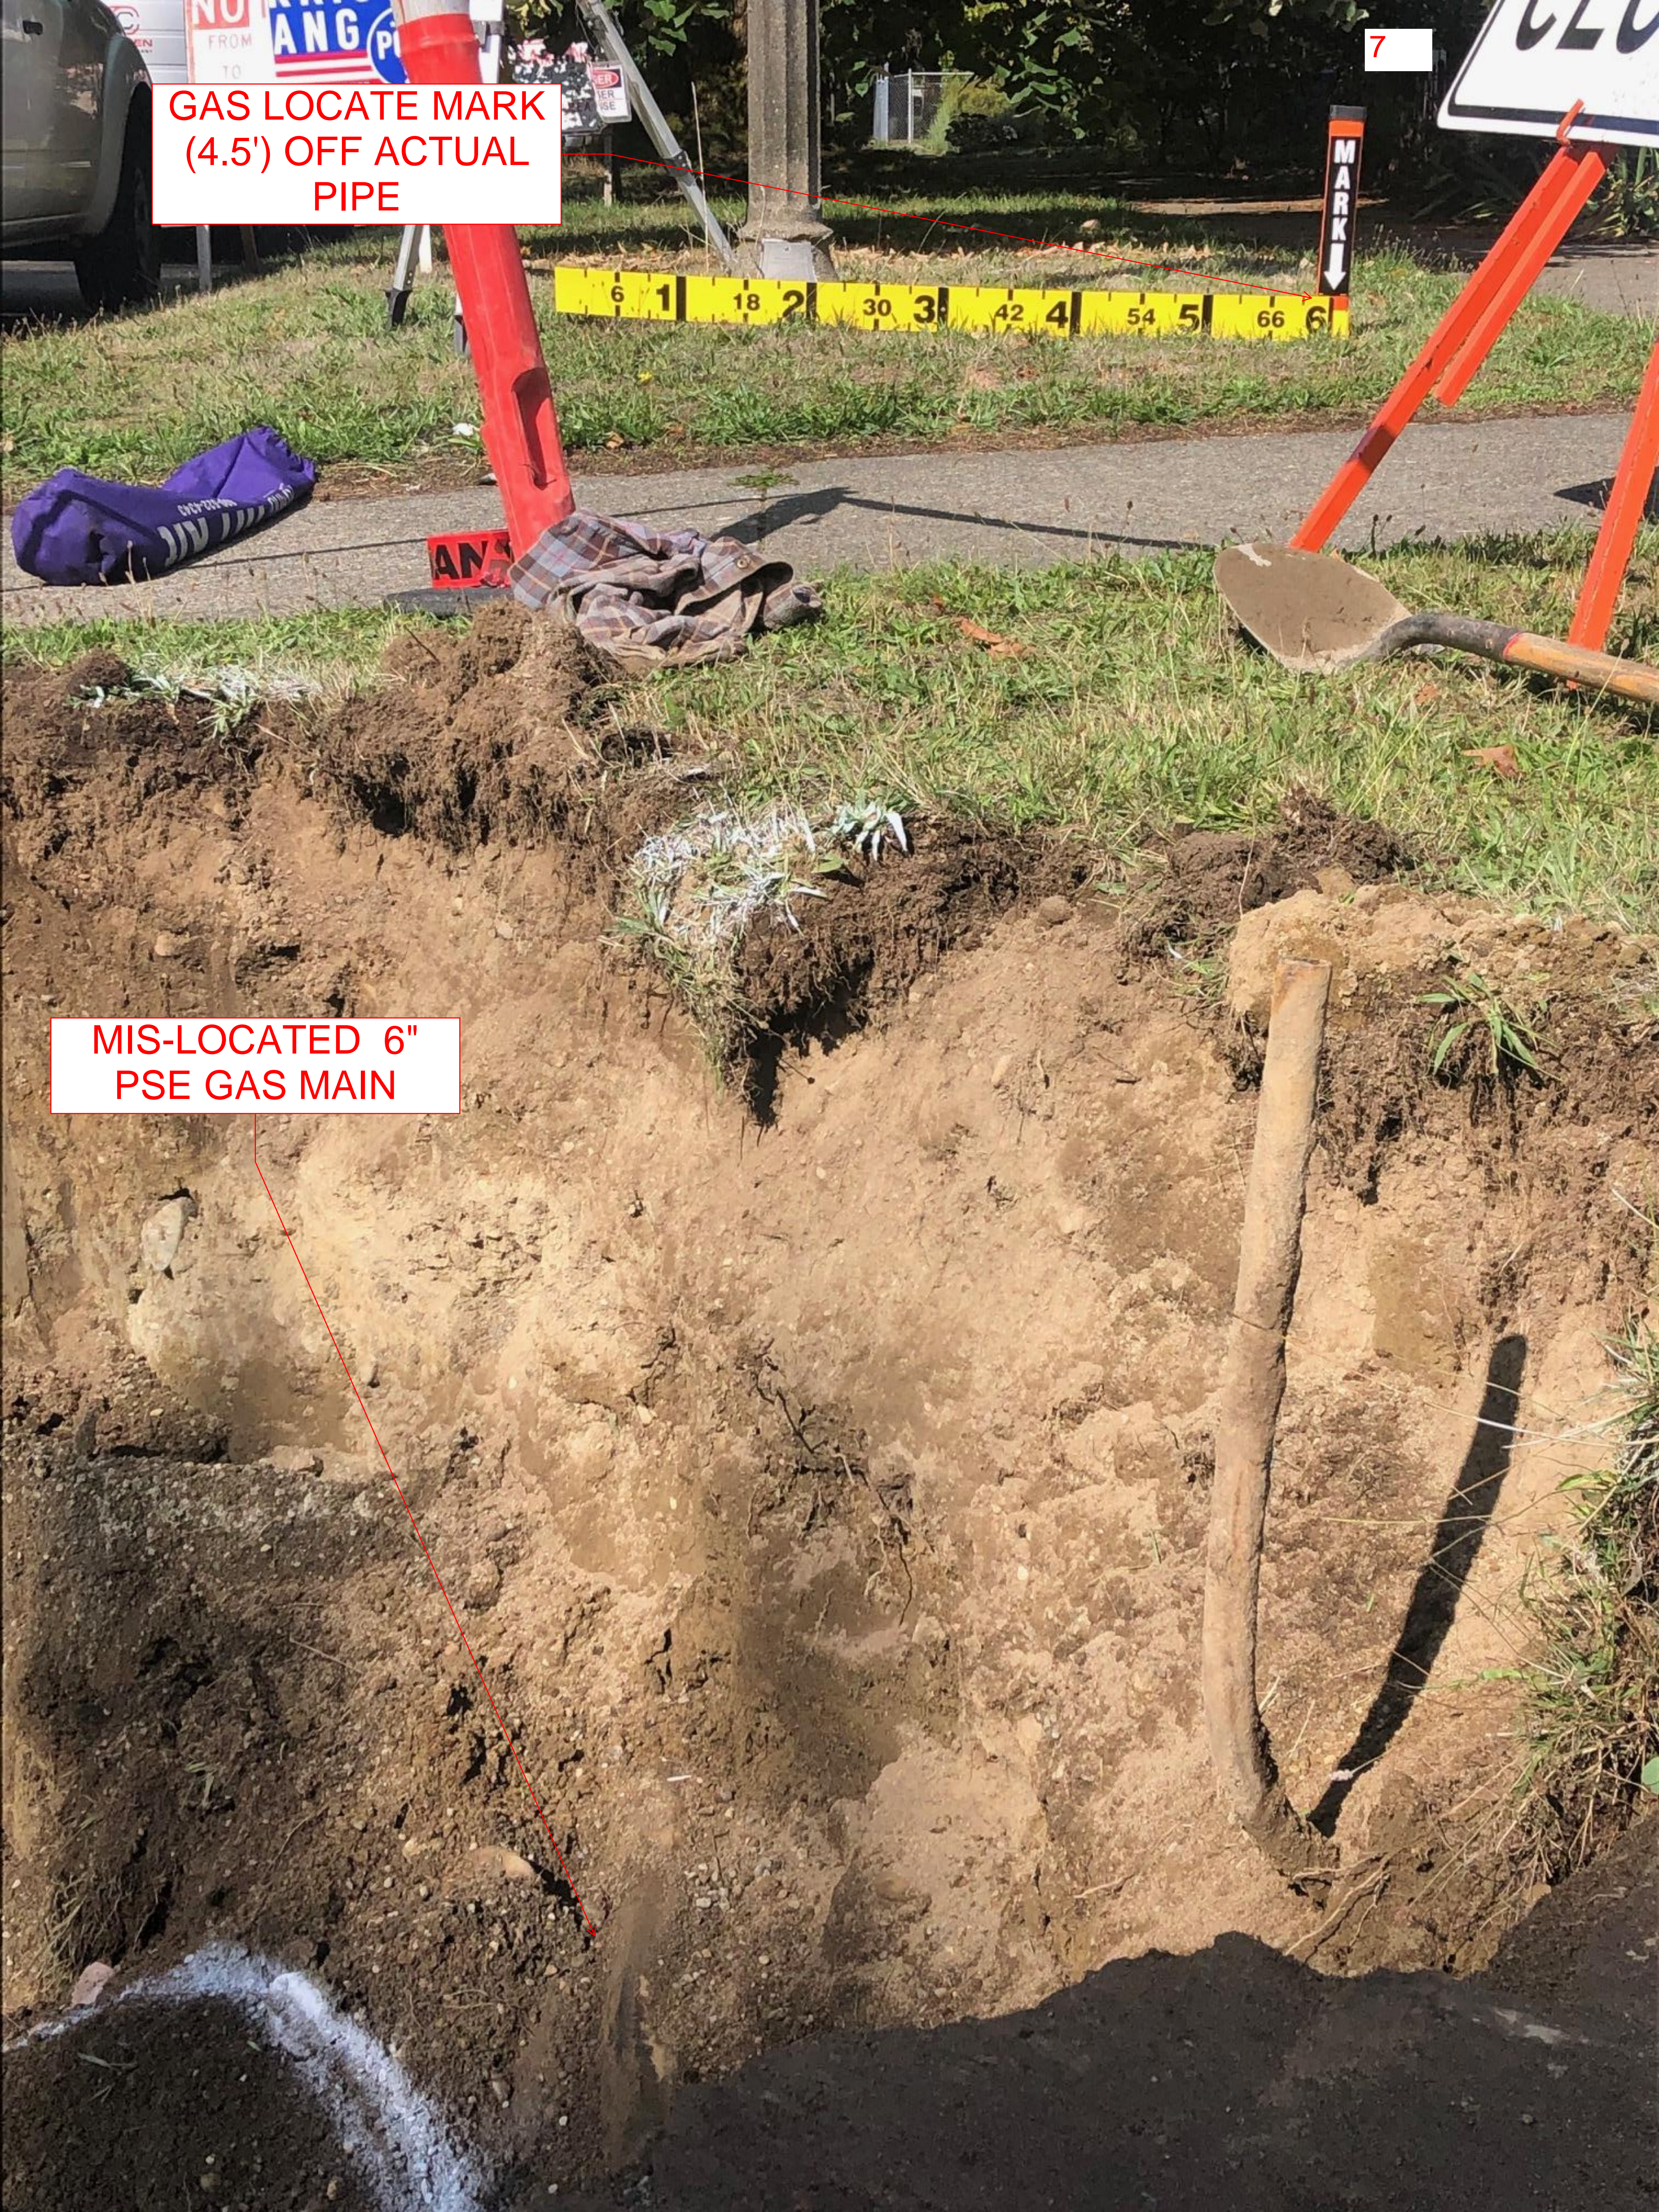
**MIS-LOCATED 6"
PSE GAS MAIN**
