**Avista's Response to
Case 21-024
M&L vs Avista – Granite Lane**

Date of Incident: June 16, 2021

Location of Incident: 11730 Granite Lane Otis Orchards WA

Locate Ticket Number: 21262536

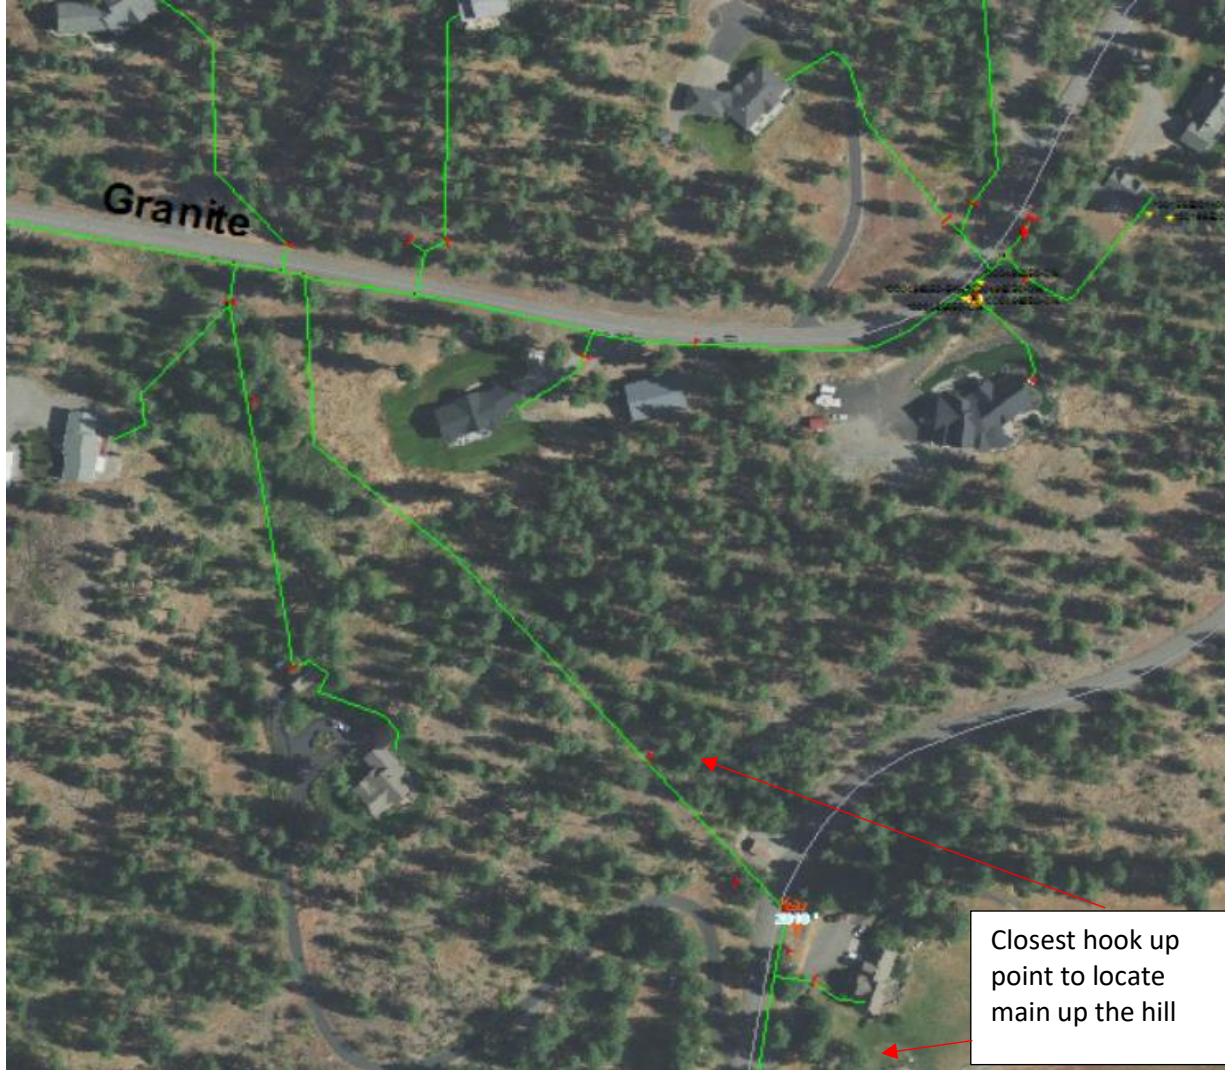
Exhibit A – Vicinity map showing where the ticket request is located along with the closest hook up point.

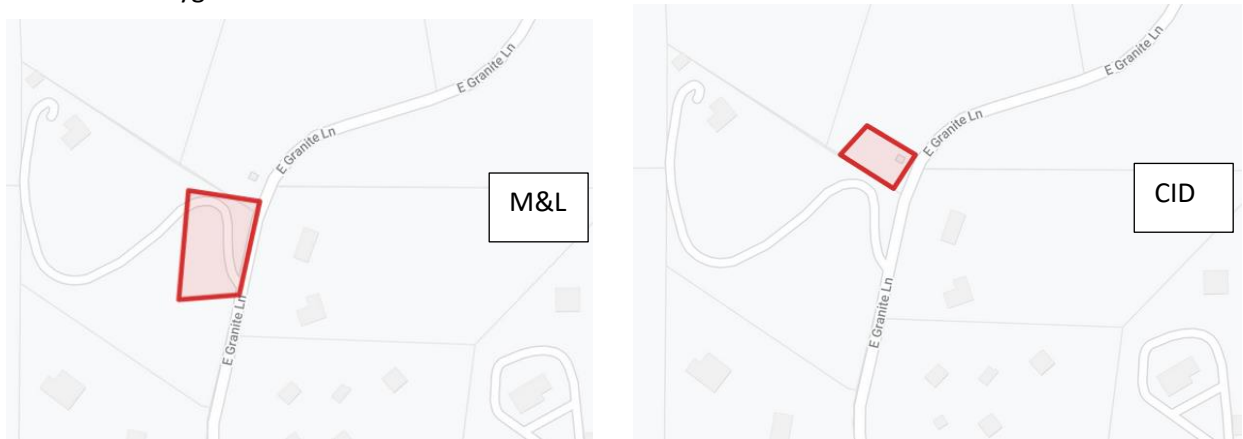
Exhibit B – Polygon area for each ticket as taken from the ticket on search and status.

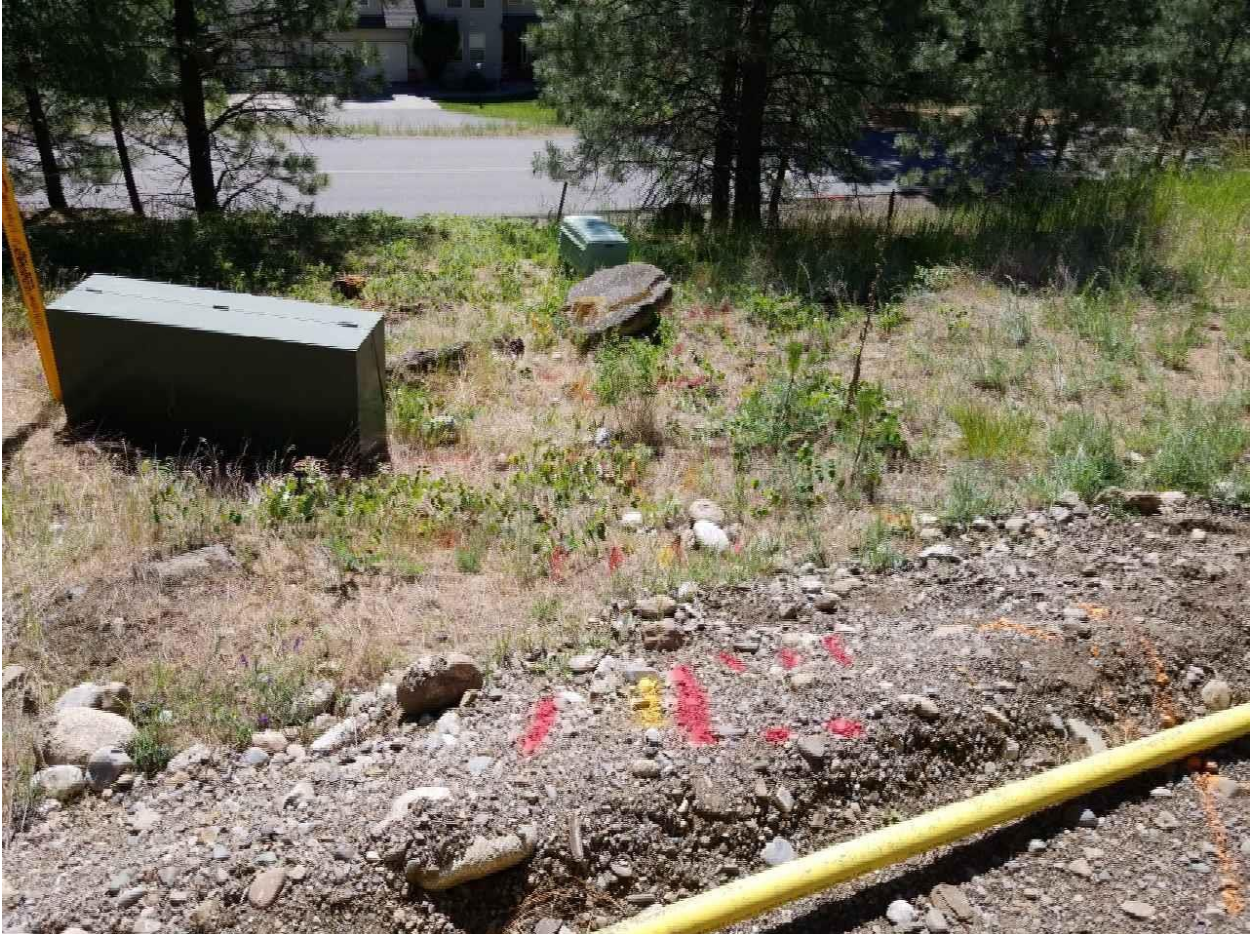
Ticket: 21262536.0 Timestamp:6/16/2021 10:29:09 AM

Exhibit F – Photos of locate at bottom of Granite Lane showing locate marks. House across the street is the one that the locator was unable to gain access to the gas meter to hook up as shown on the vicinity map in Exhibit A.
