Case 22-062

M&L Construction vs. Avista Utilities
8303 N Northview Ct, Spokane, WA

Avista Supporting Documentation

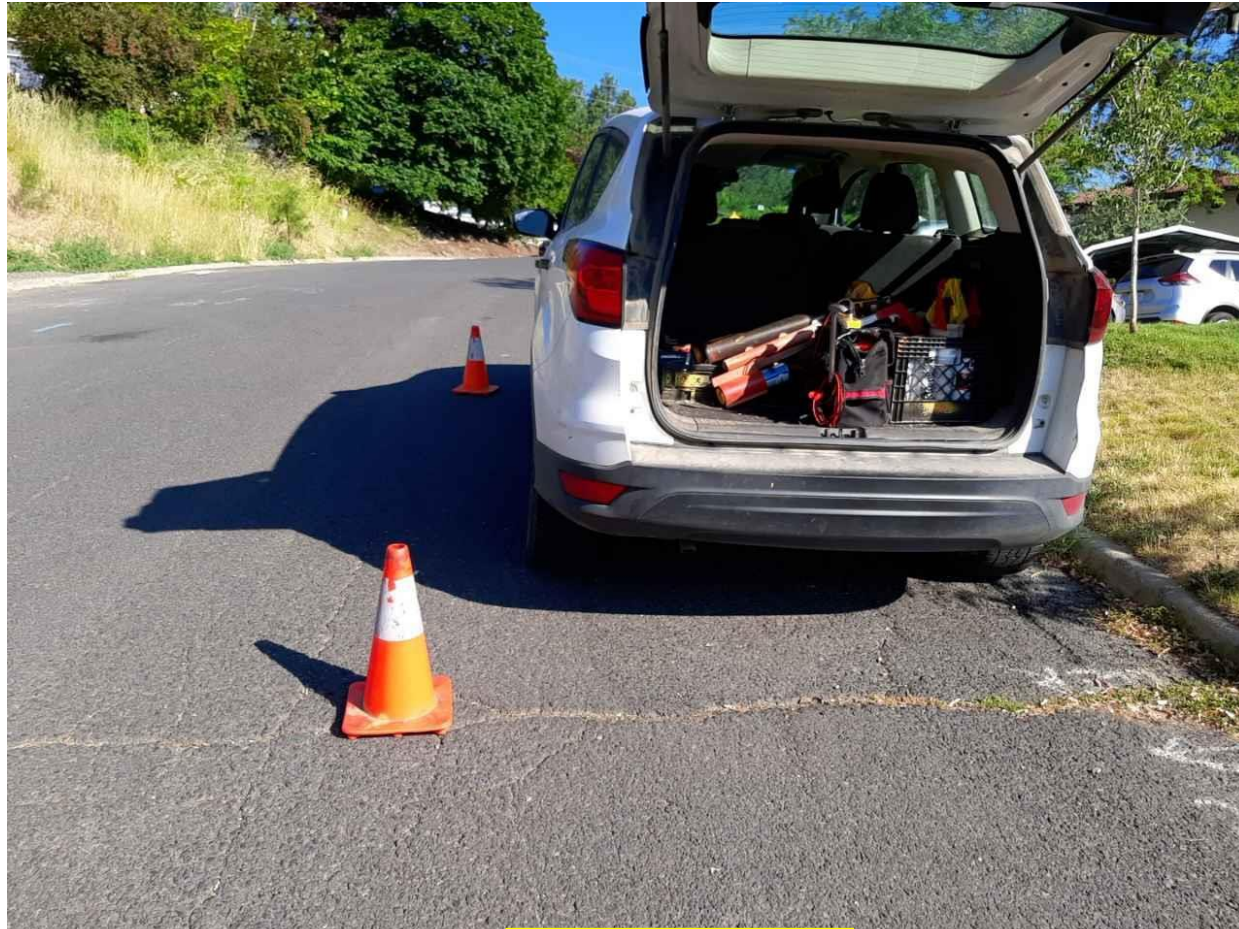
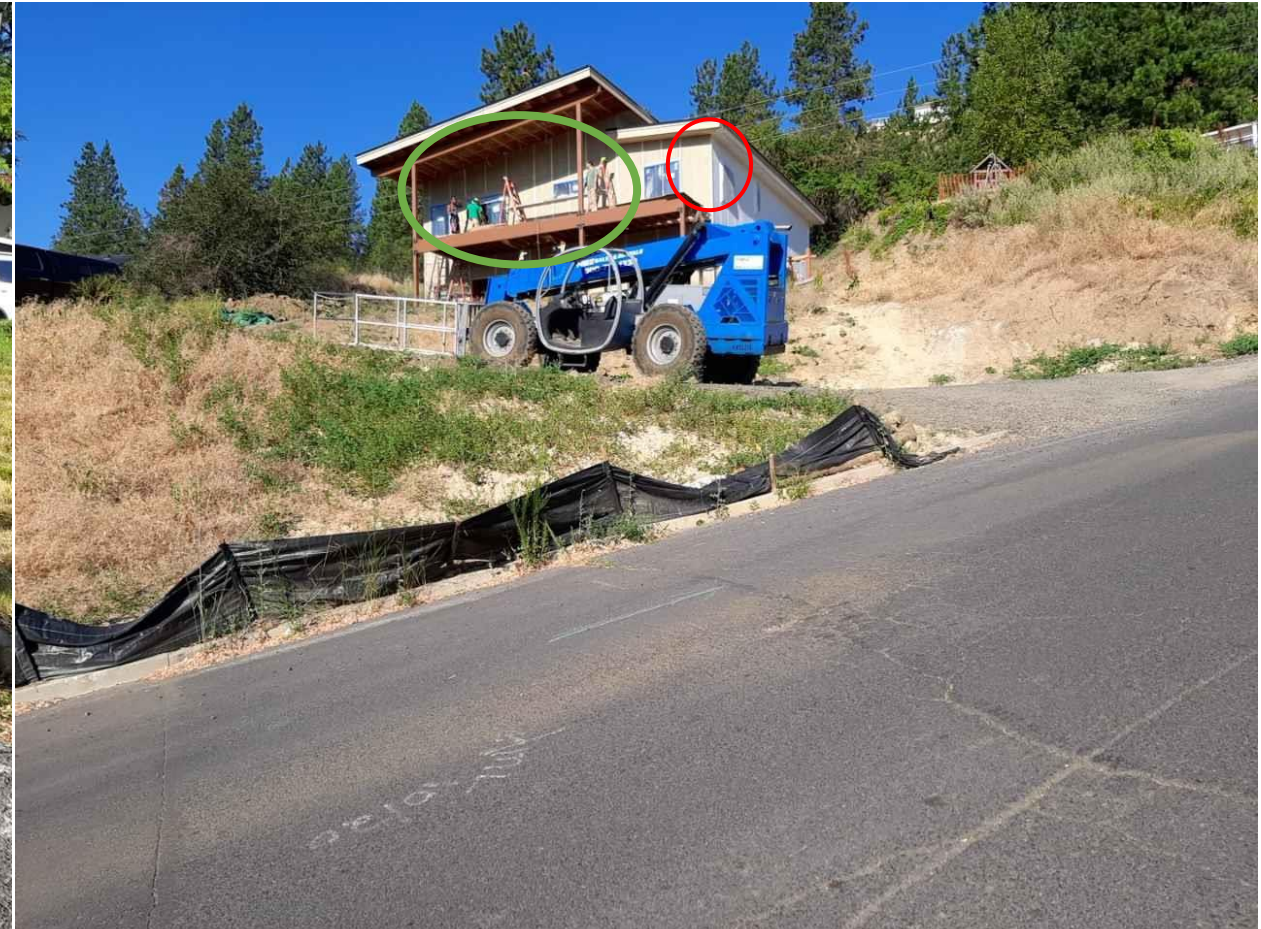
Locate Photos. ELM on site.

Ticket: 22340883.0 Timestamp: 8/5/2022 8:19:52 AM

Ticket: 22340883.0 Timestamp: 8/5/2022 8:19:56 AM

Left photo shows **timestamp** of ELM locator on site at 8:19am on August 5th. Note: the right photo shows **painters on site** and working - **there is no paint on the east wall of the house at 8:19am**

As you can see in the original locate photos for M&L's May 17, 2022 request and their August 2 request, siding has been installed and painters were then painting.

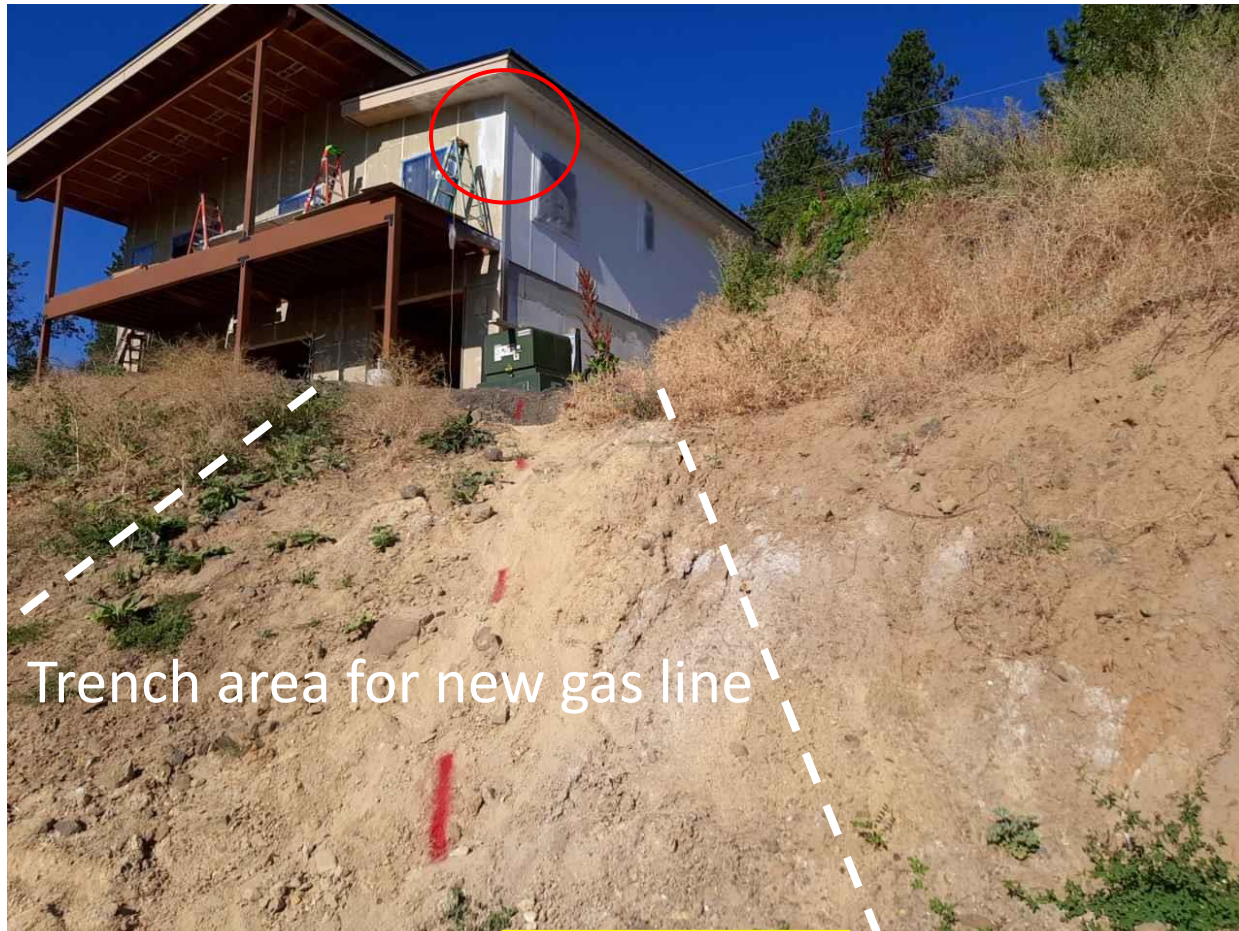
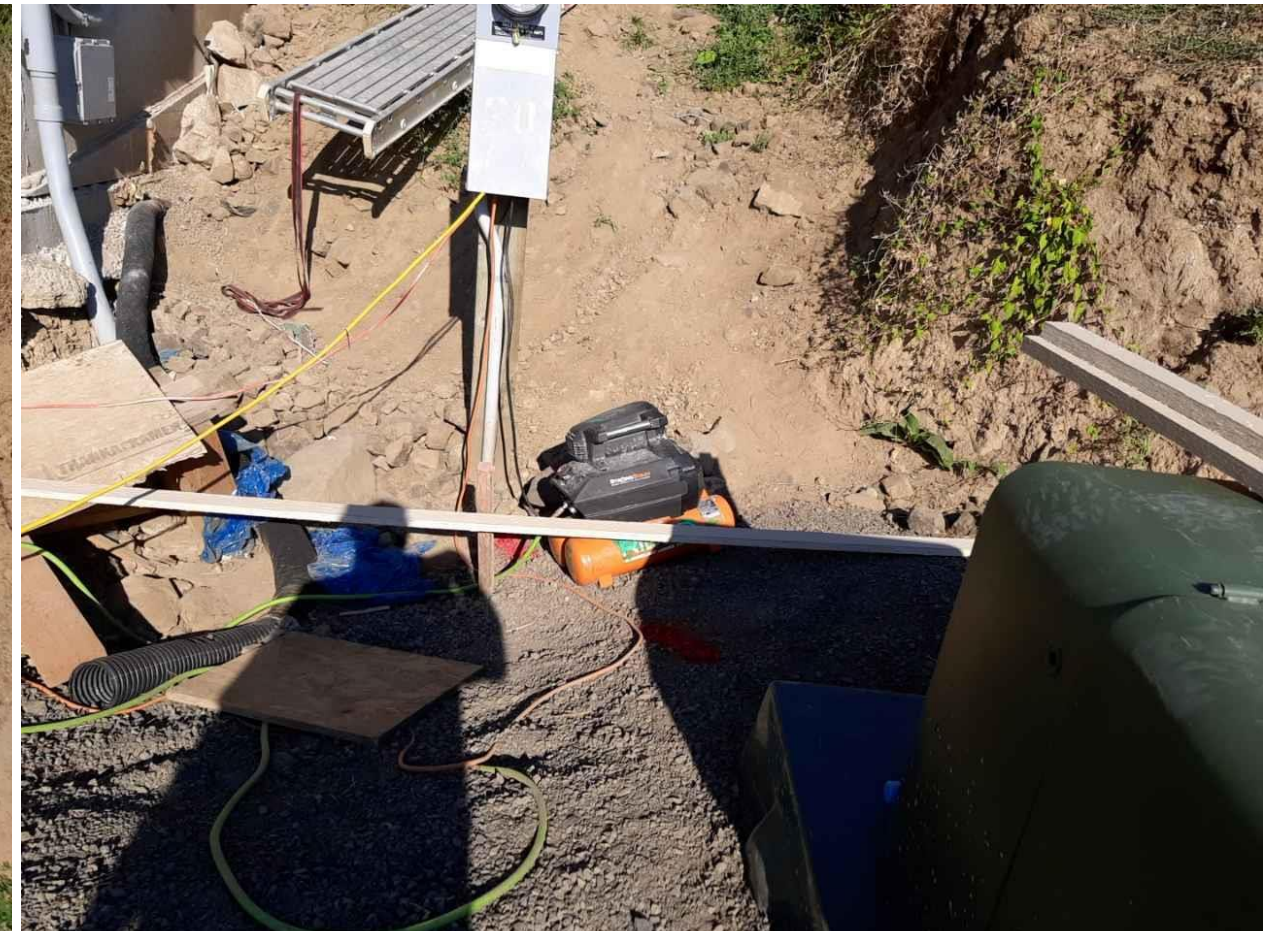
Locate Photos. Siding Complete. Painting Work.

Trench area for new gas line

Ticket: 22340883.0 Timestamp: 8/5/2022 8:38:20 AM

Ticket: 22340883.0 Timestamp: 8/5/2022 8:27:02 AM

Left photo shows ELM completing the locate request, siding is on, and painting is happening (**new paint on the east side of the house at 8:38am**). Right photo is approx. location of where the trench ended: on the wall behind the transformer.

Locate marks of all Avista locatable facilities were provided on site and documented by ELM at the time the locate was completed. *Slide 5-6, electric photos.*

The locate marks were provided prior to excavation commencing. *Slide 5-6, electric photos.*
