TECHNICAL MEMORANDUM

Project: Railroad Crossing of International Boulevard
Longview, WA

Subject: Support for Petition to
Install Stop Signs at Crossing

Date: June 14, 2023

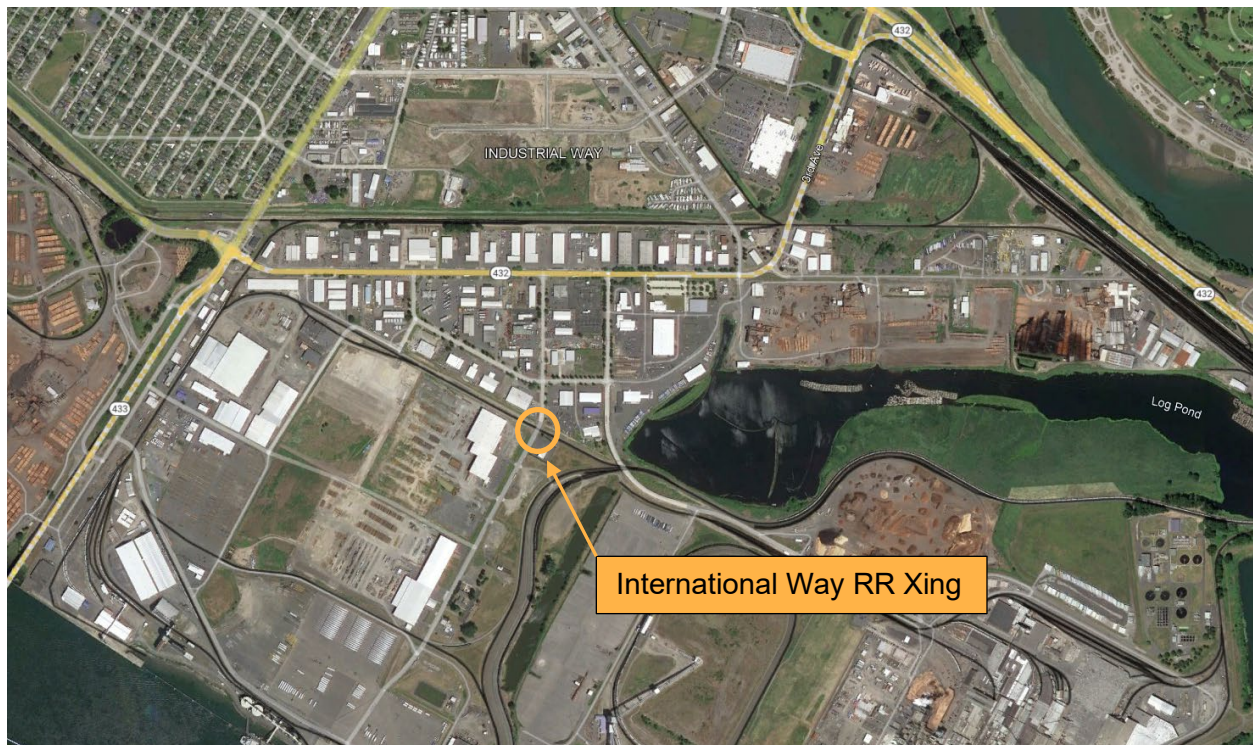
Figure 1. Railroad Crossing of International Way

The memorandum presents information and analysis to support a *Petition to the Washington Utilities and Transportation Commission to Modify Warning Devices at a Highway Railroad Grade Crossing*. The subject crossing is on International Way in unincorporated Cowlitz County as shown on Figure 1. The detailed location characteristics are provided in Table 1.

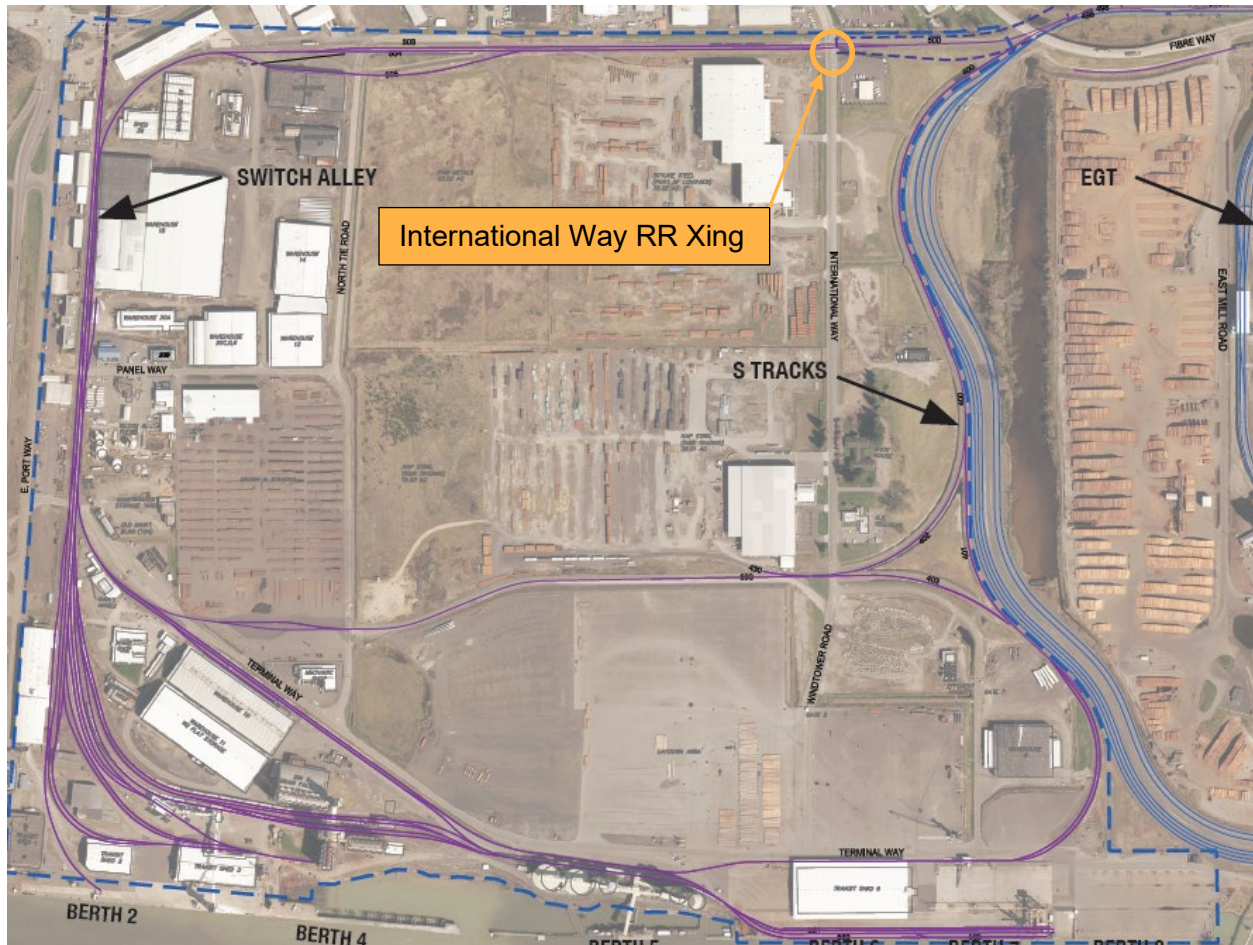
Figure 2. Existing Rail Network at Port of Longview

Information about the current rail network in the area was defined in the *Port of Longview's Transportation Optimization Plan Report*.¹ The tracks that cross International Way are part of the Longview Industrial Rail Corridor (IRC) that connects between the BNSF Railway (BNSF) and Union Pacific Railroad (UPRR) mainline corridors to the east and the Port of Longview's industrial areas. The existing rail network in the near-site vicinity is shown on Figure 2.

The rail crossing at International Way has two tracks that split at a wye about 180 feet east of International Way. Just west of the International Way crossing, there is another wye west of which there are three tracks. The multiple tracks are used to facilitate deliveries to customers where segments of trains may be temporarily set on tracks while switching other segments into local spurs.

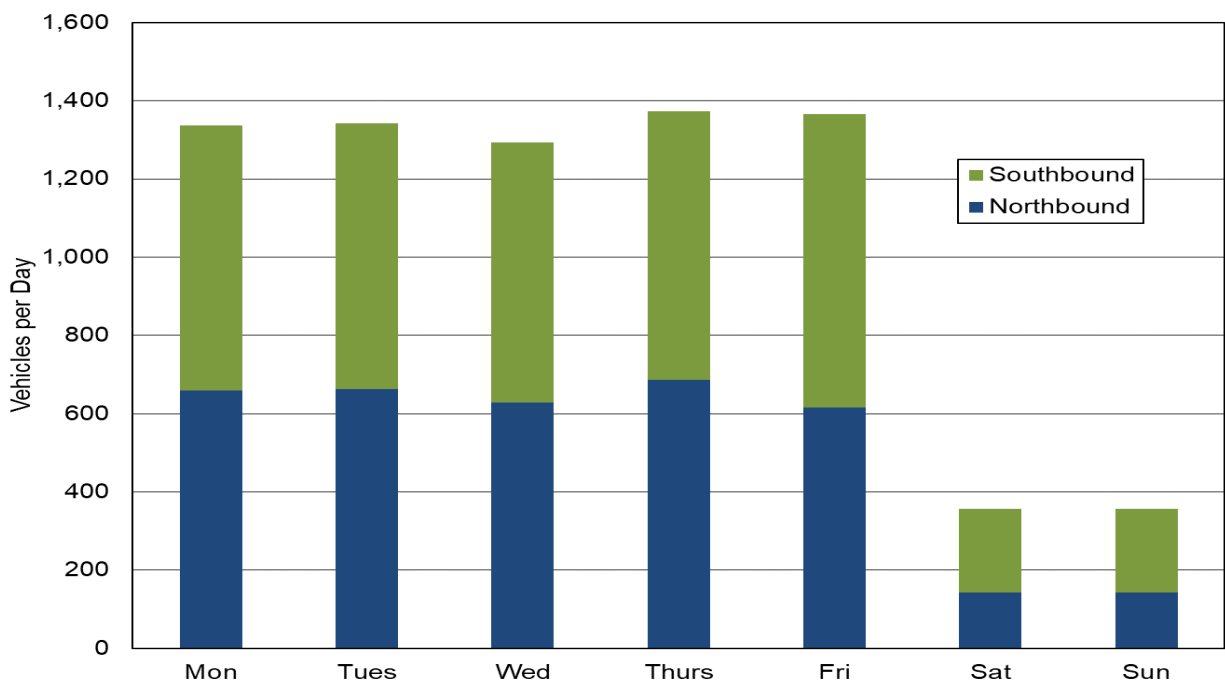
Figure 3. Daily Traffic Volumes – International Way south of Railroad Crossing (May 2023)

Figure 3 shows the observed daily traffic volumes at the crossing. As shown, volumes are highest on weekdays, with an average weekday traffic volume of 1,342 vehicles. Traffic flows are slightly unbalanced with 650 northbound vehicles and 692 southbound vehicles. This unbalanced flow is likely related to access restrictions on the west side of the Port area where vehicles cannot enter the site directly from southbound Oregon Way (State Route [SR] 433).

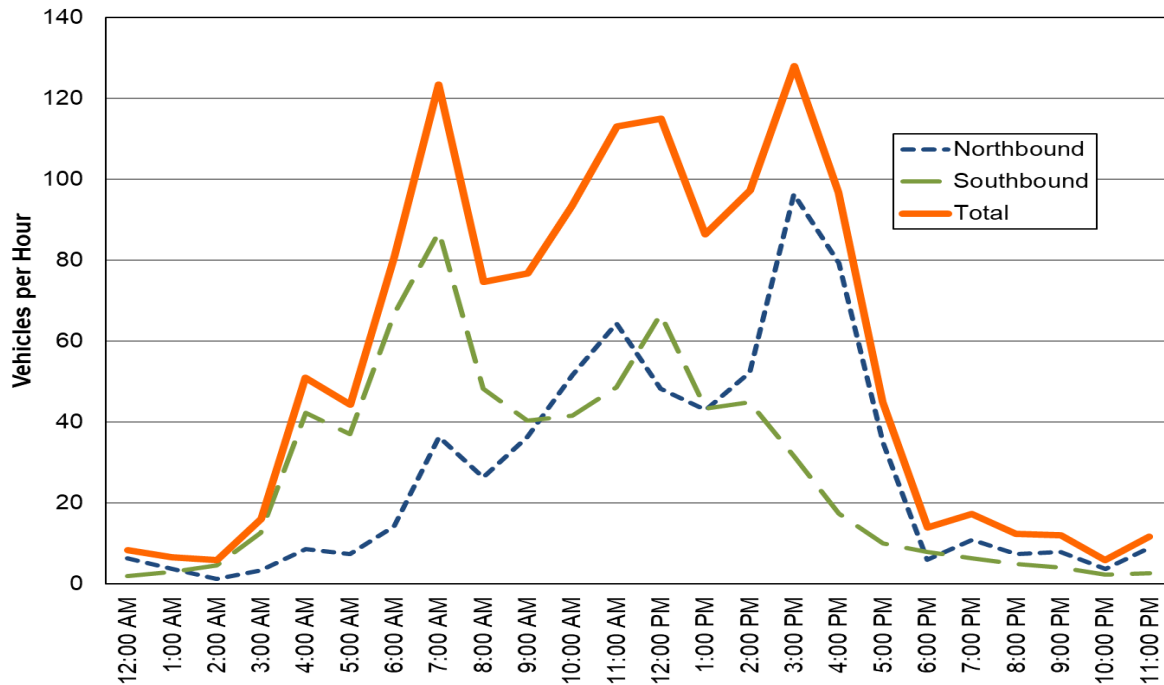
Figure 4. Hourly Weekday Traffic Volumes
International Way south of Railroad Crossing (May 2023)

Figure 4 shows the hourly weekday volumes, which reflect the average of counts for Tuesday, Wednesday, and Thursday. This figure shows the peak morning arrivals (southbound to the Port) and the peak afternoon departures (northbound), as well as the midday lunch period. Peak volumes did not exceed 100 vehicles per hour per direction.

Changing from a yield sign to a stop sign at the crossing would require all vehicles to stop, which under high volume conditions, could create unnecessary delay and queuing. However, as shown by the traffic volume data presented in Section 4.2, fewer than 100 vehicles per hour per direction cross the railroad tracks. Even during the peak 15-minute period, there were three or fewer vehicles per minute. A few seconds to complete a full stop would not create adverse congestion or queuing issues.

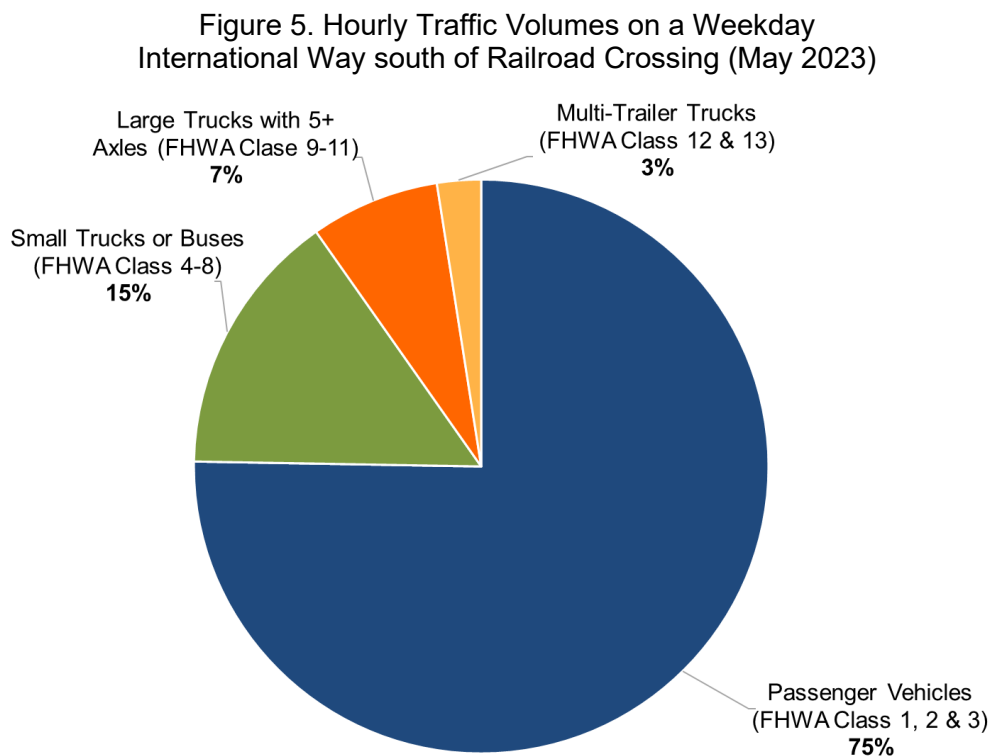
The types of vehicles were also captured during the traffic counts and were classified according to FHWA axle configurations. The classes were then grouped to show relative sizes of vehicles ranging from passenger vehicles to multi-trailer trucks. Figure 5 shows that 75% of the vehicles on International Way are passenger vehicles and 25% are trucks. About 10% of all vehicles are large trucks with more than five axles or trucks with multiple trailers.
