**EXHIBIT NO. \_\_\_(SML-5)  
DOCKET NO. UE-11\_\_\_/UG-11\_\_\_  
2011 PSE GENERAL RATE CASE  
WITNESS: SUSAN MCLAIN**

**FOURTH EXHIBIT (NONCONFIDENTIAL) TO THE  
PREFILED DIRECT TESTIMONY OF  
SUSAN MCLAIN  
ON BEHALF OF PUGET SOUND ENERGY, INC.**

# Cost Impacts Due to Municipal, County, and Other Requirements

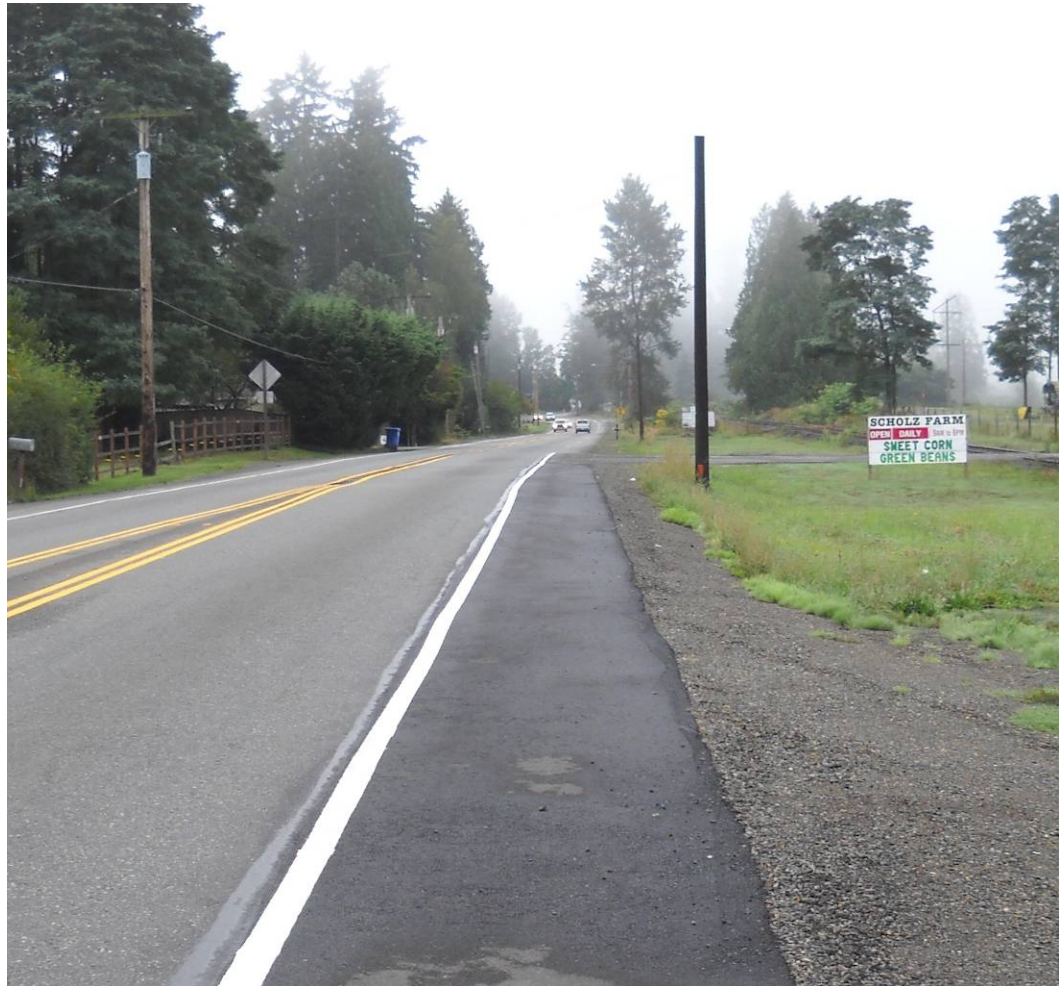
**Figure 4-1:** Orting Phase I Project, 8-Inch Diameter Supply Pipeline, In-Service 2007

1.7.1 *Figure 4-1* represents an example of a project where PSE was able to work in the shoulder where restoration was minimal and less expensive.

- 1.1.1 For example, in *Figure 4-1*, PSE was able to use the road shoulder area to replace the existing pipeline because municipal infrastructure facilities (e.g., stormwater drainage) either were not present in the shoulder area or their location did not conflict with PSE's placement of its pipeline. Thus, *Figure 4-1* shows an installation that required an approximately three-foot strip of asphalt on a roadway shoulder.

- 1.1.4 The paving costs associated with the project shown in the photograph in *Figure 4-1* were roughly \$300,000 per linear mile as compared to the costs of over \$900,000 per linear mile for the project shown in the photographs in *Figures 4-2 and 4-3*.

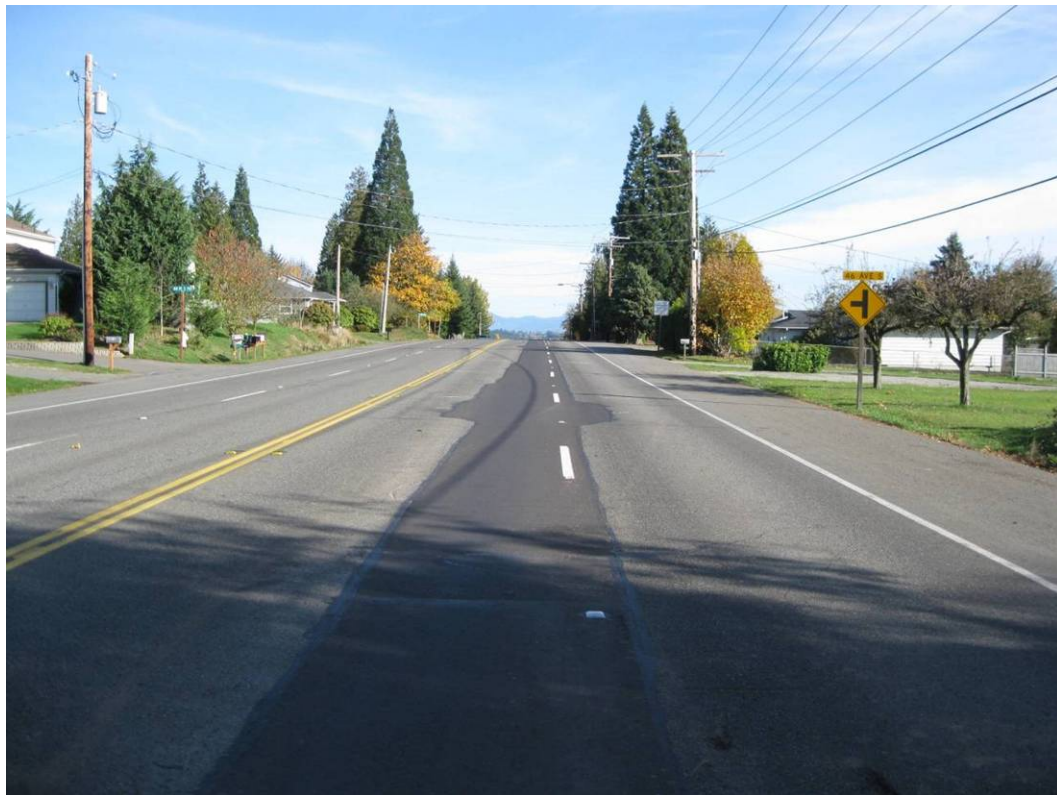
**Figure 4-2:** Kent Black Diamond Phase II Project, 16-Inch Diameter Supply Pipeline, In-Service October 2009

1.7.2 *Figure 4-2* shows an example of a project where PSE was required to work in the roadway and installed a temporary patch. PSE incurred approximately \$2.5 million in costs to install this patch that is approximately five feet wide over a five mile length of roadway.

Historically, this patch would have been an acceptable final restoration practice. More recently and more frequently, as in this project, the Company was required to return to add roadway asphalt overlay which varied from one lane to five lanes, plus shoulders. This was at an additional cost of \$2 million (yielding a total cost of \$4.5 million for paving restoration).

- 1.1.2 In contrast, *Figures 4-2 and 4-3* show the installation of a new natural gas supply pipeline where the shoulder area was not available due to existing municipal infrastructure conflicts. As the Company installs or replaces more pipe in urban areas, it often finds that the existing municipal infrastructure or anticipated municipal infrastructure plans preclude PSE from installing in the shoulder and require that construction be in the roadway.

- 1.1.3 *Figure 4-2* shows the installation of an approximately five-foot temporary strip of asphalt patch on a four-lane roadway that subsequently required a full roadway (curb-to-curb) asphalt overlay (*Figure 4-3*) in some locations and partial overlays in other locations.

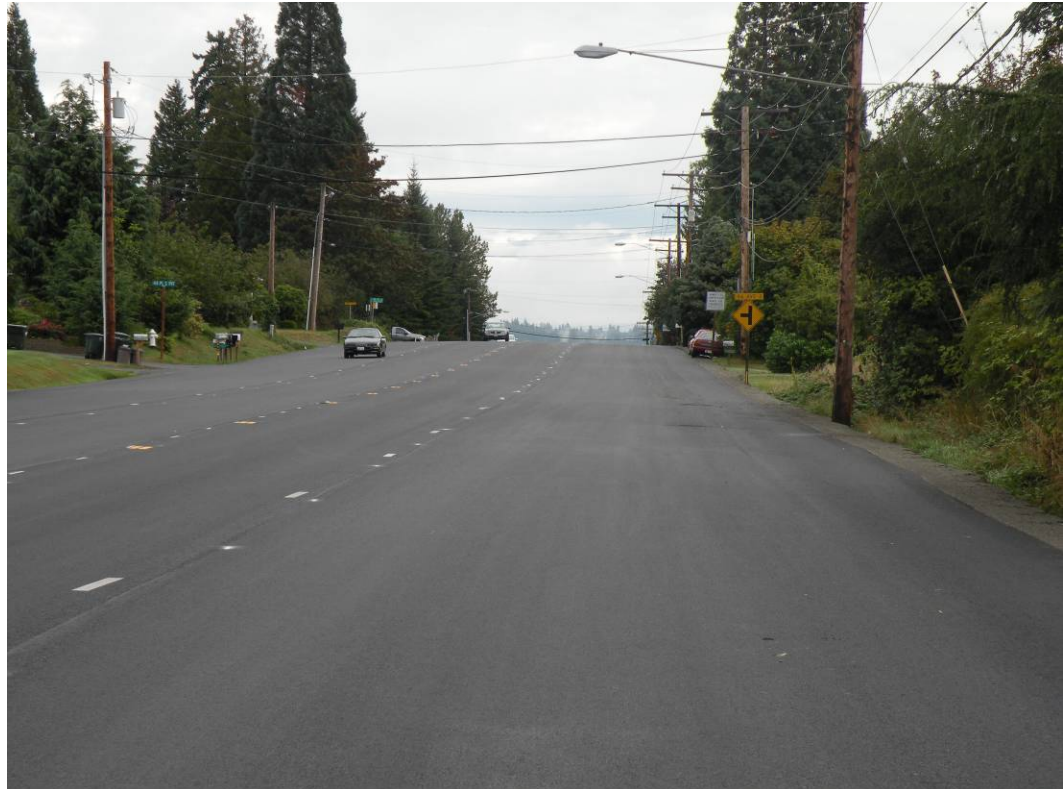
**Figure 4-3:** Kent Black Diamond Phase II Project, 16-Inch Diameter Supply Pipeline, In-Service October 2009

- 1.7.3 *Figure 4-3* depicts the required full roadway asphalt overlay on a section of the project where the road is a four-lane road. The photo was taken after the required full roadway overlay was completed, but before line striping.

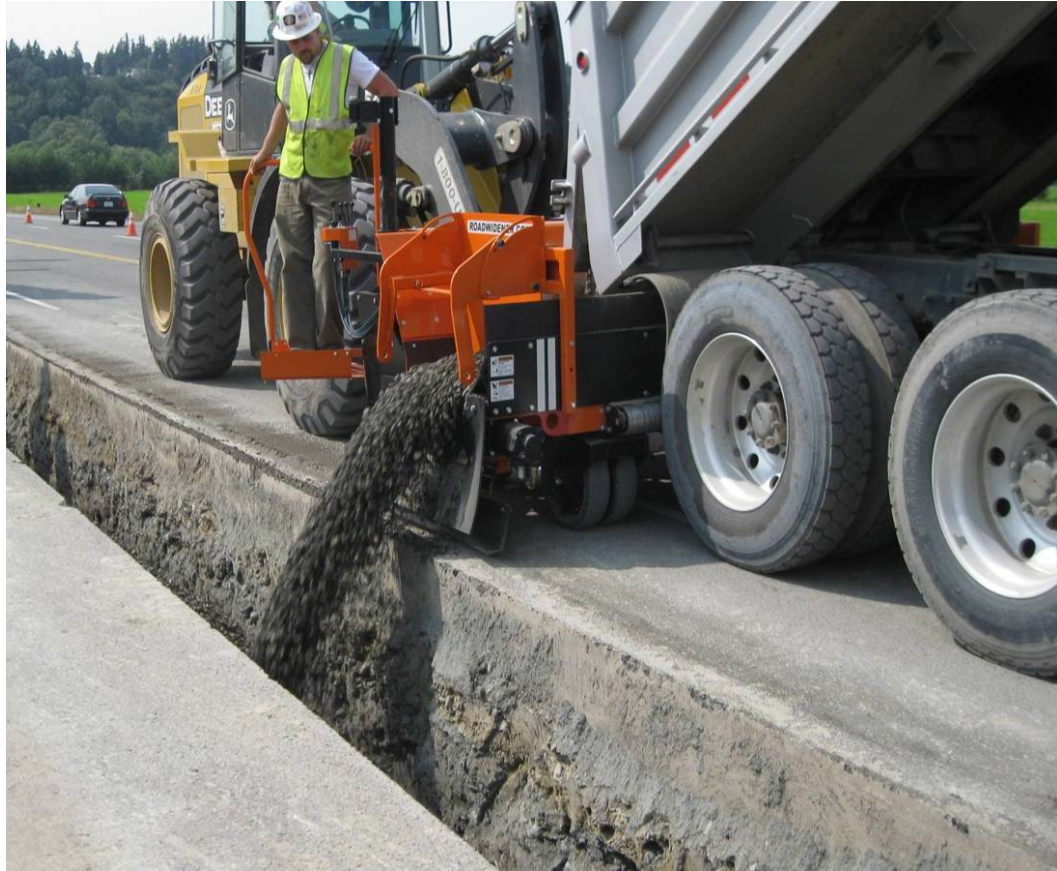
**Figure 4-4:** Kent Black Diamond Phase II Project, 16-Inch Diameter Supply Pipeline, In-Service 2009

- 1.7.4 *Figure 4-4* shows a project where a soil spreading machine was used to install select material that was hauled in to meet backfill compaction permit requirements. Since specific backfill material had to be hauled in, the existing soils that had been removed had to be hauled away.

- 1.2 *Figure 4-4* displays the replacement of roadbed soils with materials that meet specific compaction requirements that are often mandated by the municipality or county construction permit.

- 1.2.1 When specific soil materials are mandated, the removal and disposal of native roadbed soils is also required.
  - 1.2.2 These directives result in increased roadbed restoration costs as compared to the restoration costs that were previously required.

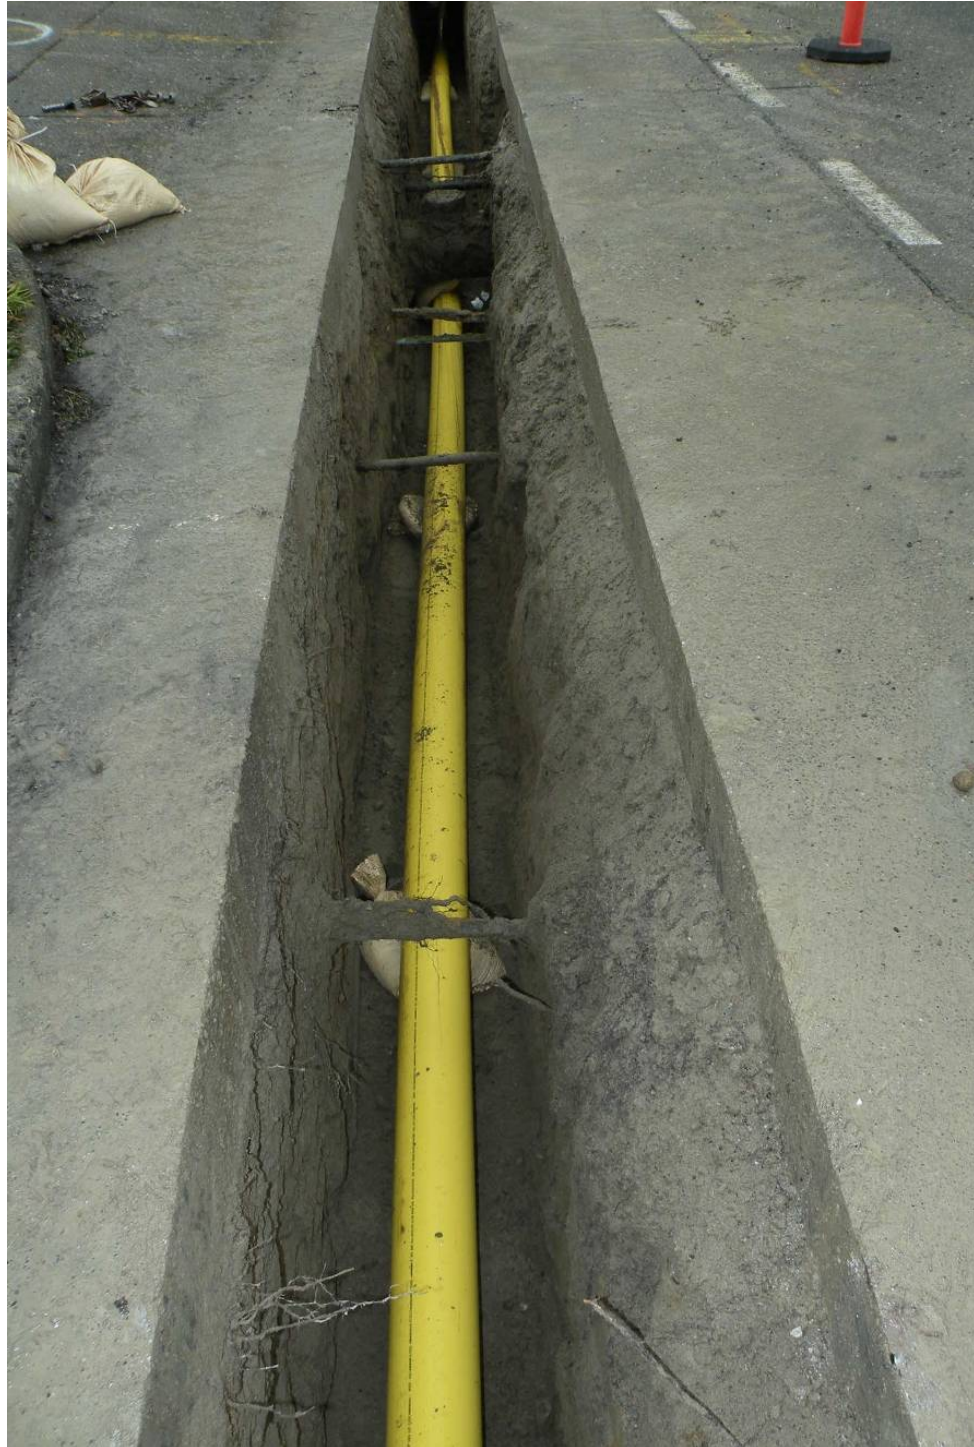
**Figure 4-5:** 6501 Beacon Ave S, 6-Inch Bare Steel Main Replacement, In-Service Expected 2010

- 1.7.5 *Figure 4-5* illustrates the trench depth for six-inch PE pipe in accordance with PSE standards that require three feet of cover.

- 1.3.1 *Figure 4-5* shows a three-foot-deep installation, while *Figure 4-6* shows a seven-foot-deep installation.
  - 1.3.2 For worker safety purposes, the seven-foot installation depth requires the use and continual movement of shoring and the incremental associated labor and equipment needed to periodically relocate the shoring as the project progresses.

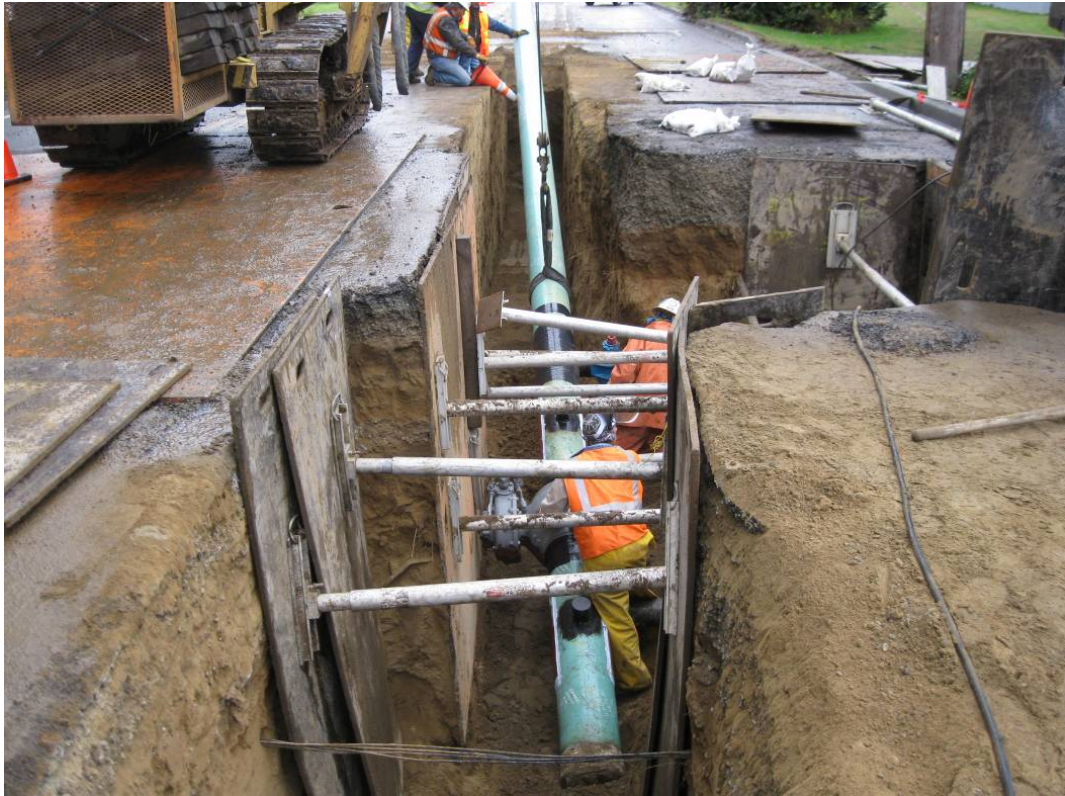
**Figure 4-6:** Lacey-Fones Road, 12-Inch Diameter Supply Pipeline, In-Service 2009

- 1.7.6 *Figure 4-6* shows the trench depth for 12-inch high pressure pipeline where the permit required seven feet of cover although PSE standards would have required three feet of cover. The seven-foot trench depth mandated the use of additional worker safety protections, such as shoring.

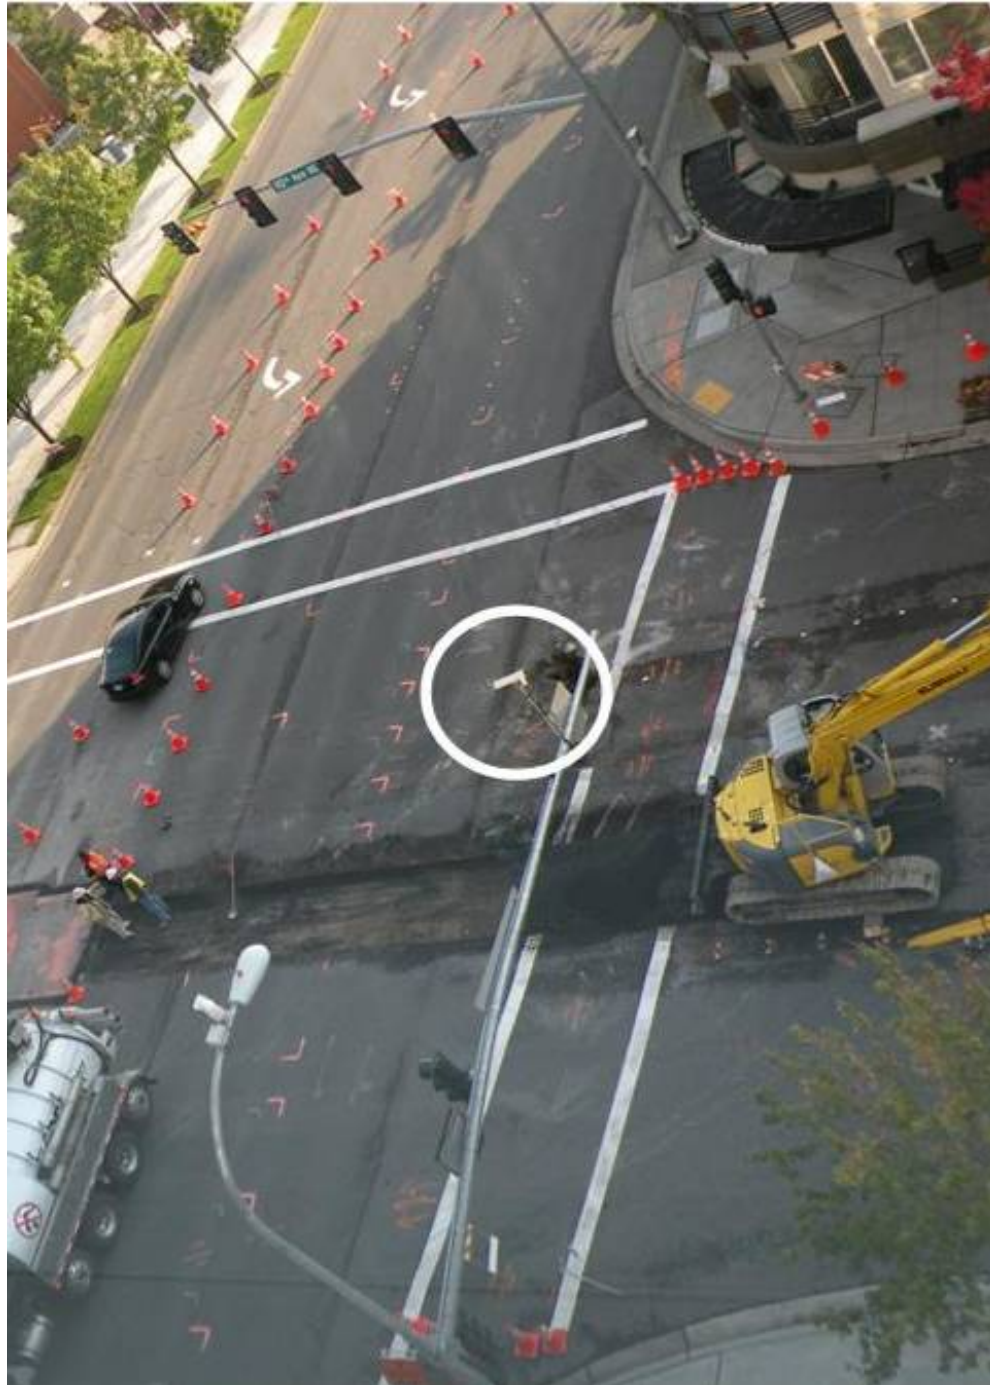
**Figure 4-7:** Bellevue Lake Hills 12- and 16-Inch-Diameter Supply Pipeline, In-Service 2009

- 1.7.7 In *Figure 4-7*, the required traffic control cameras which allowed the City to perform automated traffic control were installed prior to initiating construction and removed upon project completion. PSE incurred camera installation and removal costs of approximately \$300,000.

- 1.4.1 *Figure 4-7* shows the traffic control cameras that PSE was required to install and then remove upon project completion and demonstrates another factor that creates higher costs in the present day. In this project, traffic control camera installation and removal were required in order to secure the construction permit, and the costs were approximately \$300,000. This practice is becoming a more common requirement in urban areas.

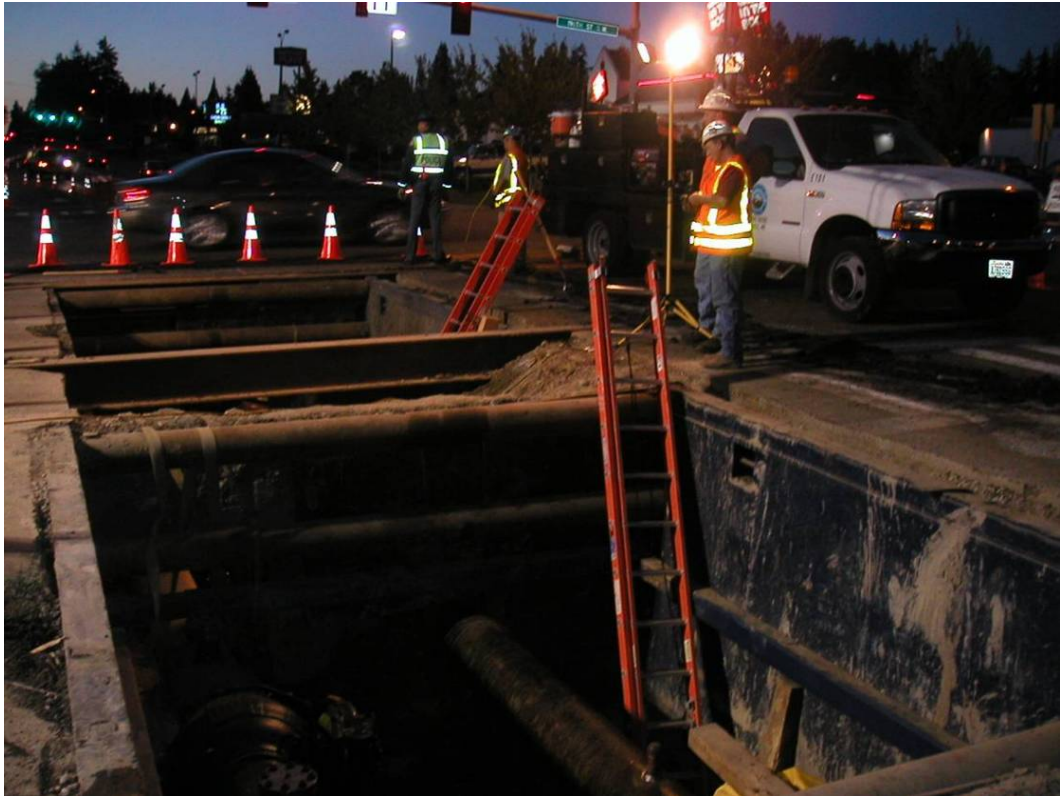
**Figure 4-8:** Lynnwood Valve Replacement, In-Service 2007

- 1.7.8 *Figure 4-8* depicts work that had to be performed at night as a condition of the construction permit. This increased project costs for added traffic control (off-duty police), lighting, overtime or shift differential, and extended hours for concrete mixing batch plants to supply backfill material.

- 1.5.1 *Figure 4-8* shows a project in which performing the work at night was a condition of the construction permit. Working at night can increase worker wage rates, and usually requires additional personnel and lighting equipment.

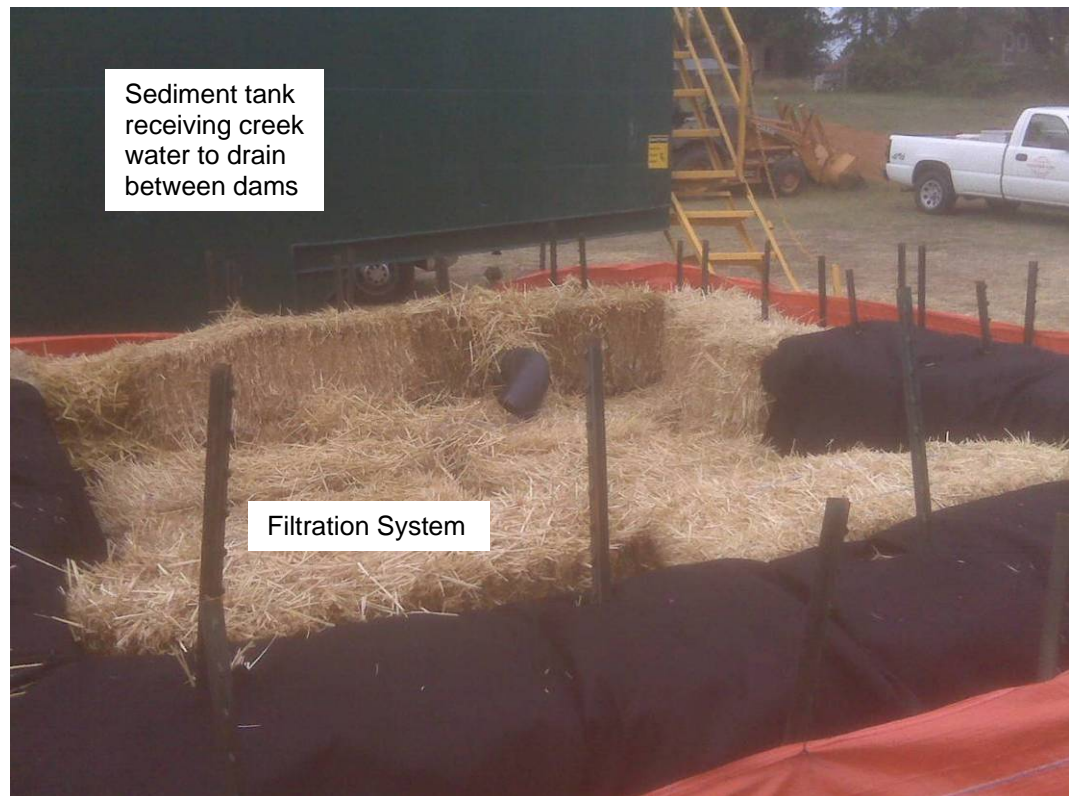
**Figure 4-9:** Frederickson 16-Inch HP Supply Pipeline, In-Service 2008

- 1.7.9 In the past, an acceptable practice was to naturally filter water by discharge through a grass field or hillside. More recent regulations require a water quality treatment and monitoring system.

*Figure 4-9* shows Clover Creek open cut crossing and the environmental protection steps that were required to preserve water quality and salmon migration. Geo-technical studies of soils indicated that conditions were not conducive to directional drill or traditional bore construction methods, therefore, PSE was required to open cut Clover Creek. Water that passed through the cut had to be filtered to meet water quality requirements. This was achieved by constructing upstream and downstream barriers – providing the water a place to settle before reentry to the creek.

- 1.6 Finally, *Figure 4-9* reflects an example of the type of actions that may be required for environmental protection in water quality and runoff shielding. In the past, an acceptable practice was to naturally filter water by discharge through a grass field or hillside. More recent regulations require a water quality treatment and monitoring system as is shown in *Figure 4-9*.
