STATE OF WASHINGTON
UTILITIES AND TRANSPORTATION COMMISSION

MEMORANDUM

Subject: Docket PL-171148, Penalty Assessment recommendation of \$10,000 against SEFNCO Communications, Inc., for violation of RCW 19.122.

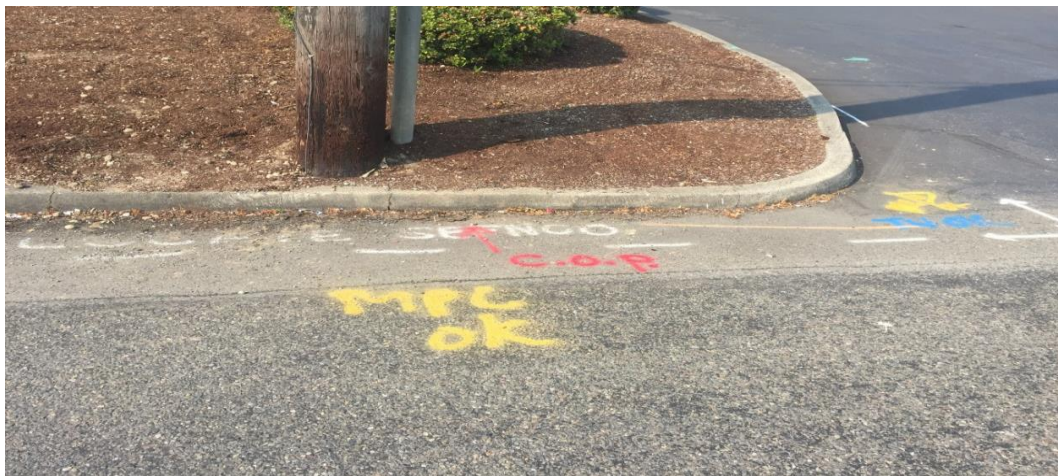
Picture 1

Staff's investigation found that SEFNCO only marked a small area in white paint by 9911 Pacific Ave. (Sound Credit Union), where they originally intended to install the new Comcast cable. Even though the locate ticket provided a description that stated the need for locates from the Credit Union to the East side of 100th and A St., staff found that the only area that was marked in white was a small corner by the Credit Union (See Picture 1).

Assuming SEFNCO wanted to be in compliance with 19.122.030(2), then they should have marked the additional excavation area in white paint and requested new utility locates for the proposed site. SEFNCO failed to perform this required action, which resulted in the puncturing of the McChord Pipeline and the associated spilling of 7,500 gallons of jet fuel into the surrounding area. SEFNCO also made contact with and caused minor damage to a 10-inch City of Tacoma water main that ultimately ended up needing to be replaced.

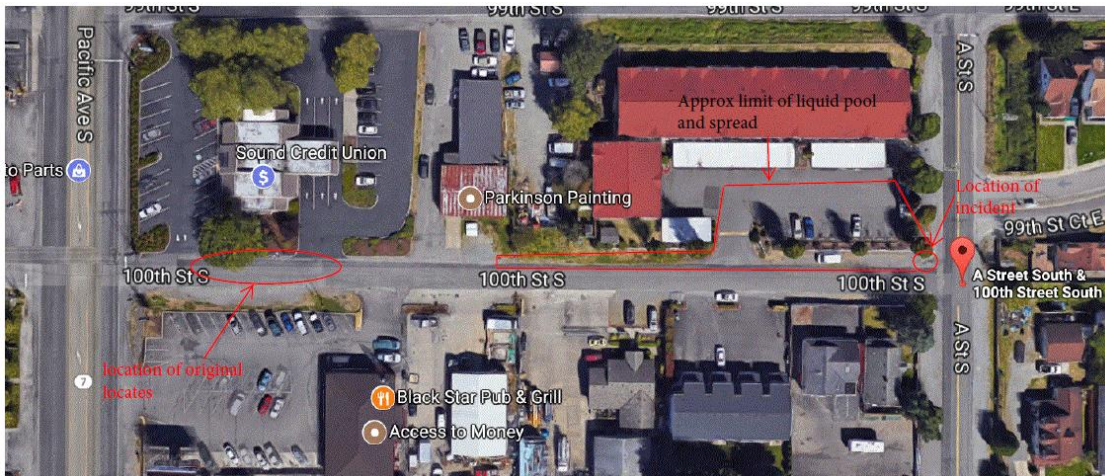
Picture 2

The only locate marks visible along 100th St. (by the Credit Union) were from McChord Pipeline, City of Tacoma Water, PSE, and Parkland Water. As demonstrated below (Picture 2), the location of the white marks and where the utility operators marked is approximately 475 feet from where SEFNCO was directionally drilling when they hit and damaged the McChord Pipeline.

RCW 19.122.030(2), specifically states that excavators must outline their proposed excavation area in white paint and provide two days' notice to a one-number locator service before beginning work. While SEFNCO did outline a small area in white and request utility locates on July 26, 2017, it was not for the area where the damage incident occurred. The area where SEFNCO hit and punctured the McChord Pipeline was approximately 475 feet away.
