BEFORE THE WASHINGTON UTILITIES AND TRANSPORTATION COMMISSION

In the Matter of a Penalty Assessment against
SEFNCO COMMUNICATIONS, INC.
in the amount of \$10,000

DOCKET PL-171148
DECLARATION OF
KEVIN JONES

10 ELM prepared an internal investigation report, and I contributed photographs as well
as my report to our internal investigation. A copy of ELM's internal investigation, "McCord
Pipeline Damage Investigation," prepared by Mr. Christel and including my input, is
attached to this declaration.

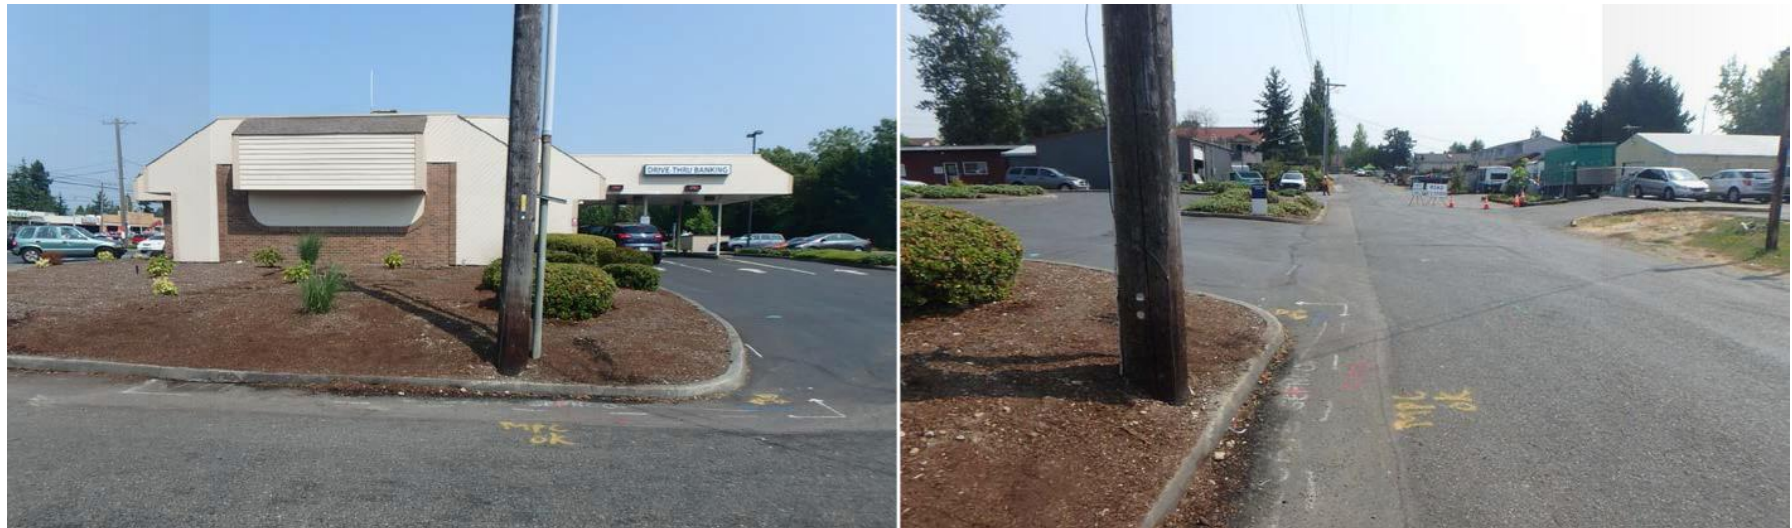
Photo showing white marked area and overhead view of white marked area

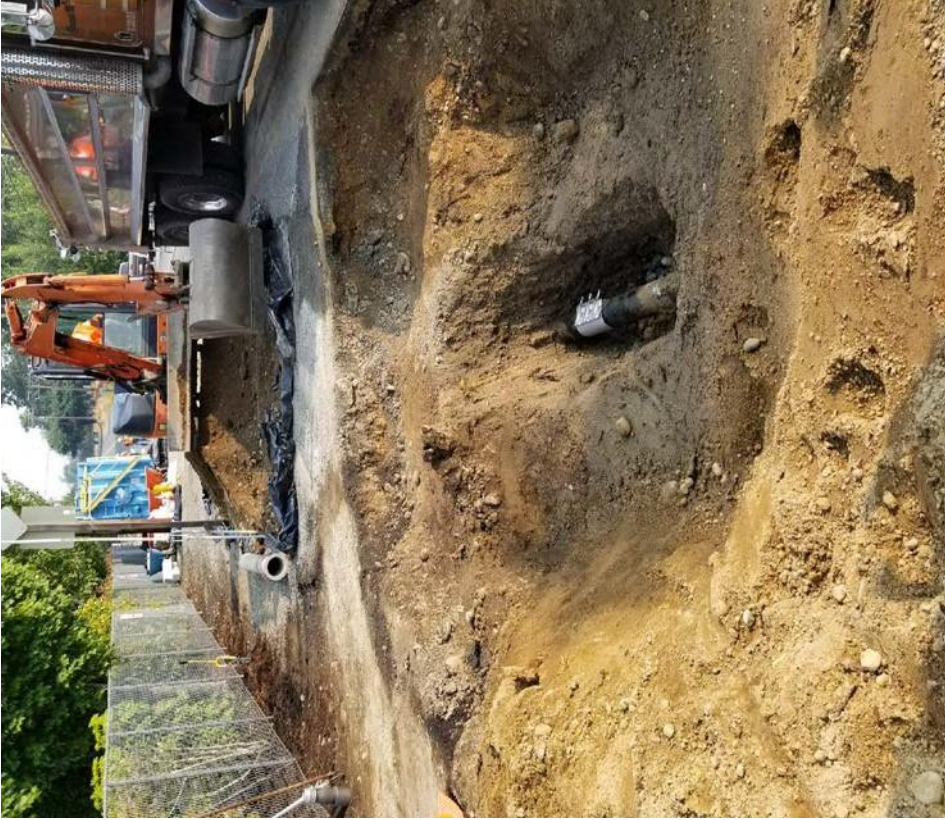
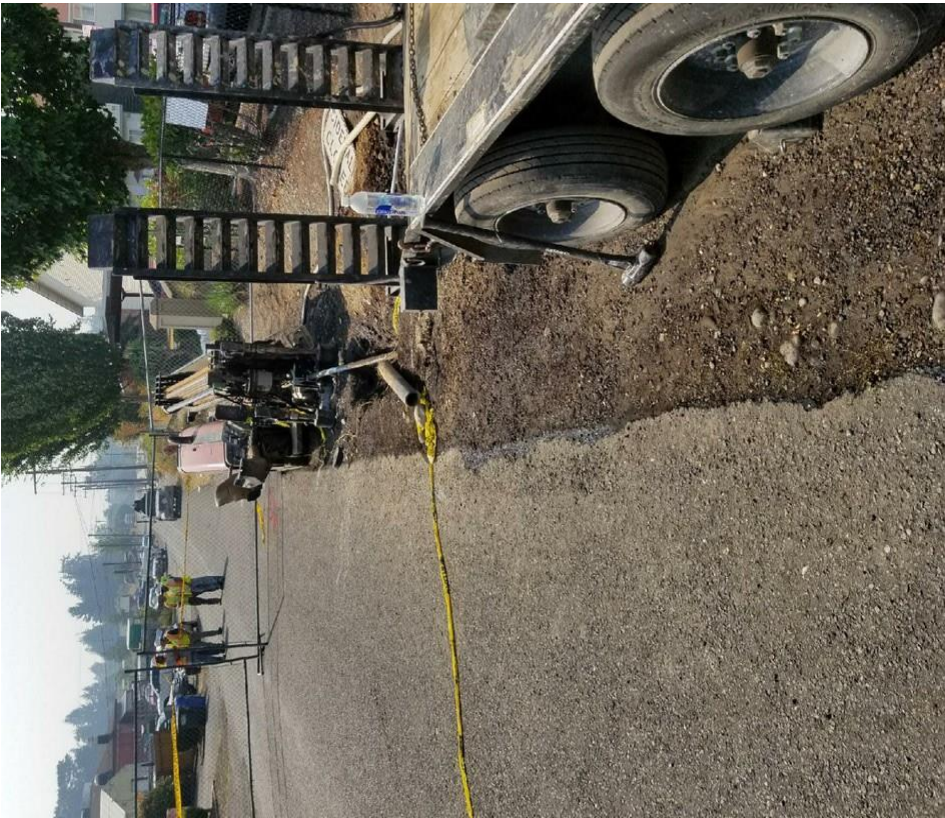
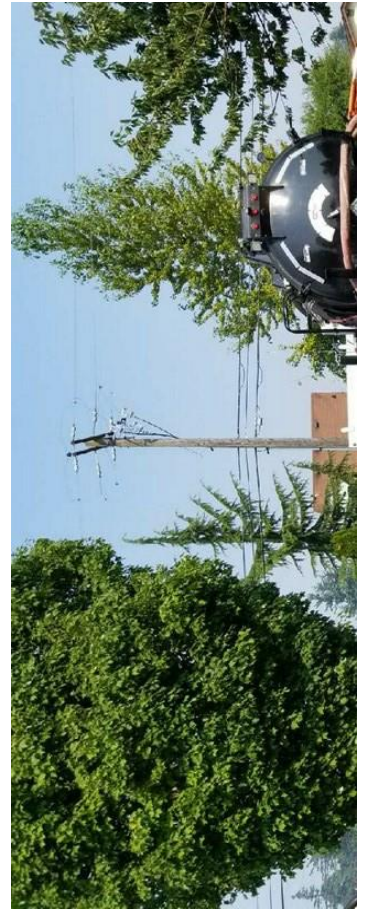
Photos from the day of damage

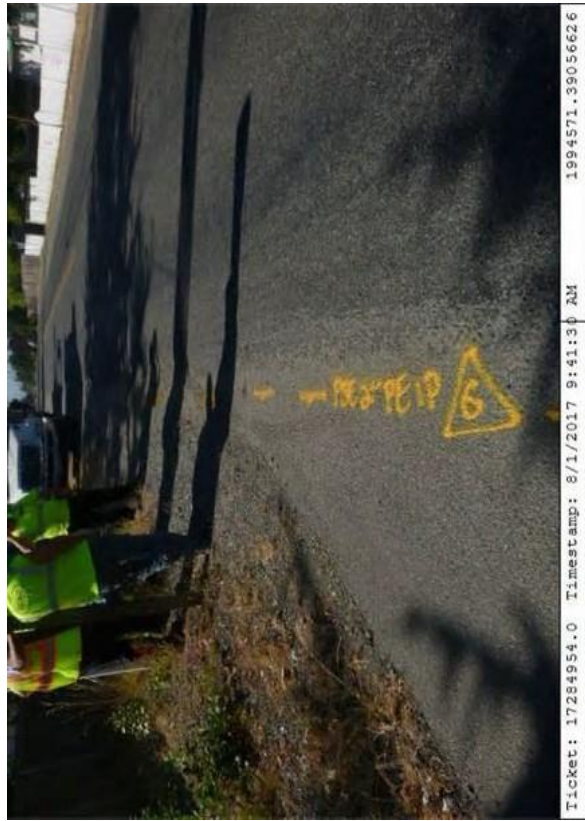
I attempted to contact Jessie, but he did not answer. I then reopened the ticket, contacted the original locator, and sent him back to the job site. When Kevin, the original locator, arrived, he met the crew on site and was verbally instructed of the work area. He then marked out the main under my instruction that passed through the described work area. Kevin recommended to the forman on site that they call in a new locate request due to the confusion of the white marks behind 9911 Pac Ave. He explained that the other utility companies in the area had marked only that location and that he did not see any white marks indicating that the work would extend to the pole on A st. Here is a photo of that meeting taking place, the gas main marked in the described on site work area. Notice white marks are not visible.

This photo is taken from the north facing south.
