Re: February 2023 Monthly Progress Report  
Administrative Settlement Agreement and Order on Consent for Removal Action  
EPA Region 10 Docket No. CERCLA 10-2009-0255  
Gasco Sediments Site Within the Portland Harbor Superfund Site

Attachment A Monthly Visual Monitoring Report for Pilot Cap Vicinity

# Visual Observations Log Form

**Project:** NW Natural – Gasco

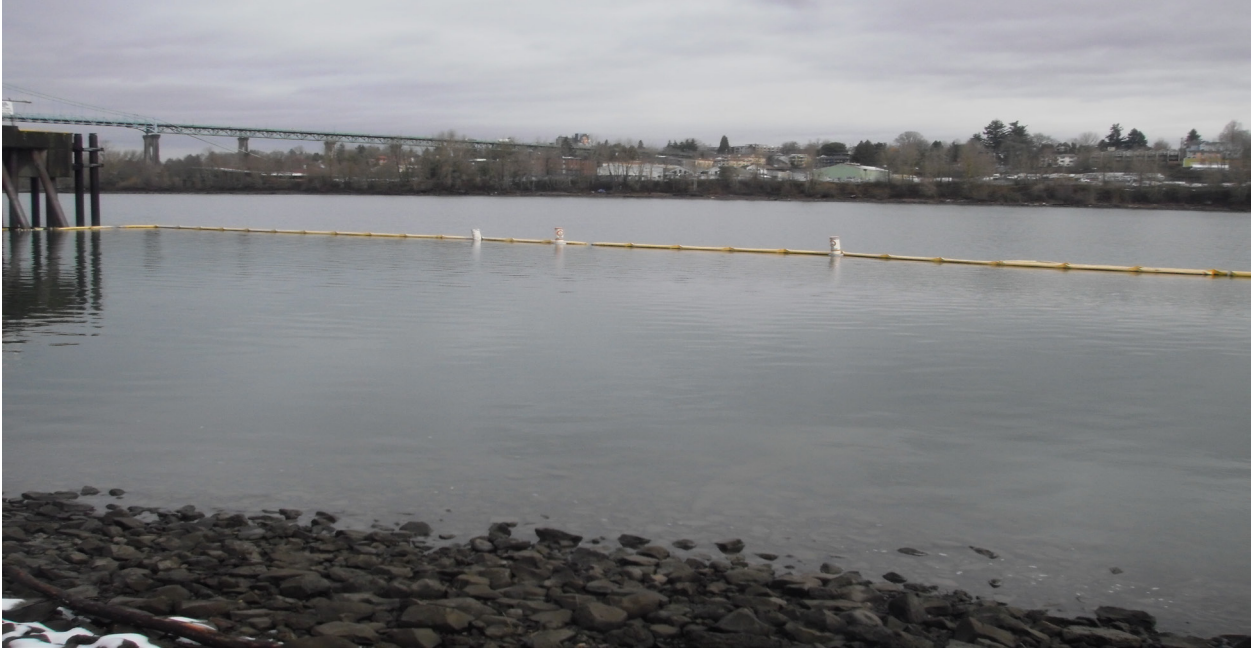
During the observation, the Centerline Logistics (Centerline) containment boom was in place from dock to dolphin. The three buoys identifying the cap area to mariners were in place as installed. The positions of the Centerline oil boom and warning buoys are shown in Photo 1.

**Photo 1**  
**Centerline Oil Boom Placement from Dock to Dolphin with Three Mariner Warning Buoys at Pilot Cap Area (2/27/2023)**

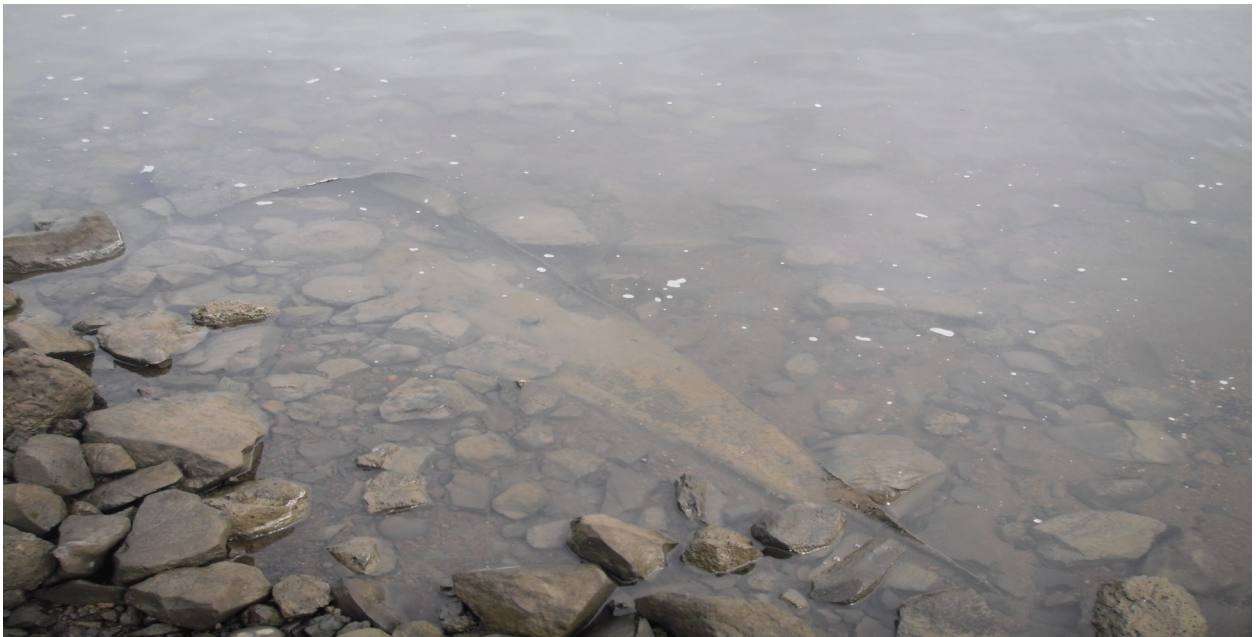
All potentially exposed organoclay mat material segments were submerged and only partially visible due to high river elevations. A 7-foot section at the lateral midpoint of the cap area was visible at the waterline (Photo 2). The visible, exposed segments of organoclay mat were in visually good condition.

**Photo 2**  
**Organoclay Mat Material at the Midpoint of the Cap Area (2/27/2023)**

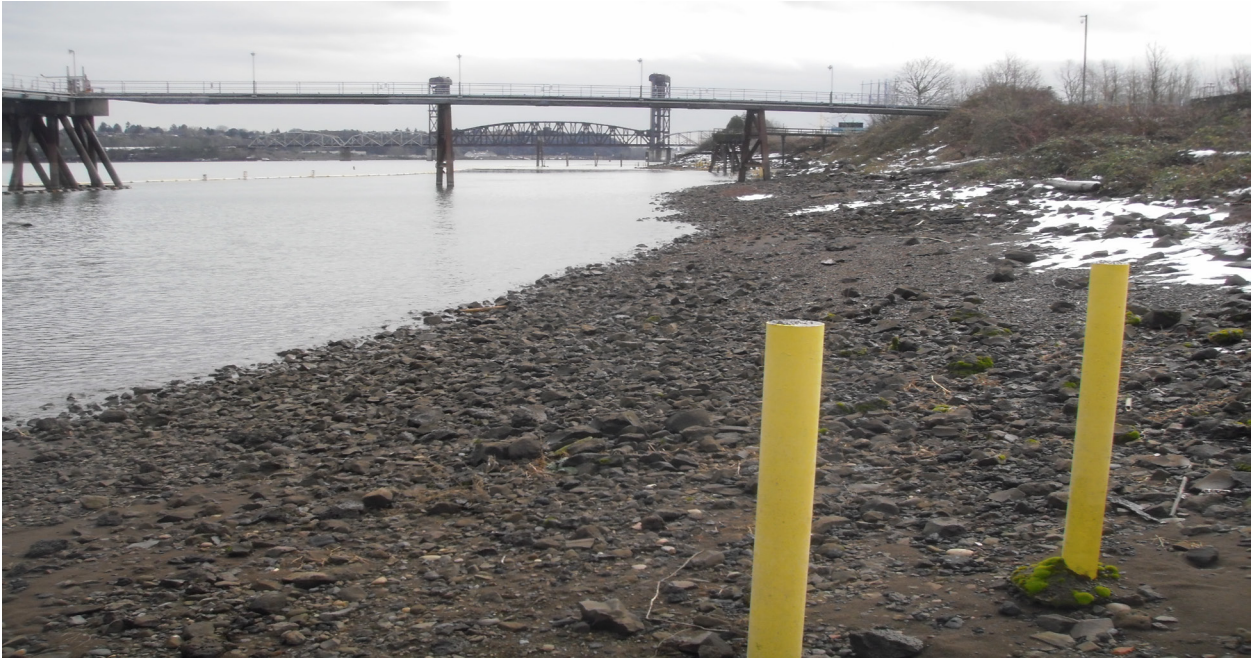
Photo 3 shows the water surface and shoreline immediately downriver of the sediment cap. No sheen was observed within the cap area.

**Photo 3**  
**Conditions Immediately Downriver of Cap Area Looking Upriver (2/27/2023)**
