18-074**M & L Construction, Inc. vs Avista**

loon lake electrical hit -Avista utilities 7-25-18 18-074

WA Complaint 18-074
M&L vs Avista Corp – South Loon Lake Rd
Avista Supporting Documentation
October 31, 2018

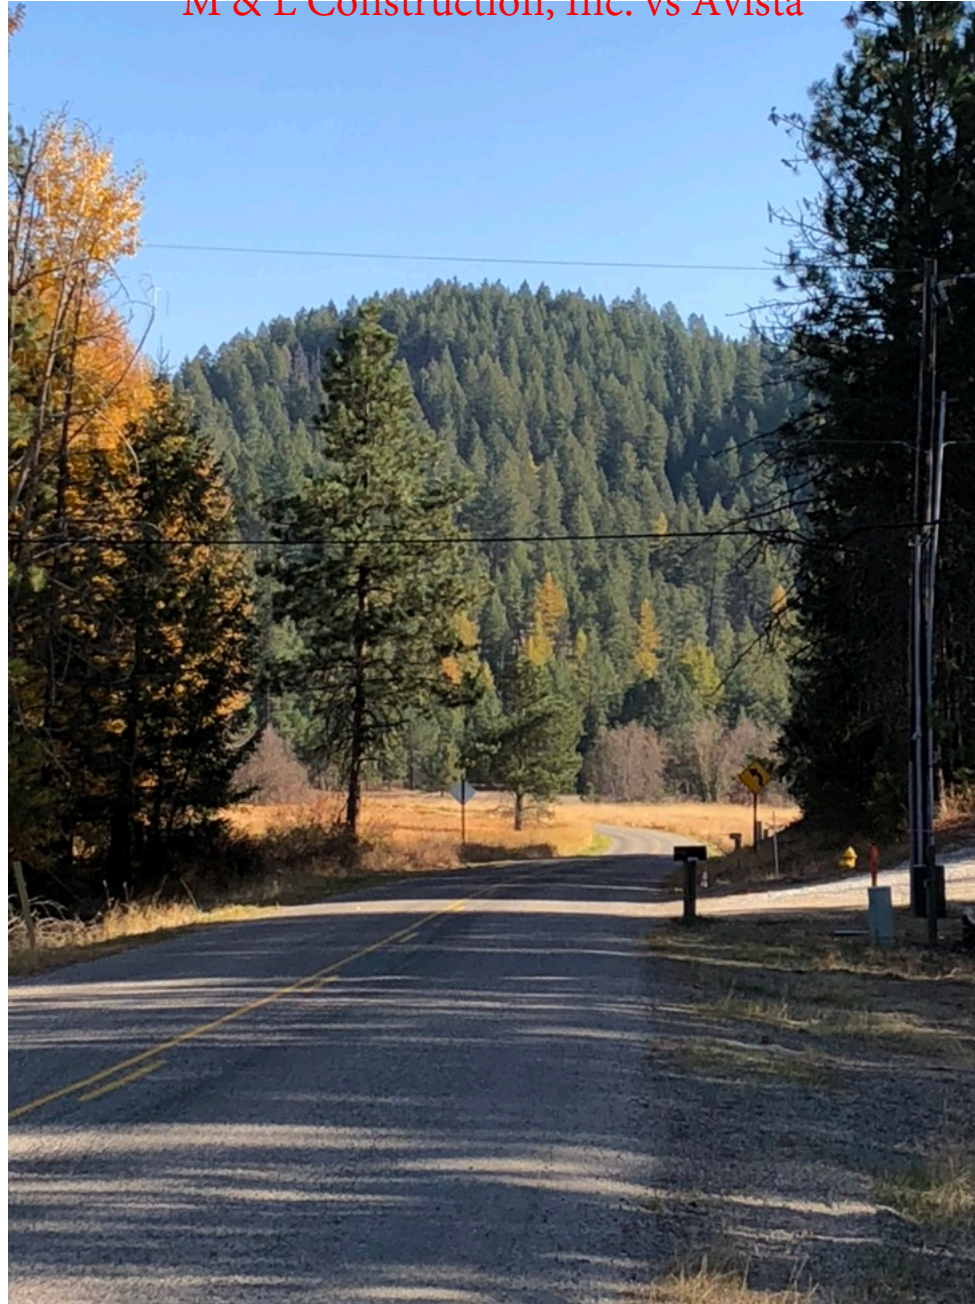
Where the line was hit

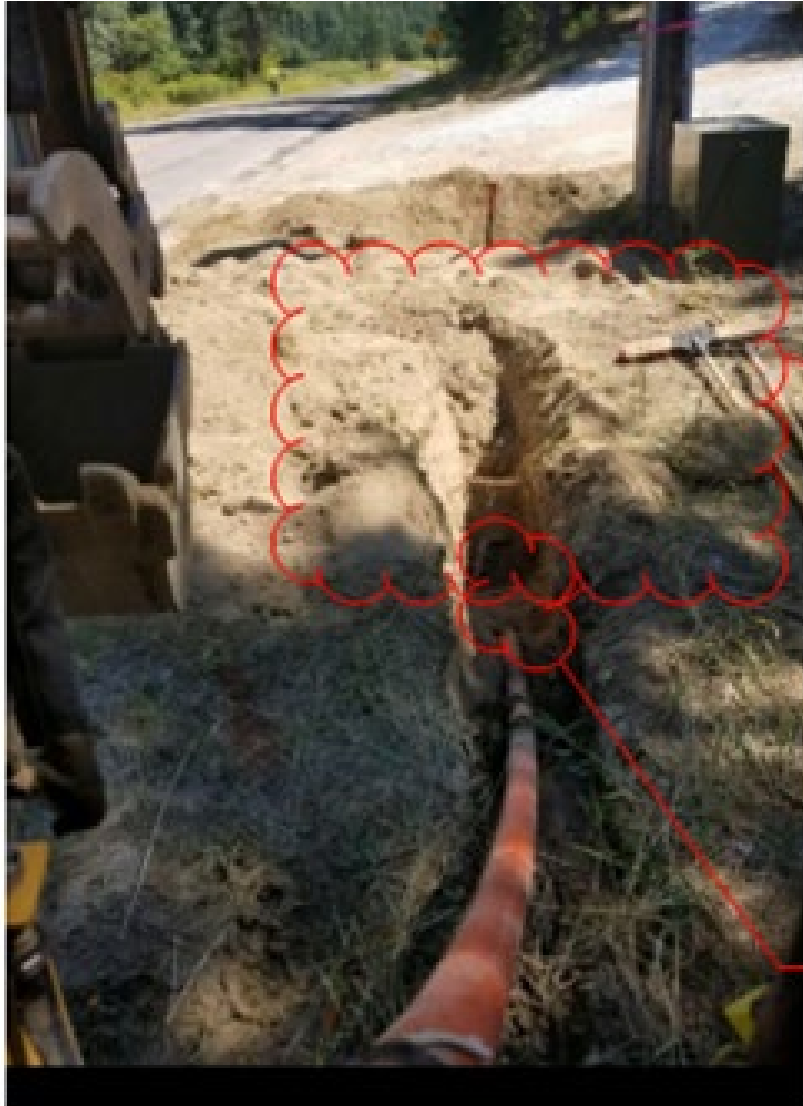
Failure to put paint on the ground

Damaged electrical line

No paint on the ground

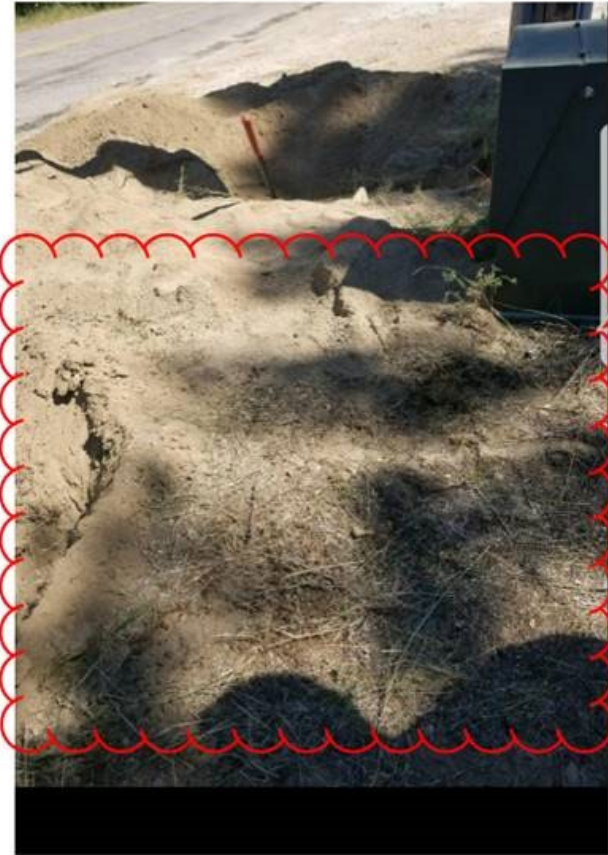
NO PAINT IN THE
DIG AREA

Within the white paint dig area

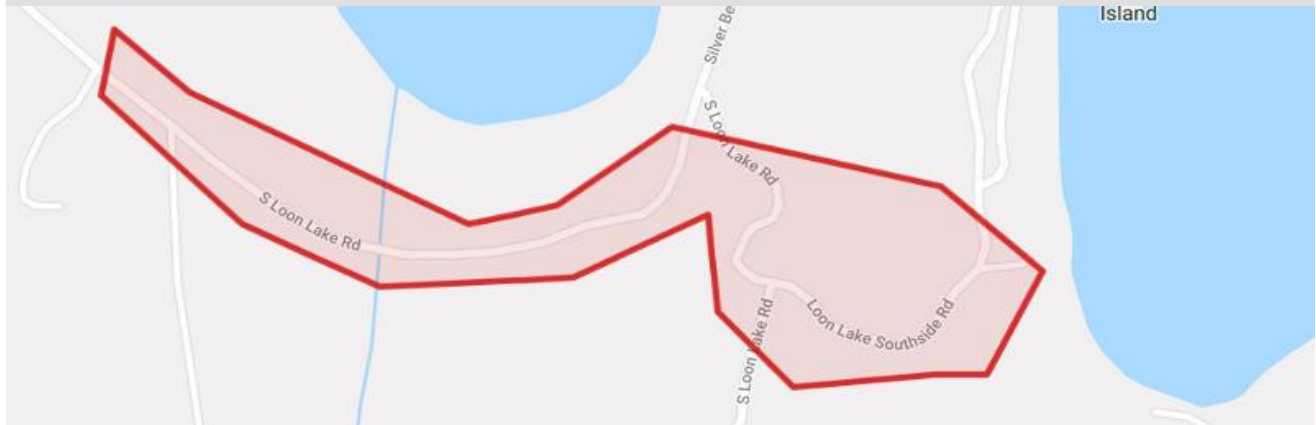
Attachment B: Vicinity map and location of damage at 42994 S. Loon Lake Rd, note that there are 2 poles in front of this property. Locator located both gas and electric

Avista's contract locator did not see white marks west of the pole at 42994 S. Loon Lake Rd. See **Attachment B**, picture of beginning of locate marks at pole as described in the locate ticket (also note, there are actually 2 poles located in front of this property).

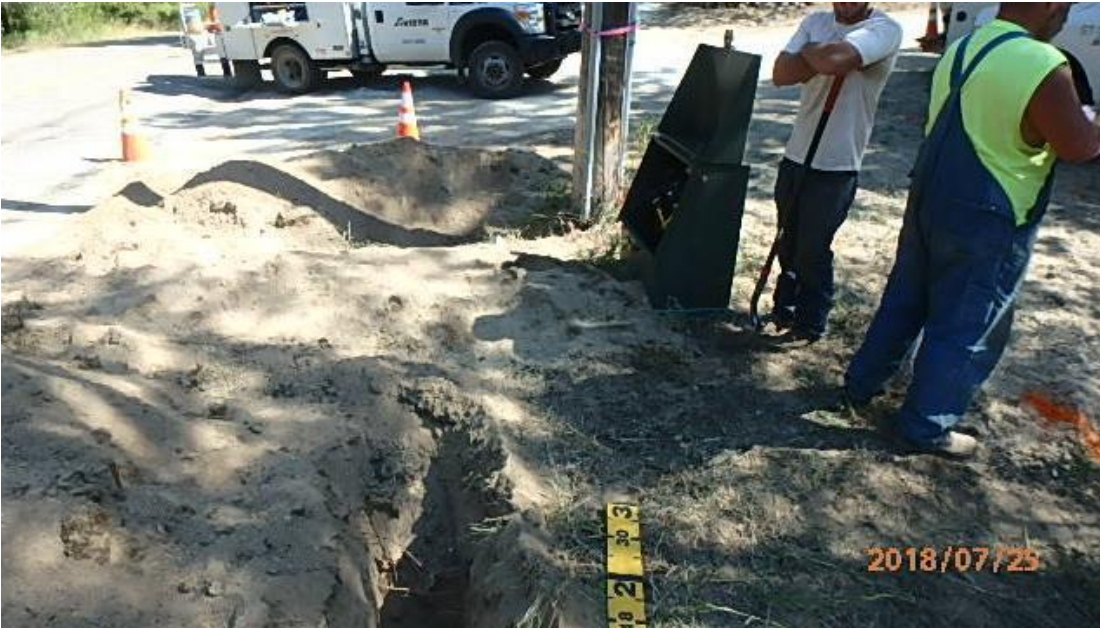
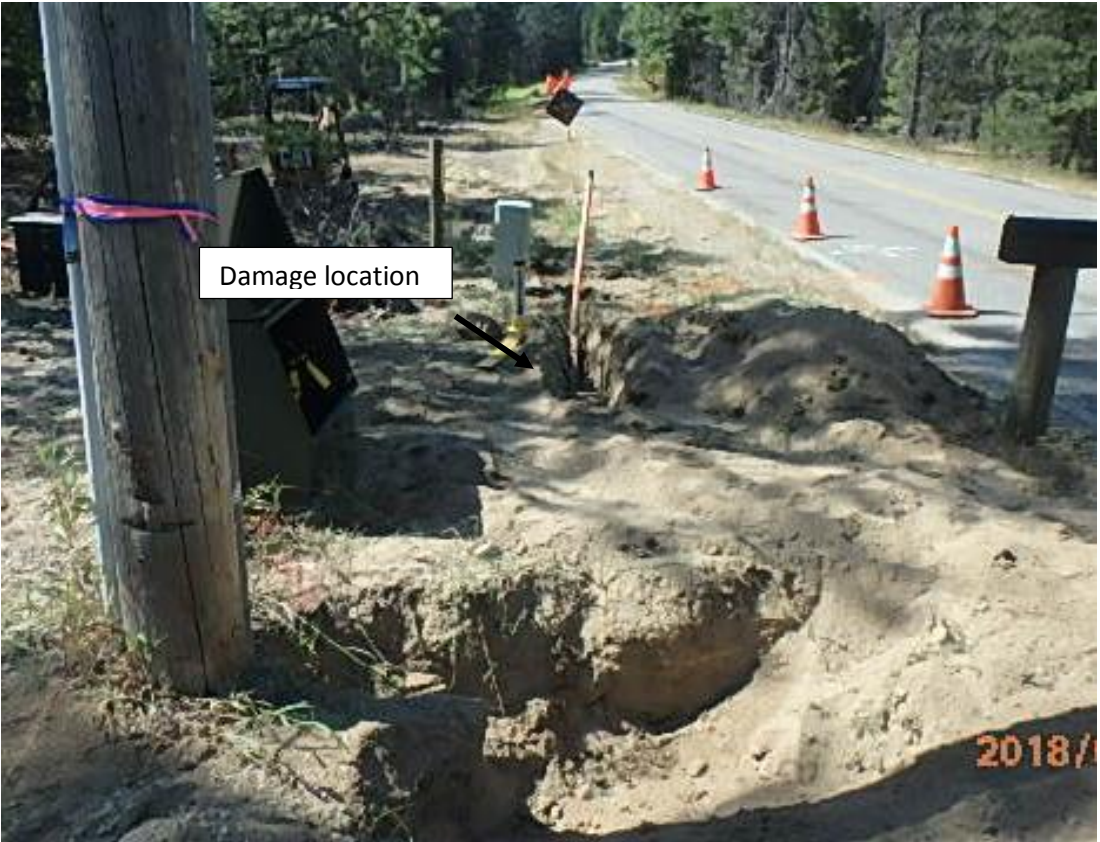
Attachment D: Pictures of damage location showing the pole and the date of the damage

On July 25, 2018 M&L Construction damaged Avista's electric primary west of the pole located at 42994 S. Loon Lake Road, **Attachment C**.

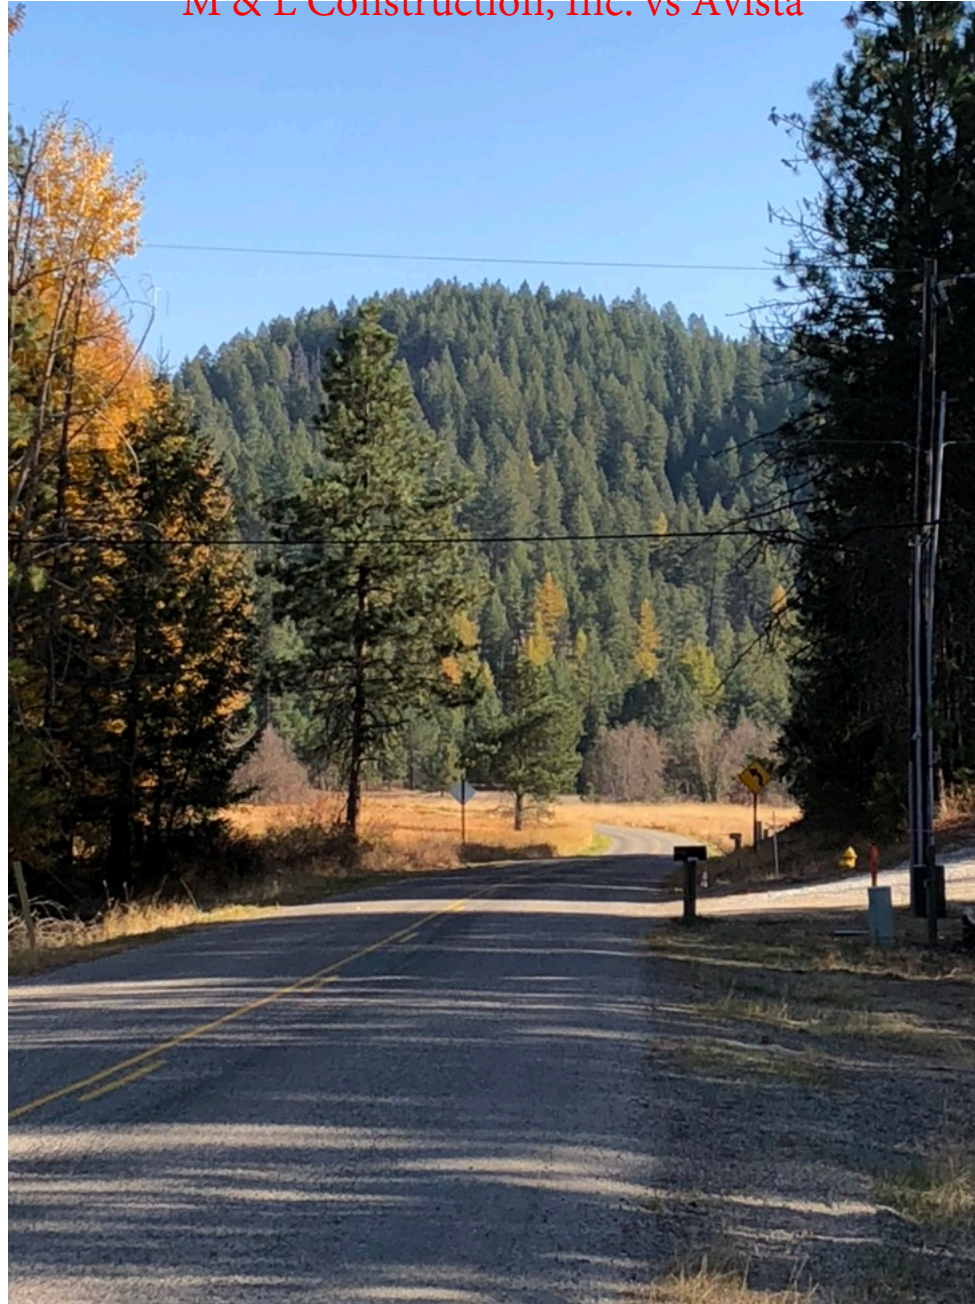
Where the line was hit

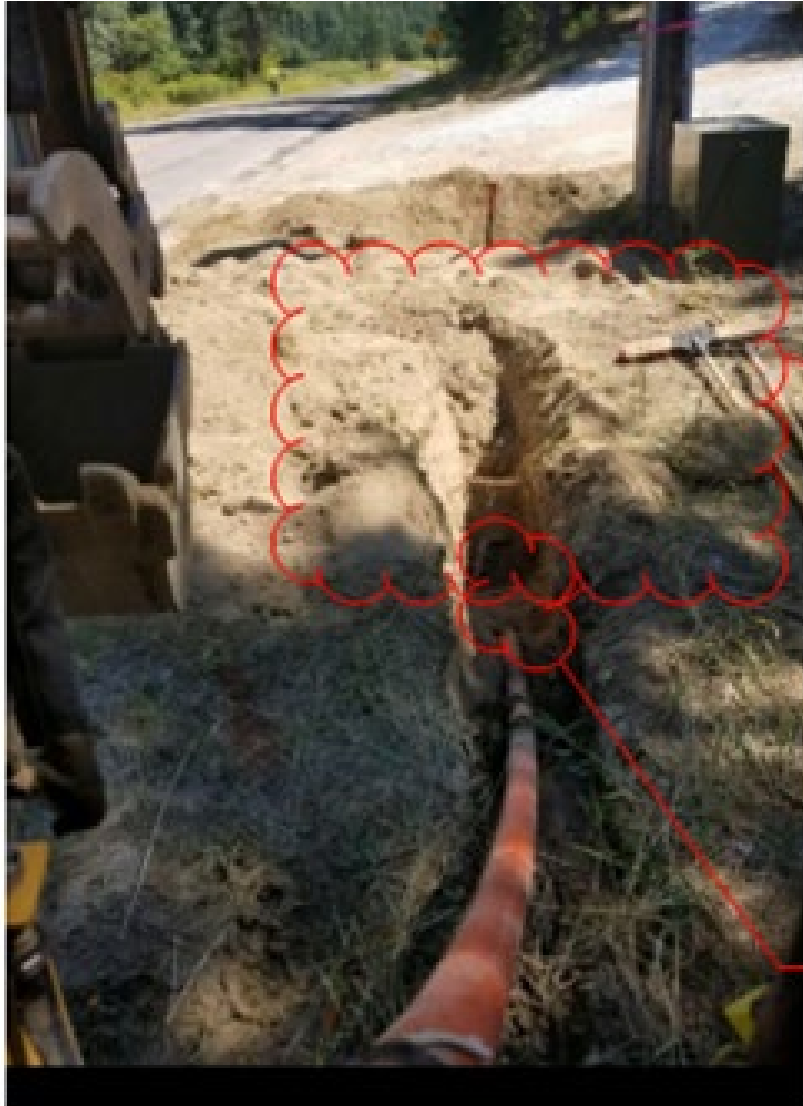
Failure to put paint on the ground

Damaged electrical line

No paint on the ground

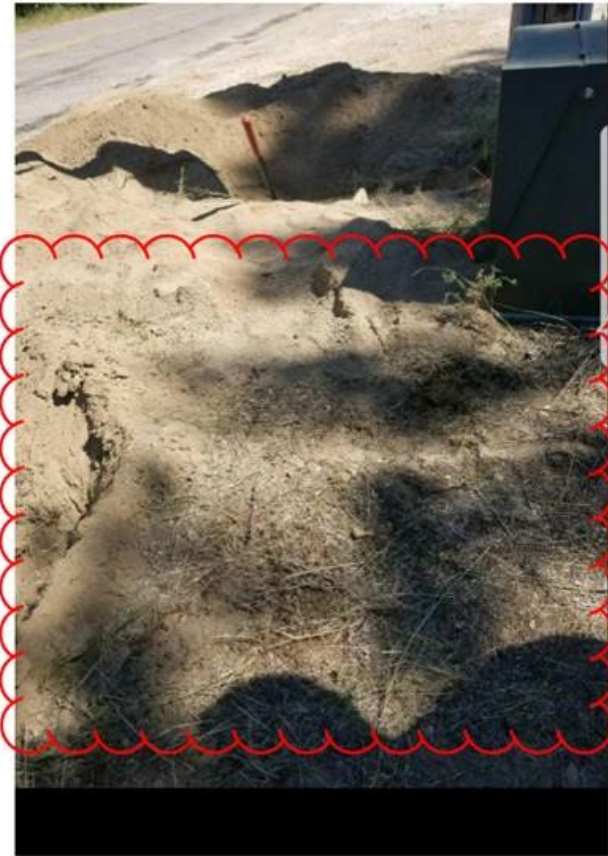
NO PAINT IN THE
DIG AREA

Within the white paint dig area
