**Case 20-024
Halme vs Avista**

Alleged Violation: RCW 19.122 failed to properly locate a buried gas line that resulted in a rupture

Summary: ELM locator, Jacob Edwards, mis-located the service that resulted in a natural gas line being damaged by Halme that occurred on 5/7/20 at 428 S Neyland in Liberty Lake, see Exhibit A for vicinity map of damage location. The locator mistakenly located the telephone line that made the service look like it was a split service when in reality it was a service crossing Neyland. See Exhibit B email from ELM accepting responsibility for this damage and an excerpt from ELM's Incident Investigation Report #191852 the Assessment comments completed by Tyler Proszek indicating that it was an inaccurate locate.

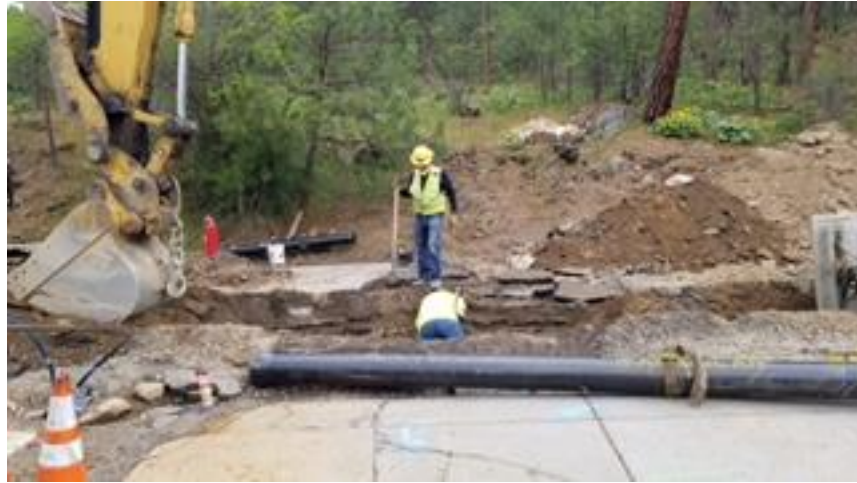
Exhibit E – Photo of damage location

Assessment Comments: Proszek- The gas service was damaged in the west lane of traffic along the north property line. The locator failed to accurately locate the service. He located the telephone and indicated the service to be a split with 422, connecting on the west side of the street as opposed to a single service, crossing Neyland. Confirmed inaccurate locates with original locate pictures. No locate marks on site for where the line is.

The gas piping locates for this project were validated on 5/9/20 to assure that all marks were accurate.
