WSDL complaint 24-062

Ticket number 24198375

5/23/24

515 W Regina

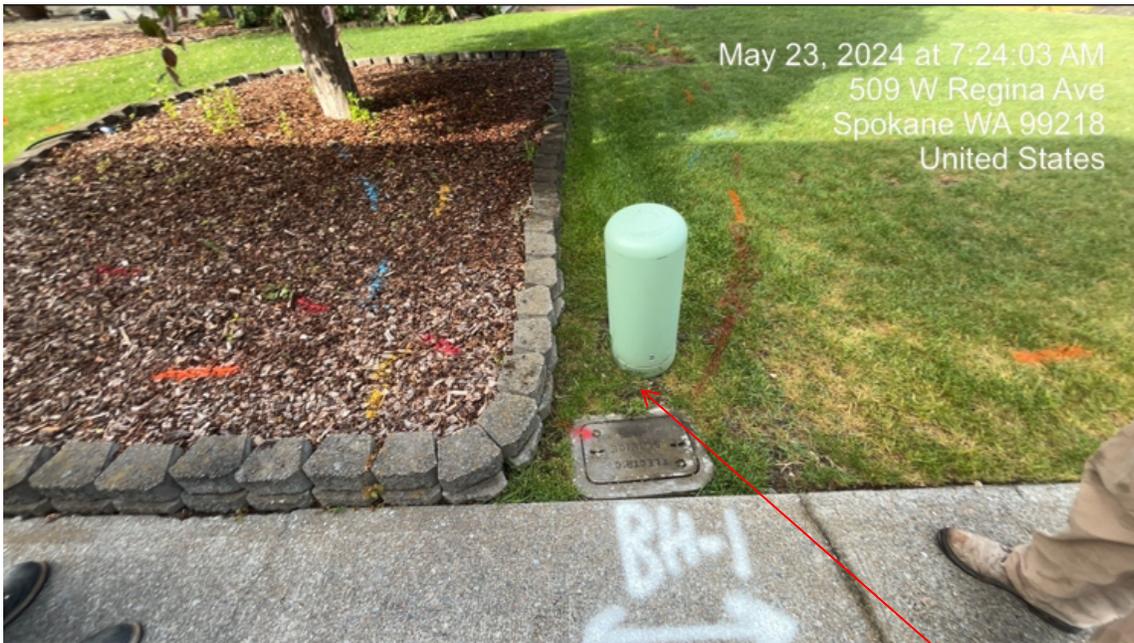
View of east exit pit and locates, note 1 secondary electrical line feeding house to the south. Nothing continuing west in the bore path.

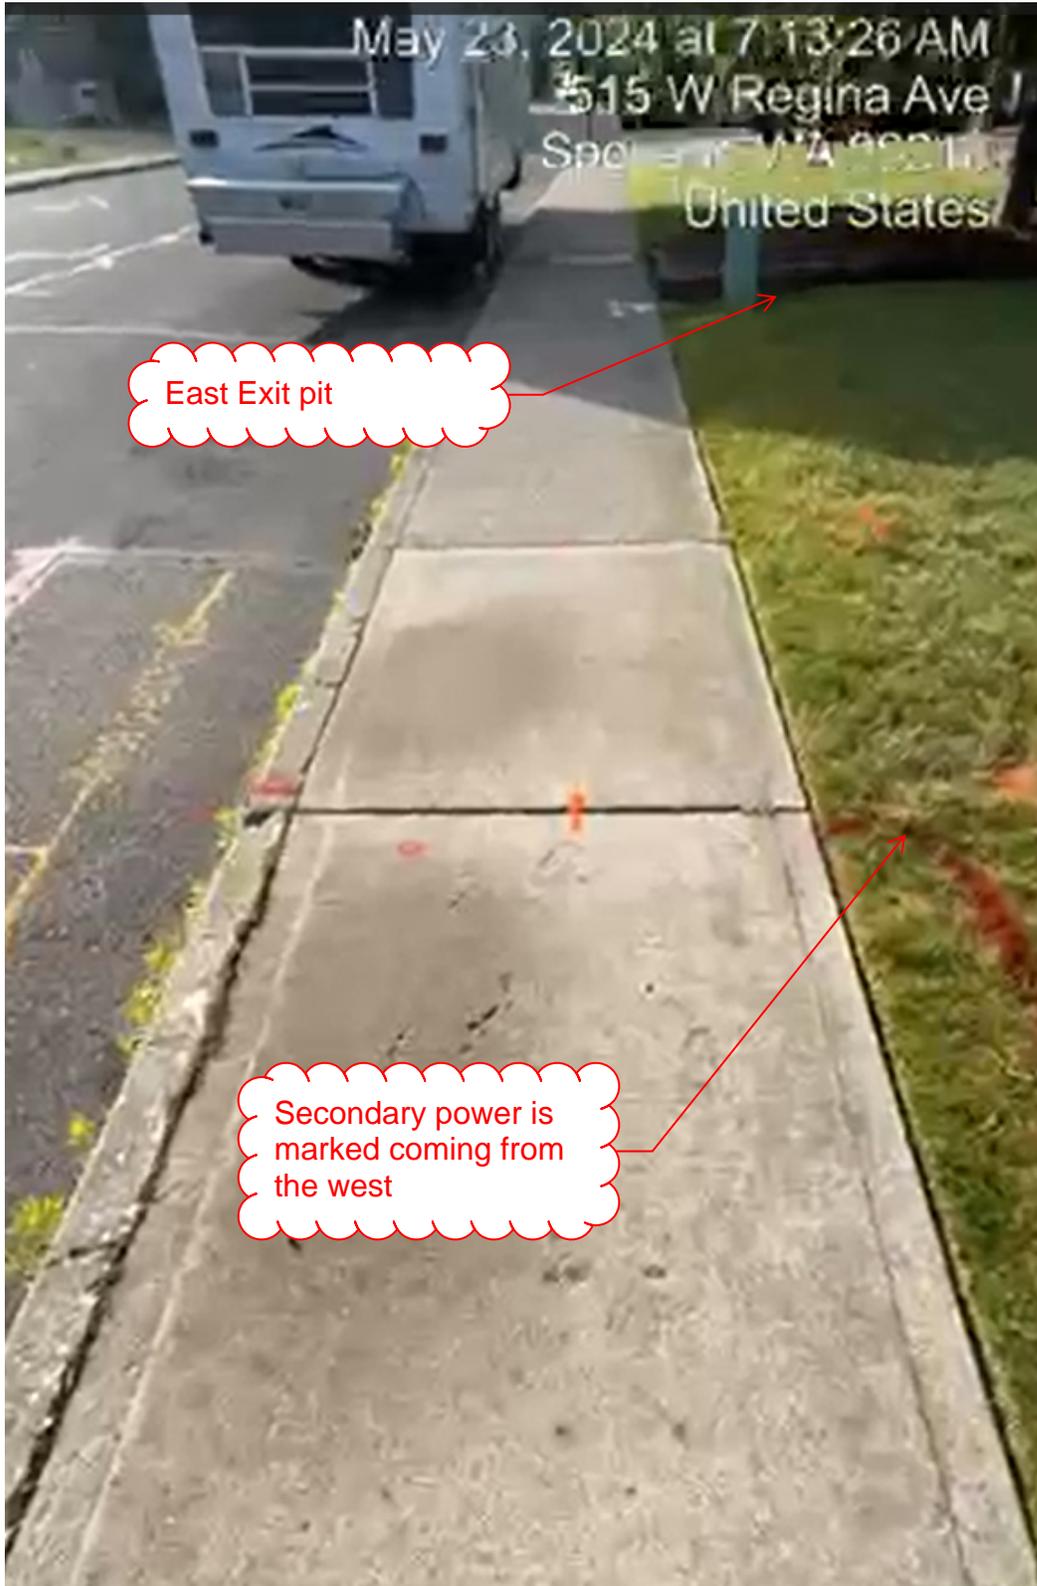
no secondary power is marked.

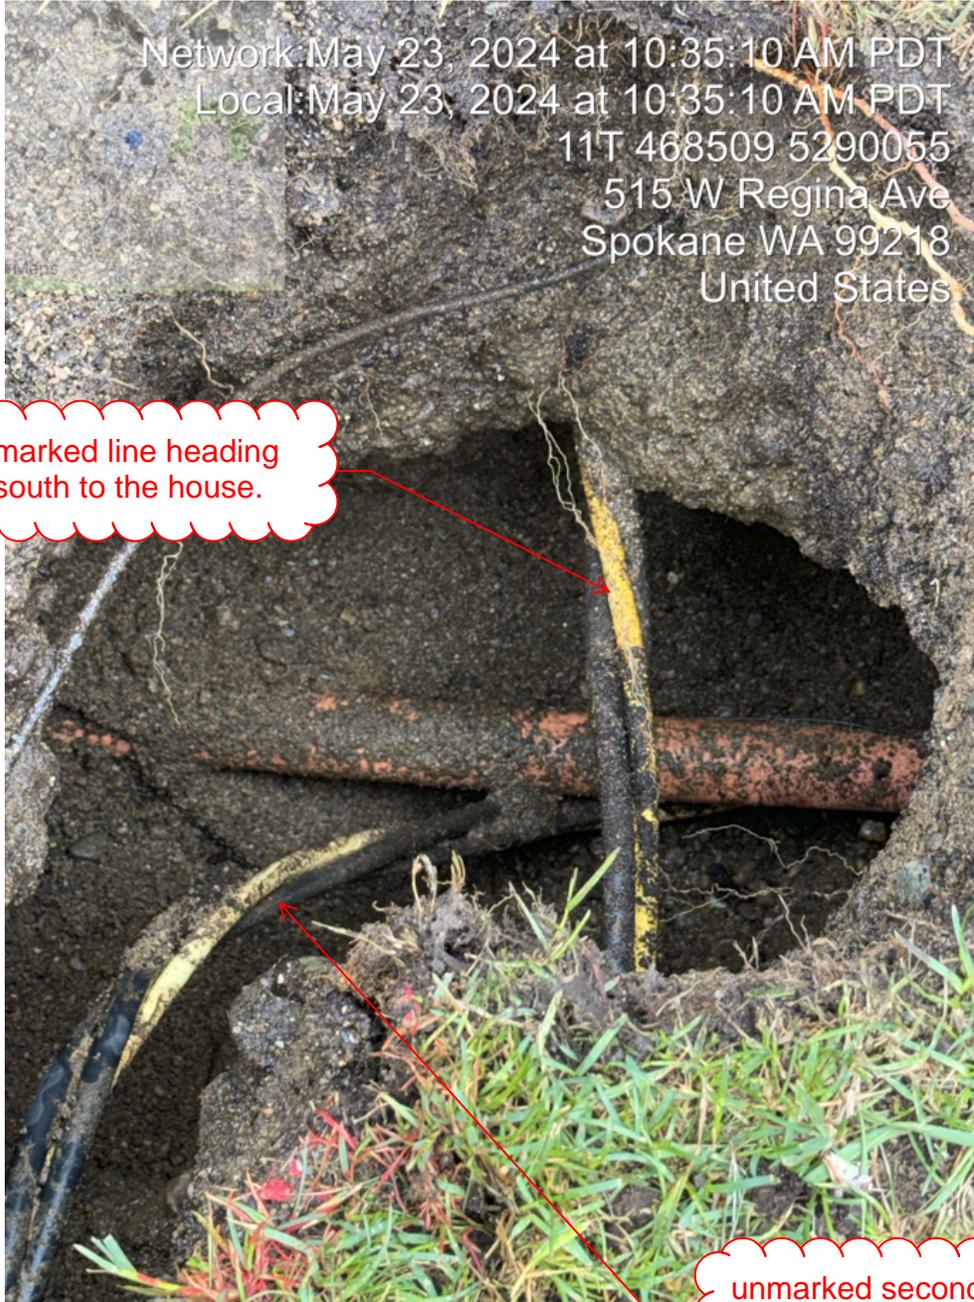
East Exit pit

Secondary power is marked coming from the west

We stopped the bore to about 30' short of the east exit pit to wait for the Hydrovac to open it up. When we opened up the exit pit we found 2 secondary power lines. One line appeared to go west.

marked line heading south to the house.

unmarked secondary power line heading west.

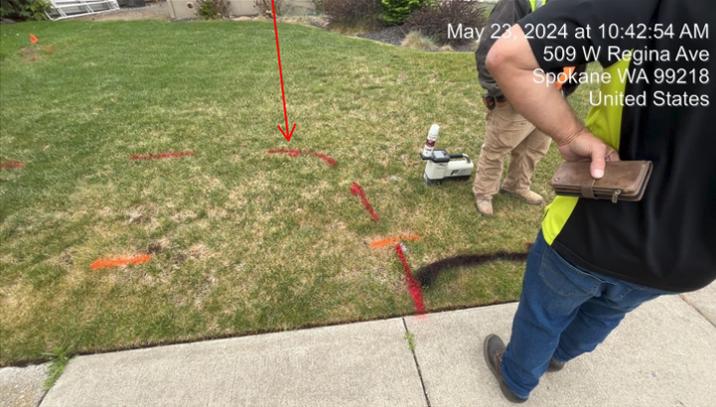
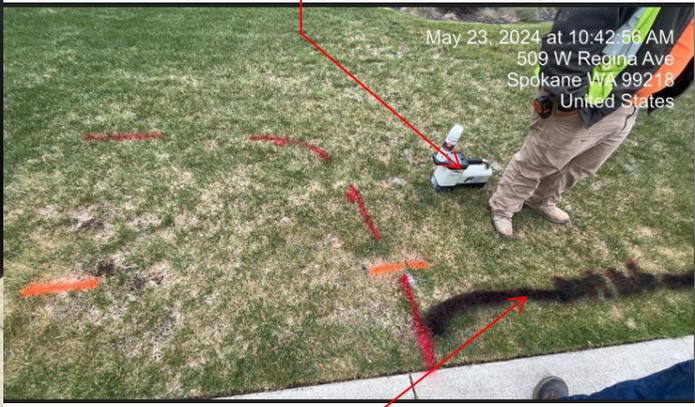
new mark coming from the east from the above picture.

locator indicating presence of the drill head on the pilot bore

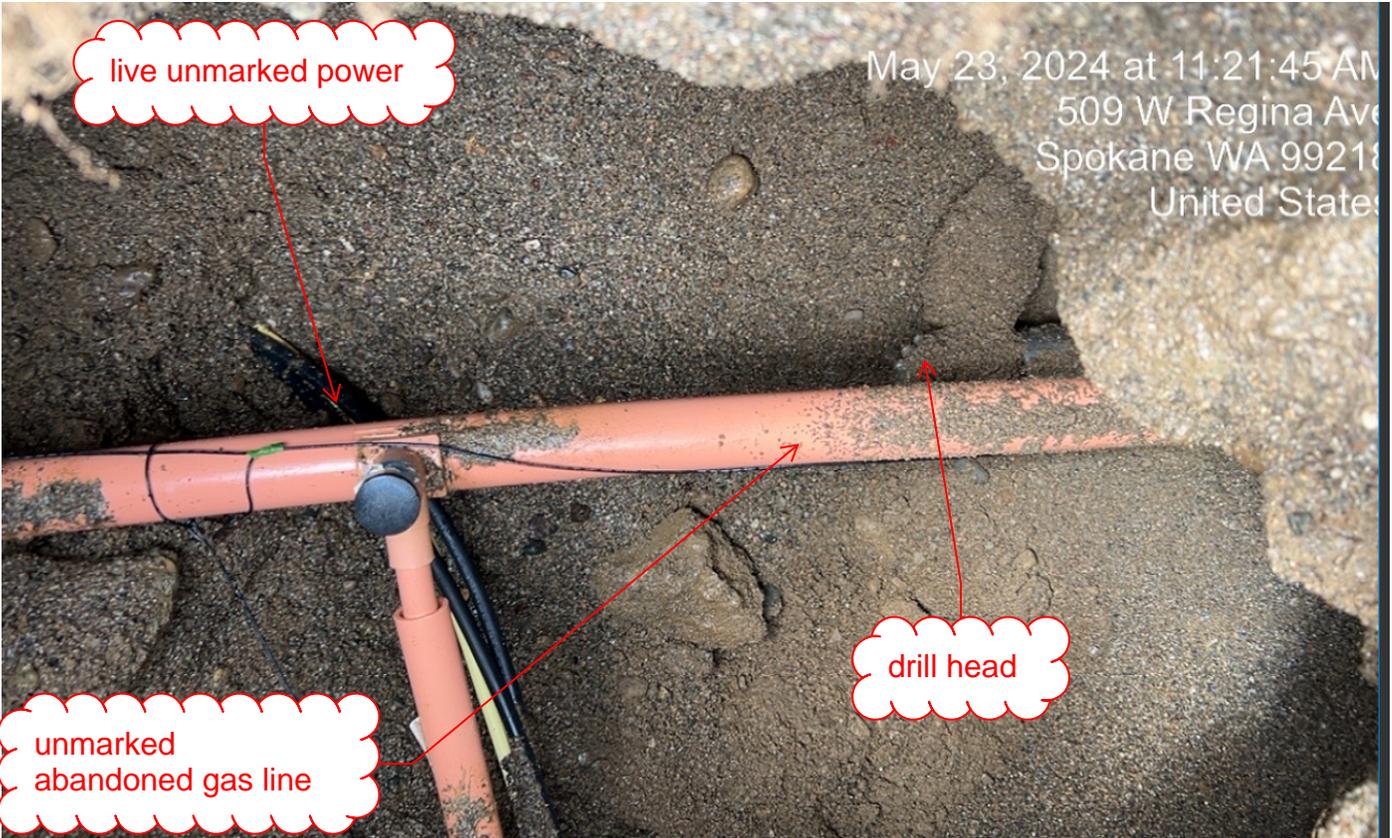
old mark blacked out

live unmarked power

drill head

unmarked abandoned gas line
