**EVALUATION OF AT GRADE RAIL CROSSING AT OLYMPIA AVE AND ADAMS
ST AND THURSTON AVE AND FRANKLIN ST**

September 24, 2024

JOSEPH REED JONES, PE

PUBLIC WORKS TRANSPORTATION PROJECT ENGINEER

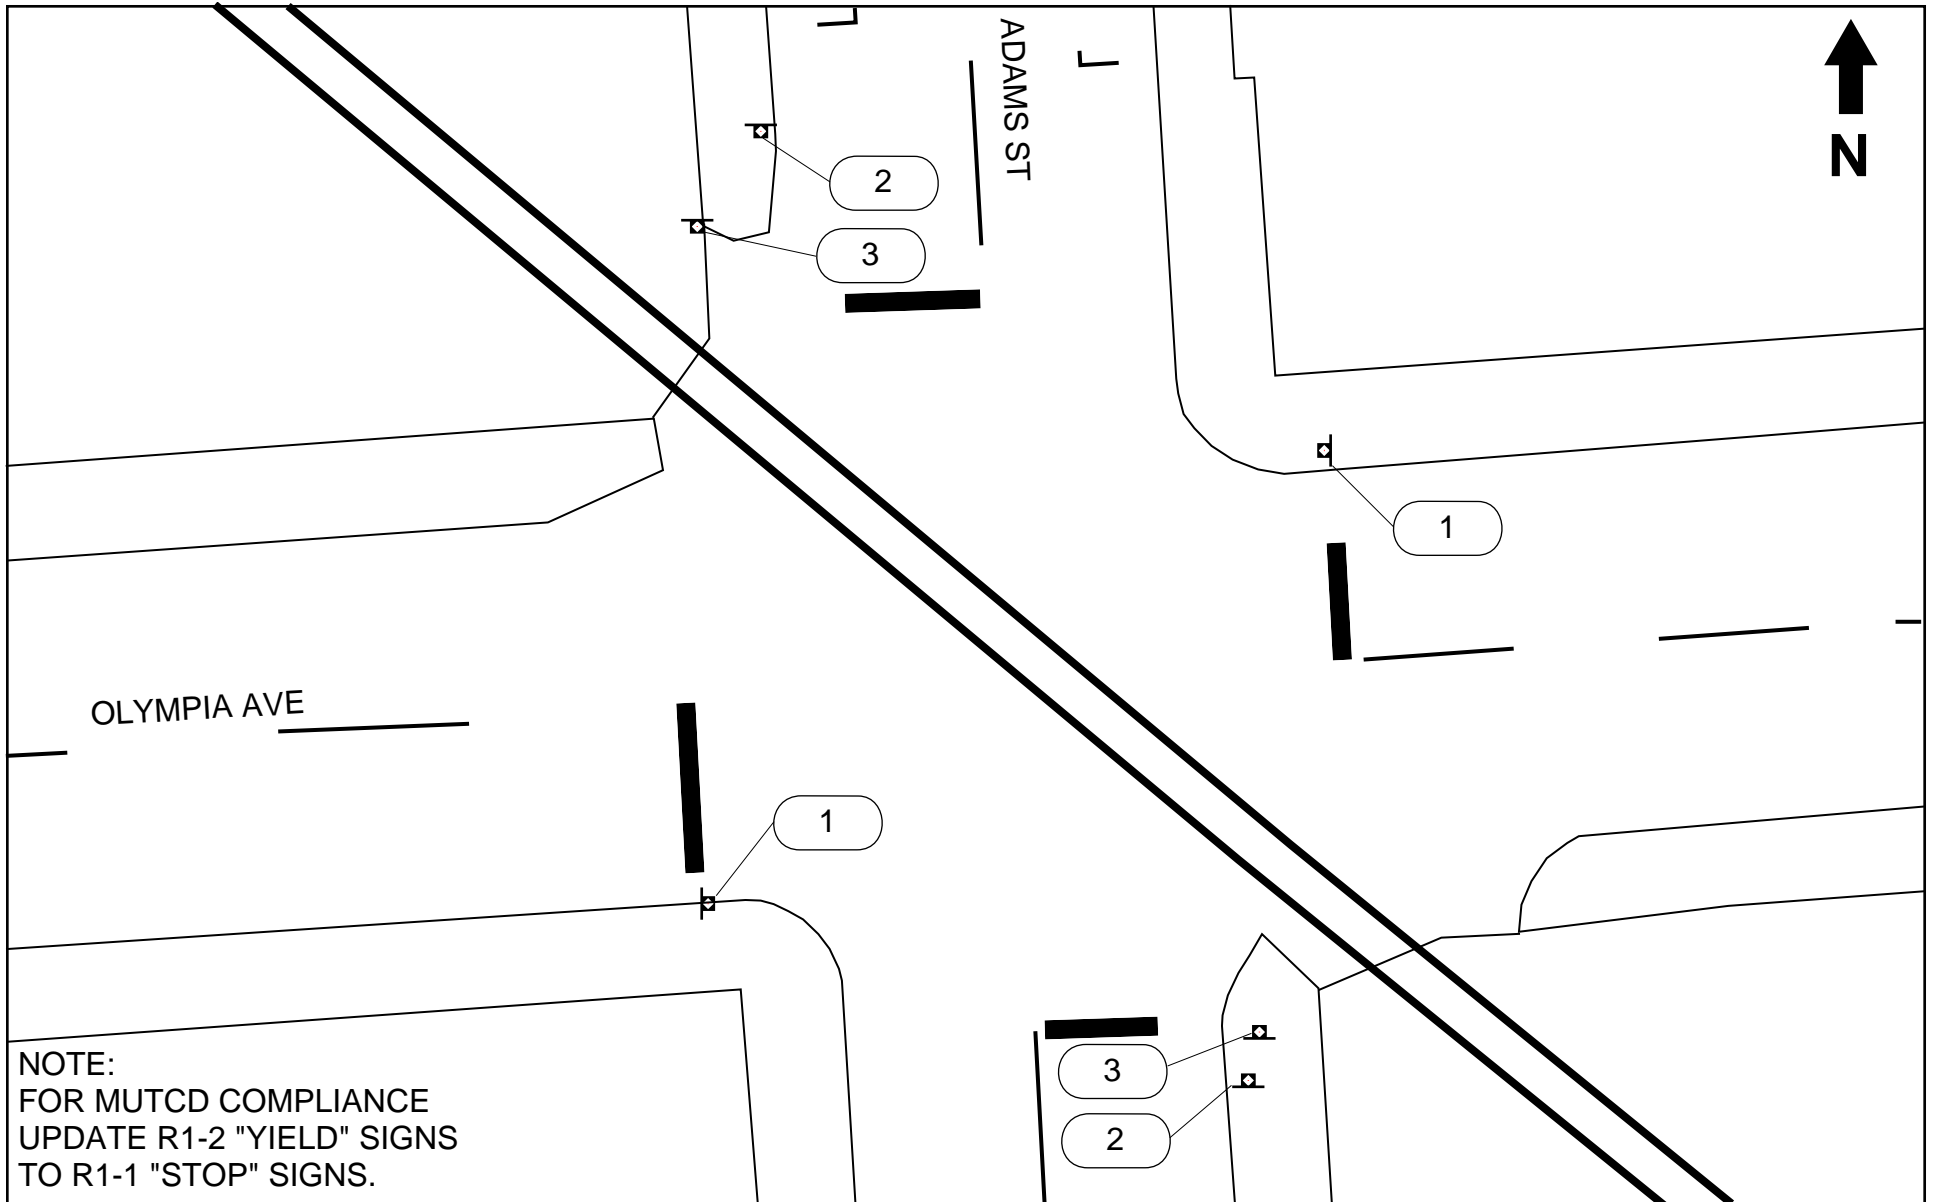
FIGURE 1: EXISTING LAYOUT OF OLYMPIA AVE AND ADAMS ST INTERSECTION

**NOTE:
FOR MUTCD COMPLIANCE
UPDATE R1-2 "YIELD" SIGNS
TO R1-1 "STOP" SIGNS.**

SIGN LOCATION	TYPE	DESCRIPTION
1 (SEE NOTE)	R1-2	YIELD
	R15-1	GRADE CROSSING
2	R1-1	STOP

SIGN LOCATION	TYPE	DESCRIPTION
3	R15-1	GRADE CROSSING

The yield signs on the crossbuck assemblies at Olympia Ave approaching Adams St and on Thurston Ave approaching Franklin St should be immediately replaced with stop signs. No further evaluation of all way stop warrants are needed.

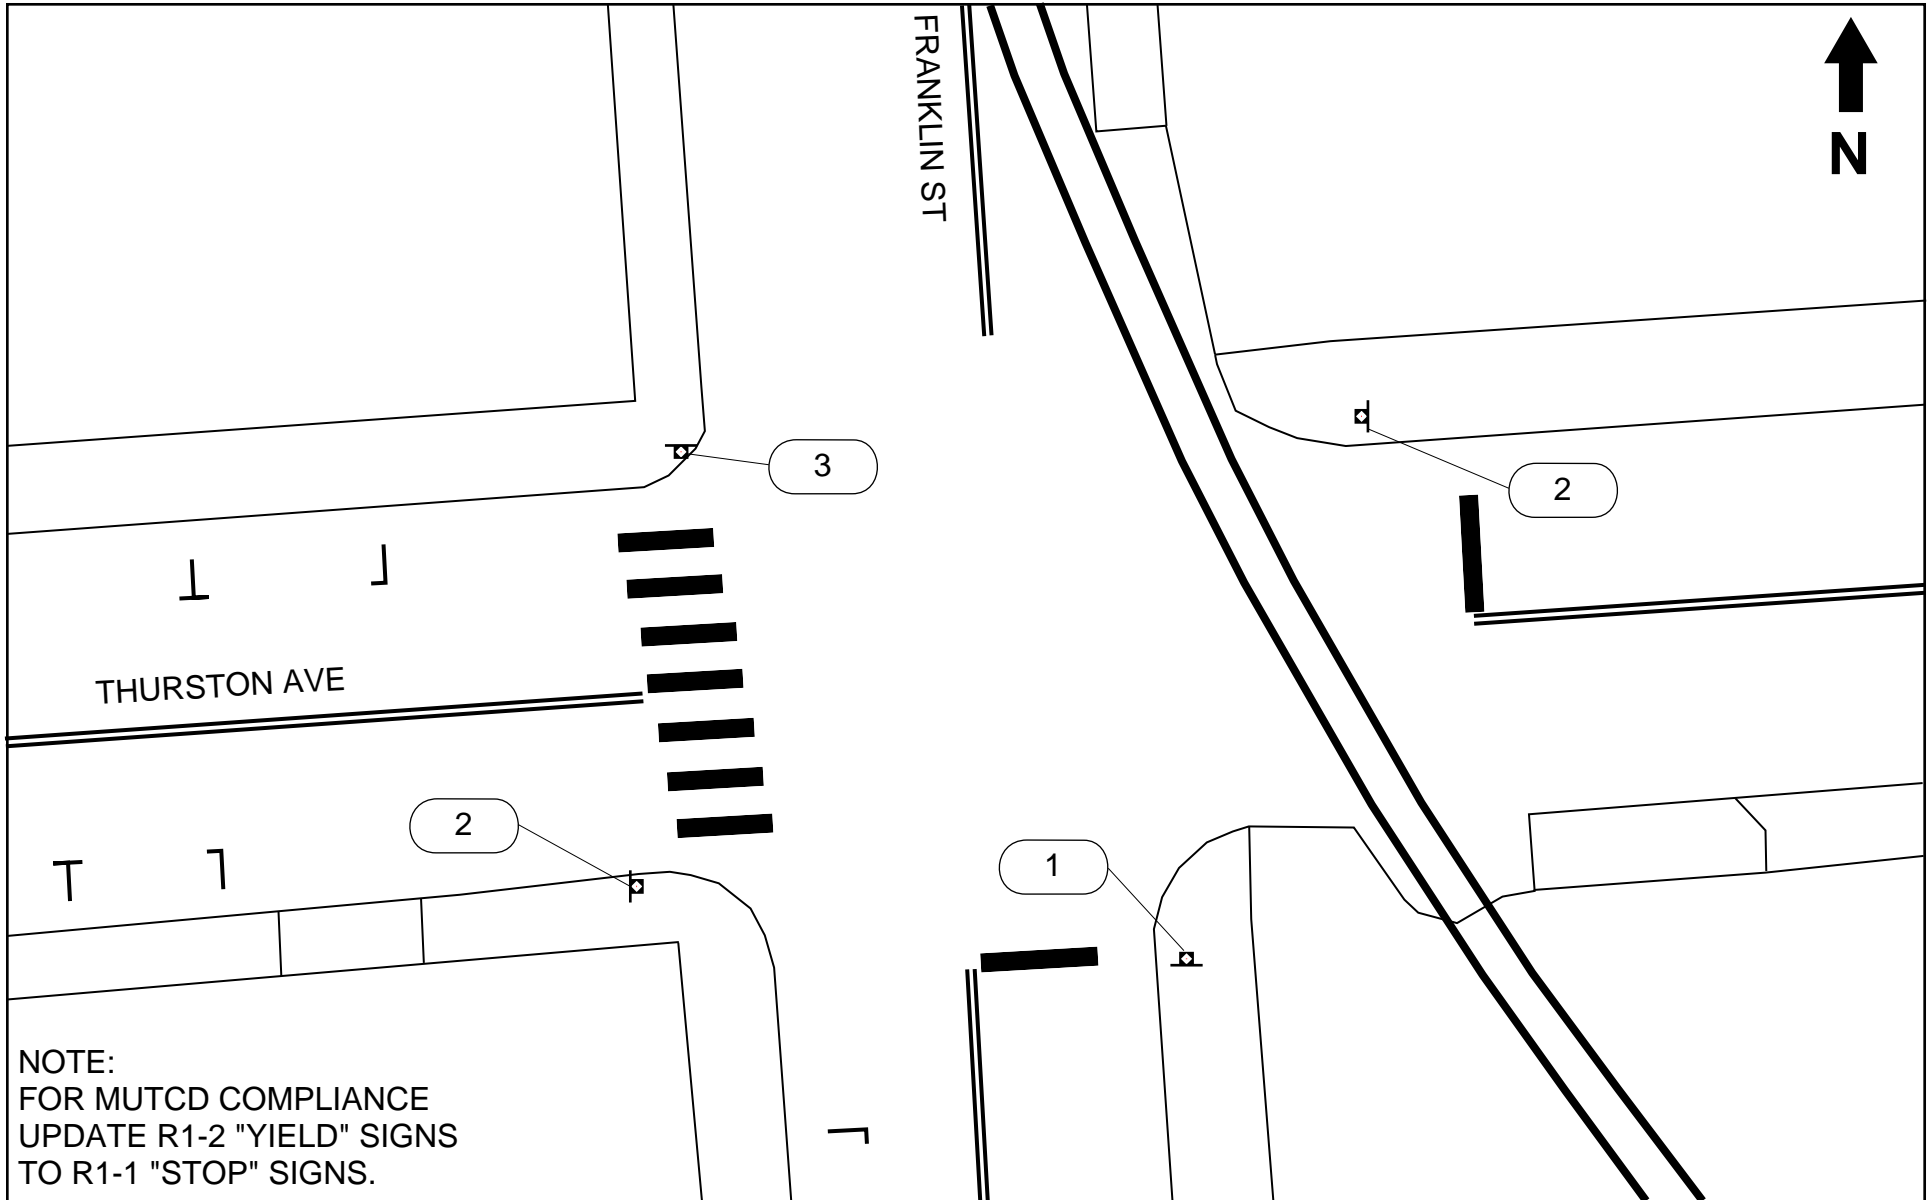
FIGURE 2: EXISTING LAYOUT OF THURSTON AVE AND FRANKLIN ST INTERSECTION

NOTE:
FOR MUTCD COMPLIANCE
UPDATE R1-2 "YIELD" SIGNS
TO R1-1 "STOP" SIGNS.

SIGN LOCATION	TYPE	DESCRIPTION
1	R1-1	STOP
	R15-1	GRADE CROSSING
	R15-2P	NUMBER OF TRACKS

SIGN LOCATION	TYPE	DESCRIPTION
2 (SEE NOTE)	R1-2	YIELD
	R15-1	GRADE CROSSING
3	R1-1	STOP

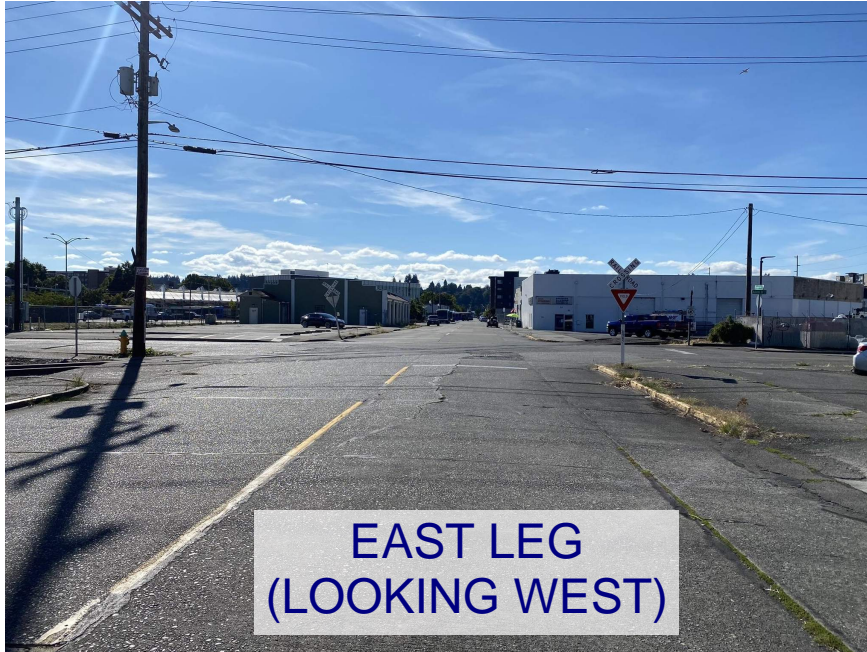
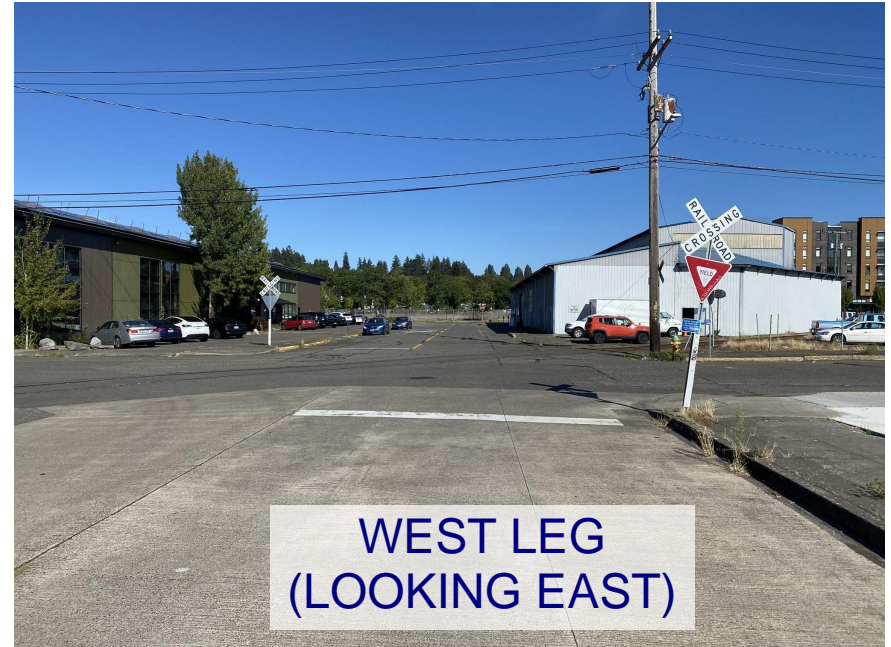
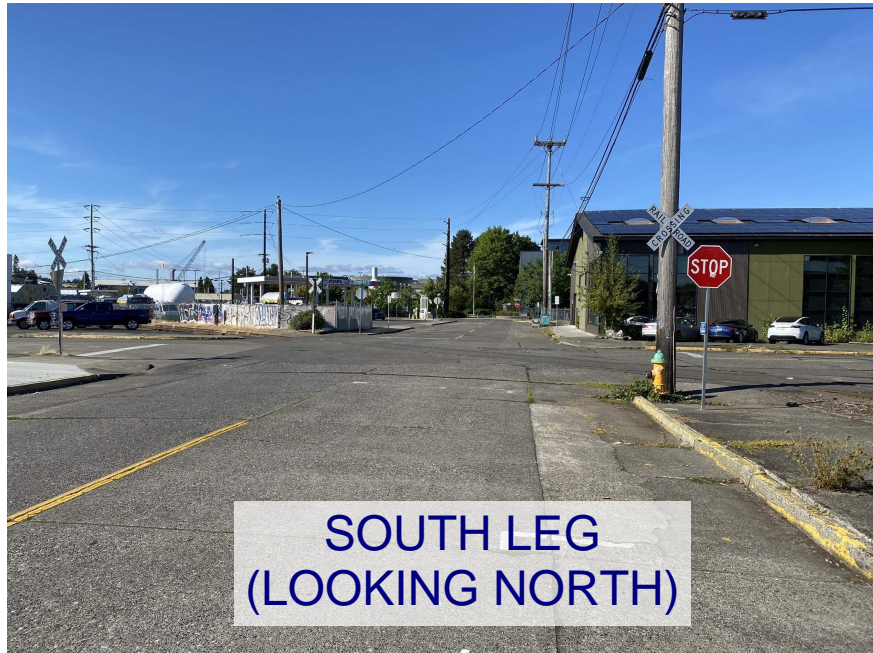
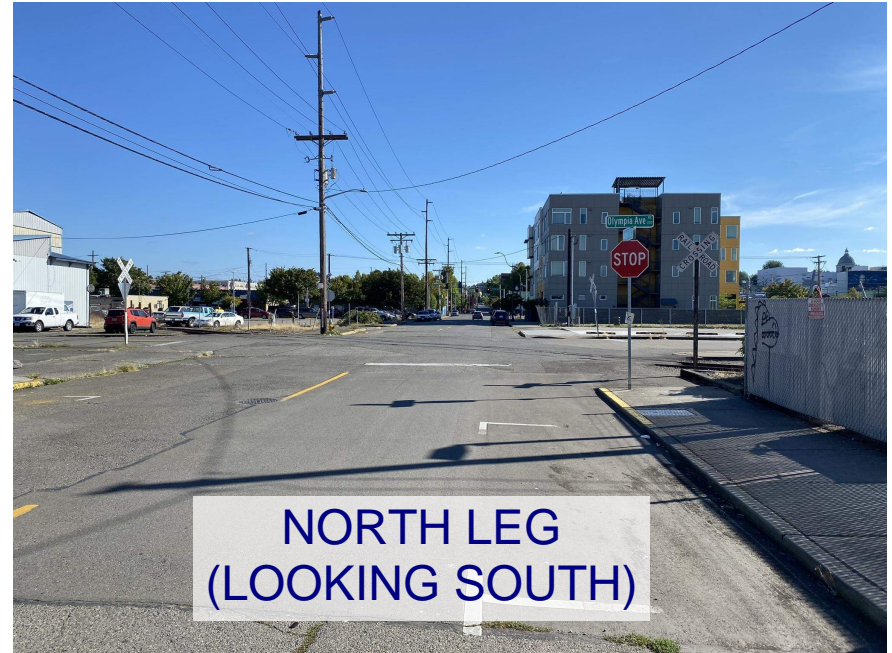
FIGURE 3: PHOTOS OF OLYMPIA AVE AND ADAMS ST INTERSECTION

Currently, at the Olympia and Adams intersection, crossbuck assemblies are present on all four legs, with stop signs for northbound and southbound traffic, and yield signs for eastbound and westbound traffic. The Thurston and Franklin intersection is equipped with crossbuck assemblies on the east, west, and south legs, including a stop sign for northbound traffic and yield signs for eastbound and westbound traffic. Additionally, the City of Olympia has installed a stop sign for southbound traffic that does not include a crossbuck due to the railway configuration. The crossbuck with yield sign for southbound traffic occurs further north from the intersection and does not influence the intersections traffic control.
