Re: December 2022 Monthly Progress Report
Administrative Settlement Agreement and Order on Consent for Removal Action
EPA Region 10 Docket No. CERCLA 10-2009-0255
Gasco Sediments Site Within the Portland Harbor Superfund Site

Attachment A Monthly Visual Monitoring Report for Pilot Cap Vicinity

Project: NW Natural – Gasco

Monitoring Period: Monthly (Year 16) – December 2022

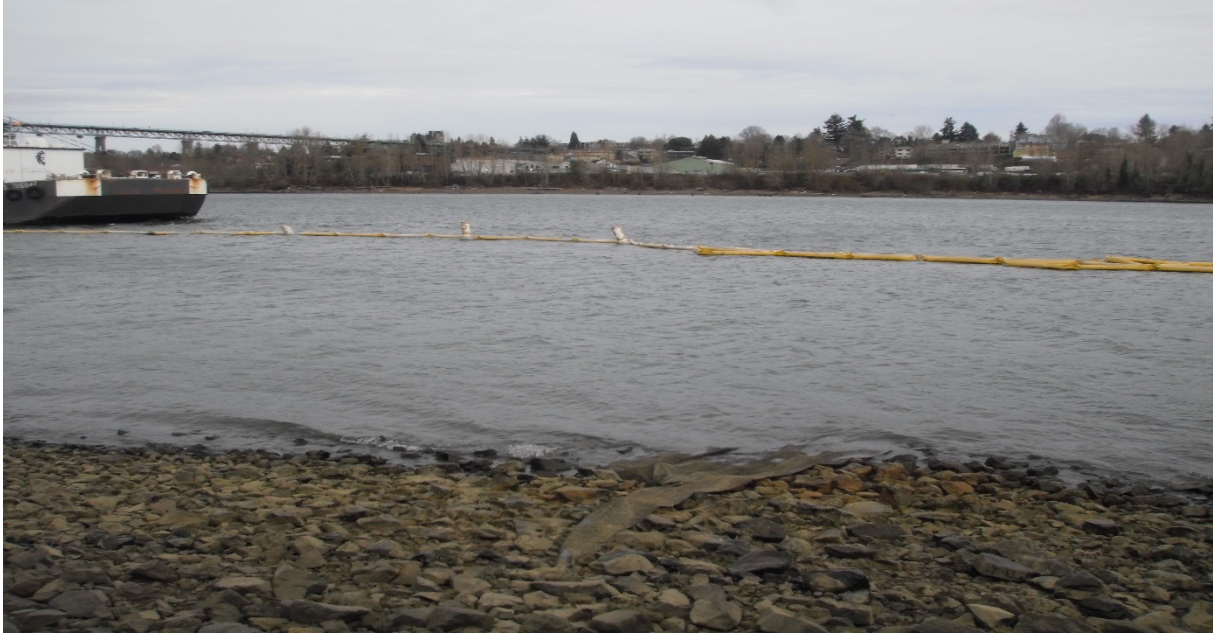
During the observation, a barge was moored at the dock, but the Centerline Logistics (Centerline) containment boom was in place from dock to dolphin. The three buoys identifying the cap area to mariners were in place as installed. The positions of the Centerline oil boom and warning buoys are shown in Photo 1.

Photo 1
Centerline Oil Boom Placement from Dock to Dolphin with Three Mariner Warning Buoys at Pilot Cap Area (12/22/2022)

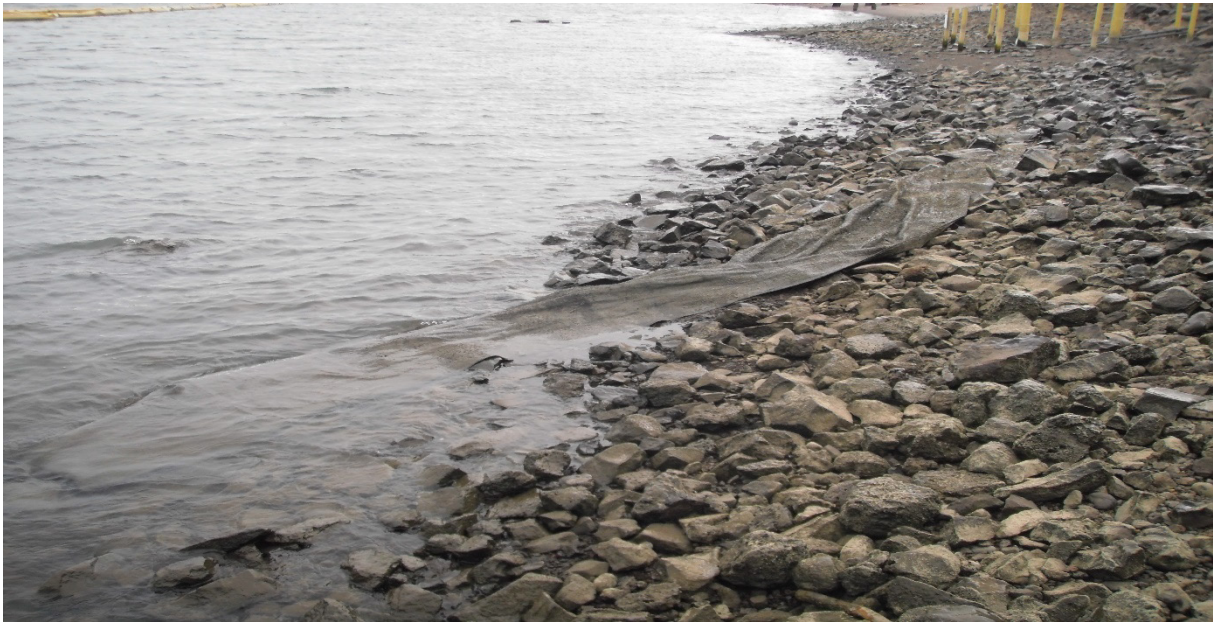
All potentially exposed organoclay mat material segments were visible and partially exposed above the waterline. A 40-foot section at the downriver extent of the cap area was partially exposed above the waterline, and a 7-foot section at the lateral midpoint of the cap area is exposed approximately 1 foot above the waterline. A 15-foot section at the upriver extent of the cap area is exposed approximately 12 feet above the waterline. Photo 2 shows the mat segment at the upriver end of the cap. The exposed segments of organoclay mat were in visually good condition.

Photo 2
Organoclay Mat Material at the Downriver Extent of the Cap Area (12/22/2022)

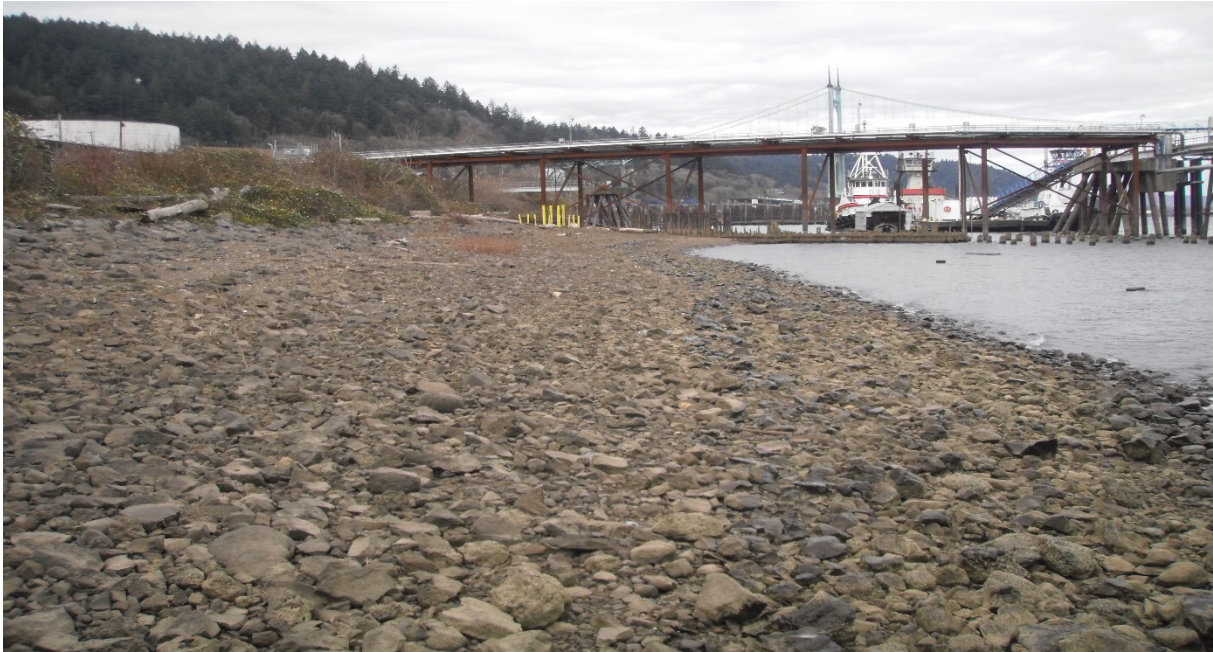
No erosion or deposition was evident along the shoreline within the cap area.

Photo 3 shows the water surface and shoreline immediately downriver of the sediment cap. No sheen was observed within the cap area.

Photo 3
Conditions Immediately Downriver of Cap Area Looking Downriver (12/22/2022)
