Re: January 2023 Monthly Progress Report
Administrative Settlement Agreement and Order on Consent for Removal Action
EPA Region 10 Docket No. CERCLA 10-2009-0255
Gasco Sediments Site Within the Portland Harbor Superfund Site

Attachment A Monthly Visual Monitoring Report for Pilot Cap Vicinity

Visual Observations Log Form

Project: NW Natural – Gasco

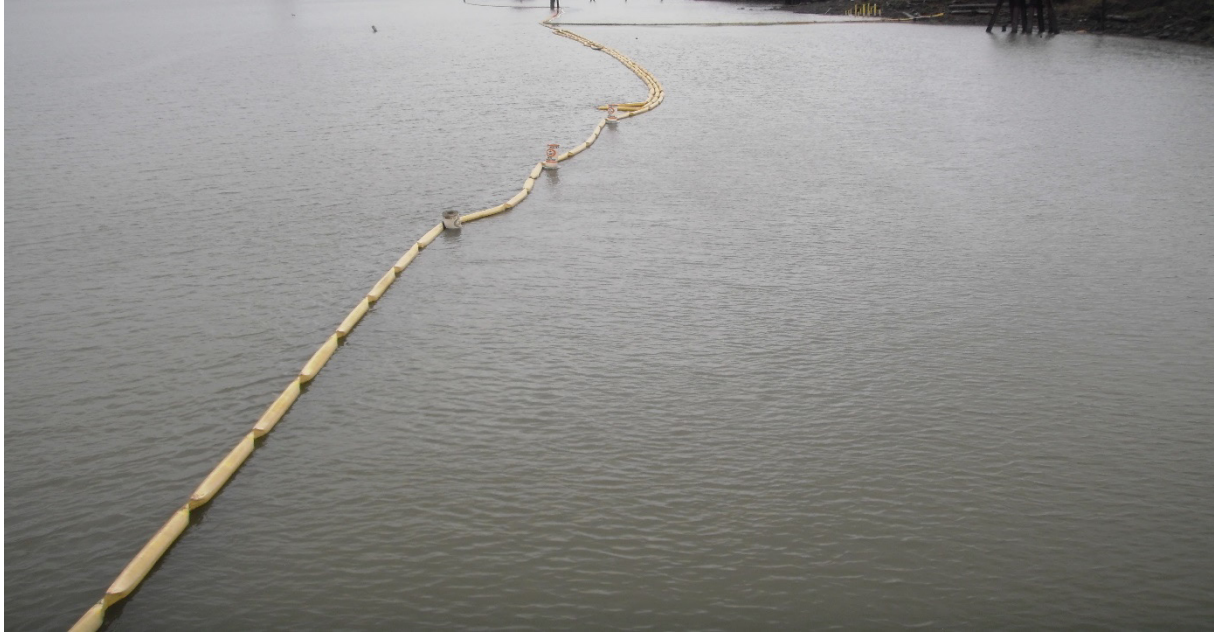
During the observation, the Centerline Logistics (Centerline) containment boom was in place from dock to dolphin. The three buoys identifying the cap area to mariners were in place as installed. The positions of the Centerline oil boom and warning buoys are shown in Photo 1.

Photo 1
Centerline Oil Boom Placement from Dock to Dolphin with Three Mariner Warning Buoys at Pilot Cap Area (1/18/2023)

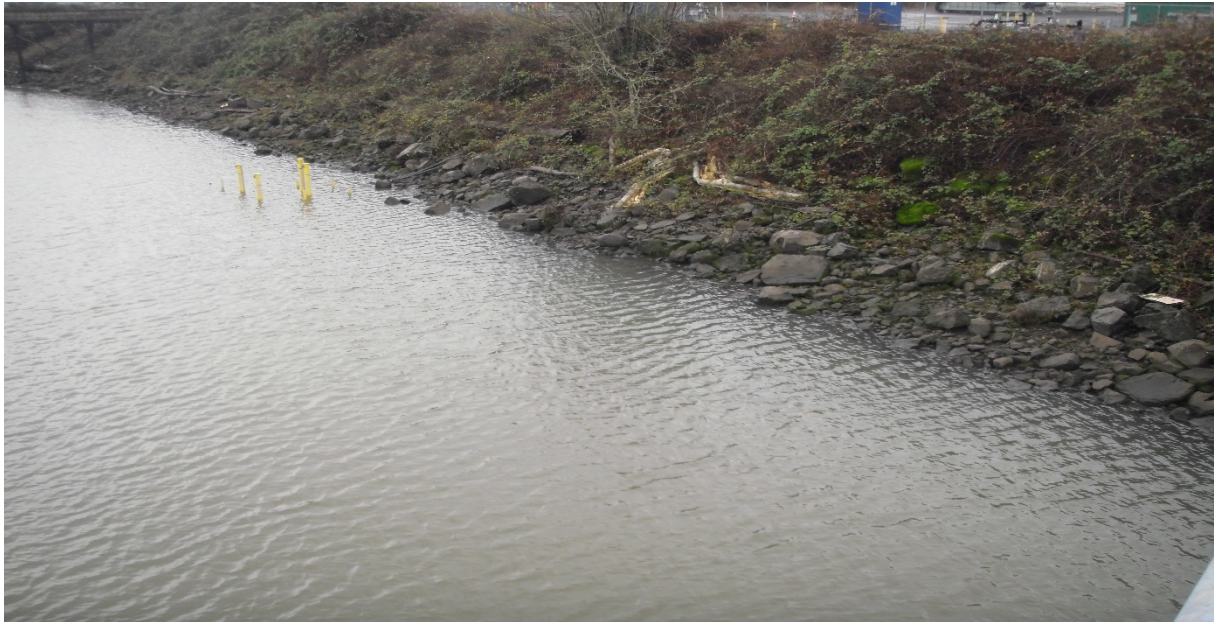
All potentially exposed organoclay mat material segments were submerged and not visible due to high river elevations (Photo 2). It was not possible to visually inspect the physical condition of the mat material during this observation event.

Photo 2
Extent of High River Water Elevation Along the Cap Shoreline (1/18/2023)

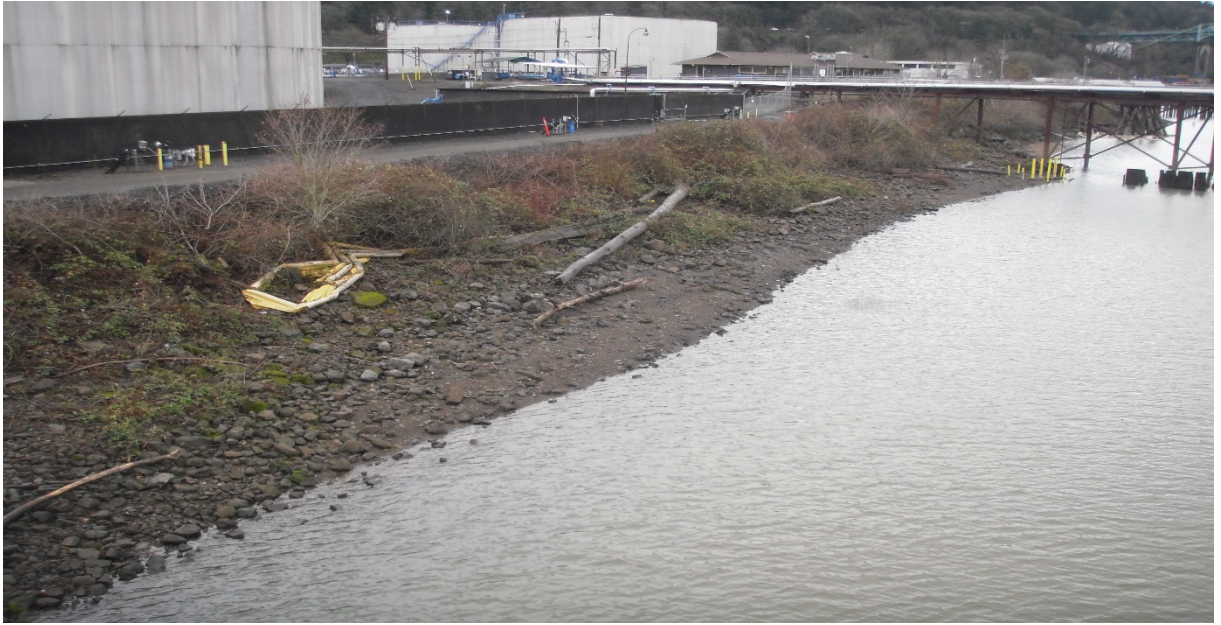
Photo 3 shows the water surface and shoreline immediately downriver of the sediment cap. No sheen was observed within the cap area.

Photo 3
Conditions Immediately Downriver of Cap Area Taken from Dock (1/18/2023)
