**AVISTA CORP.  
RESPONSE TO REQUEST FOR INFORMATION**

JURISDICTION:	WASHINGTON	DATE PREPARED:	06/18/2021
CASE NO.:	UE-200900 & UG-200901	WITNESS:	DiLuciano/La Bolle
REQUESTER:	Public Counsel	RESPONDER:	Larry La Bolle
TYPE:	Data Request	DEPT:	Transm Ops/System Planning
REQUEST NO.:	PC – 352	TELEPHONE:	(509) 495-4710
		EMAIL:	larry.labolle@avistacorp.com

**SUBJECT: Joint Rebuttal Testimony Exh. JD/LL-1**

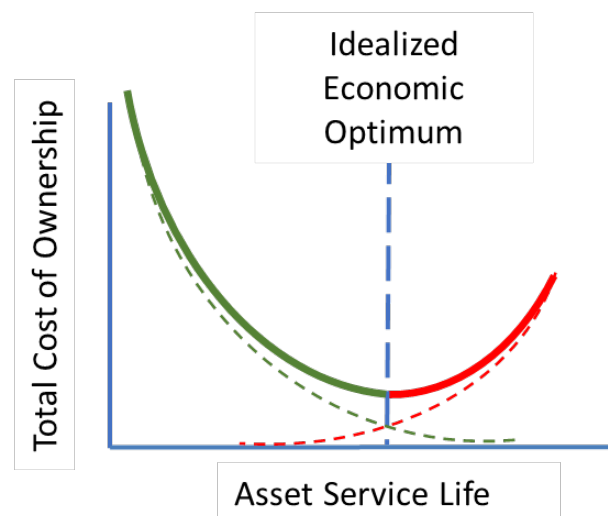
The adjacent illustration, provided in response to PC-DR-351, was used to depict the financial value for the remaining service life in an asset at the point of the economic optimum. There is residual value in this illustration because the initial cost of the asset through the lifecycle, represented by the green dashed line, has not yet reached zero (bottom of the total cost of ownership axis) at the point of replacement. As also explained in PC-DR-351, inspection, testing, maintenance, repair and risks costs are represented by red dashed line, which costs are summed with annual costs in the green dashed line for each year of the lifecycle to create the lifecycle cost curve, represented by the solid green and red lines.

While there is residual financial value in the asset at the point of the economic optimum, that value is now overcome by the increasing inspection, testing and maintenance costs expected to occur, along with the risk costs of failure. As we explained in response to PC-DR-338 Revised, even though the asset could have years of physical life remaining, replacing it at its economic optimum reduces the cost customers pay, compared with the alternative of squeezing out the remaining serviceable life and replacing it upon failure. This concept is illustrated below where the black dashed line intersects the total cost of ownership axis at the point of the economic optimum, while the orange dashed line depicts the additional cost customers would have to pay in order to run this particular asset to failure (extract 100% of its potential service life).
