Re: March 2023 Monthly Progress Report
Administrative Settlement Agreement and Order on Consent for Removal Action
EPA Region 10 Docket No. CERCLA 10-2009-0255
Gasco Sediments Site Within the Portland Harbor Superfund Site

Attachment A Monthly Visual Monitoring Report for Pilot Cap Vicinity

Visual Observations Log Form

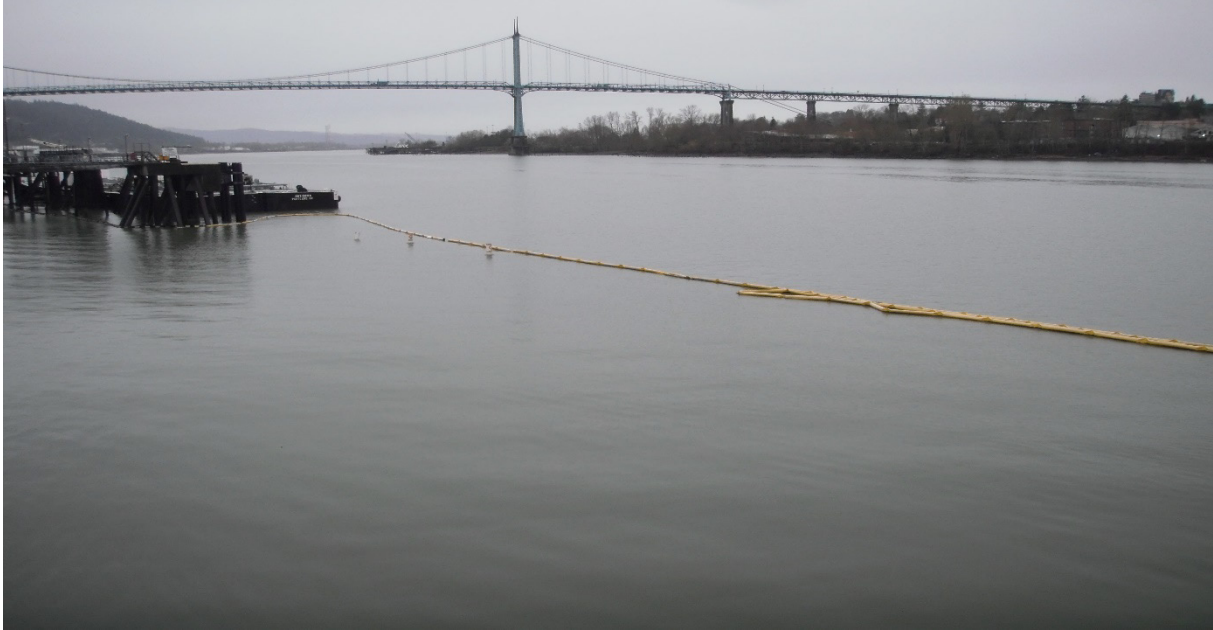
Photo 1

During the observation, a barge was moored at the dock, but the Centerline Logistics (Centerline) containment boom was in place from dock to dolphin. The three buoys identifying the cap area to mariners were in place as installed. The positions of the Centerline oil boom and warning buoys are shown in Photo 1.

Centerline Logistics Oil Boom Placement from Dock to Dolphin with Three Mariner Warning Buoys at Pilot Cap Area (3/28/2023)

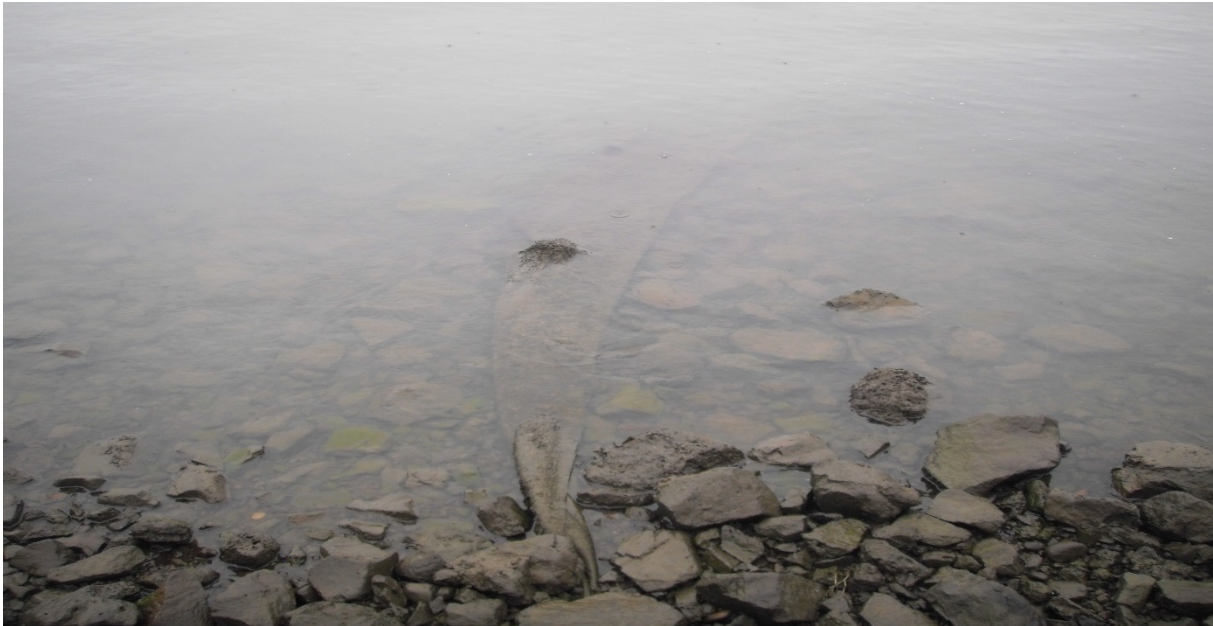
Photo 2

All potentially exposed organoclay mat material segments were submerged and only partially visible due to high river elevations (Photo 2). A 7-foot section at the lateral midpoint of the cap area was partially exposed above the water line. The visible, exposed segments of organoclay mat were in visually good condition.

Organoclay Mat Material at the Upriver End of the Cap Area (3/28/2023)

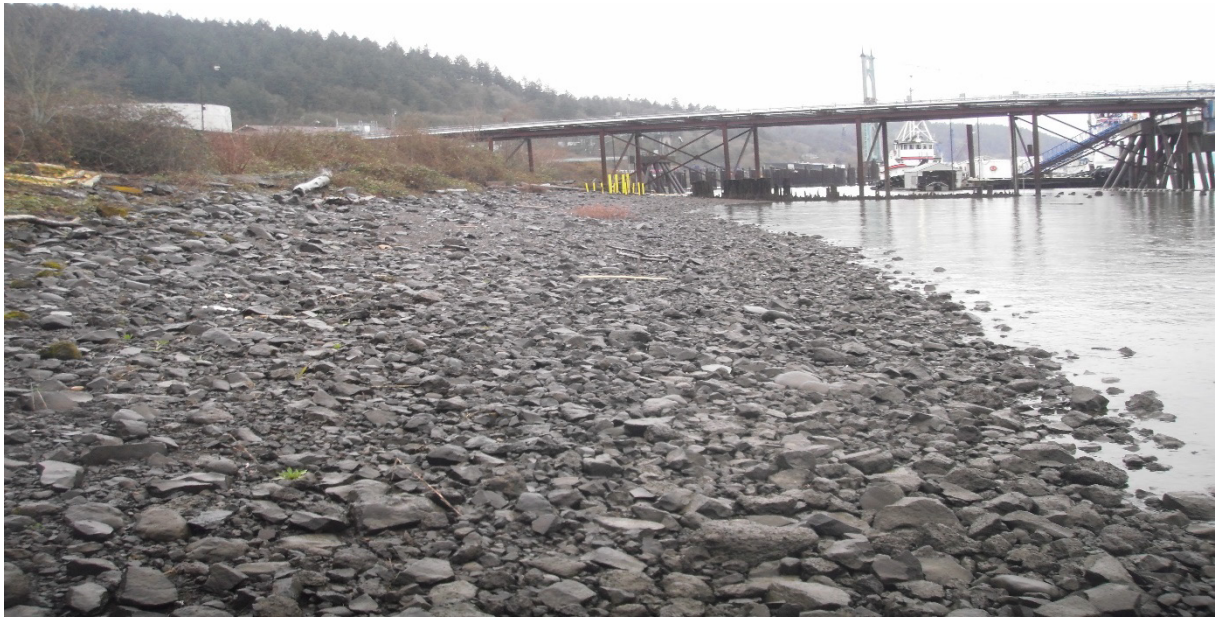
Photo 3 shows the water surface and shoreline immediately downriver of the sediment cap. No sheen was observed within the cap area.

Photo 3
Conditions Immediately Downriver of Cap Area Looking Downriver (3/28/2023)
