Re: April 2023 Monthly Progress Report
Administrative Settlement Agreement and Order on Consent for Removal Action
EPA Region 10 Docket No. CERCLA 10-2009-0255
Gasco Sediments Site Within the Portland Harbor Superfund Site

Attachment A Monthly Visual Monitoring Report for Pilot Cap Vicinity

Visual Observations Log Form

Project: NW Natural – Gasco

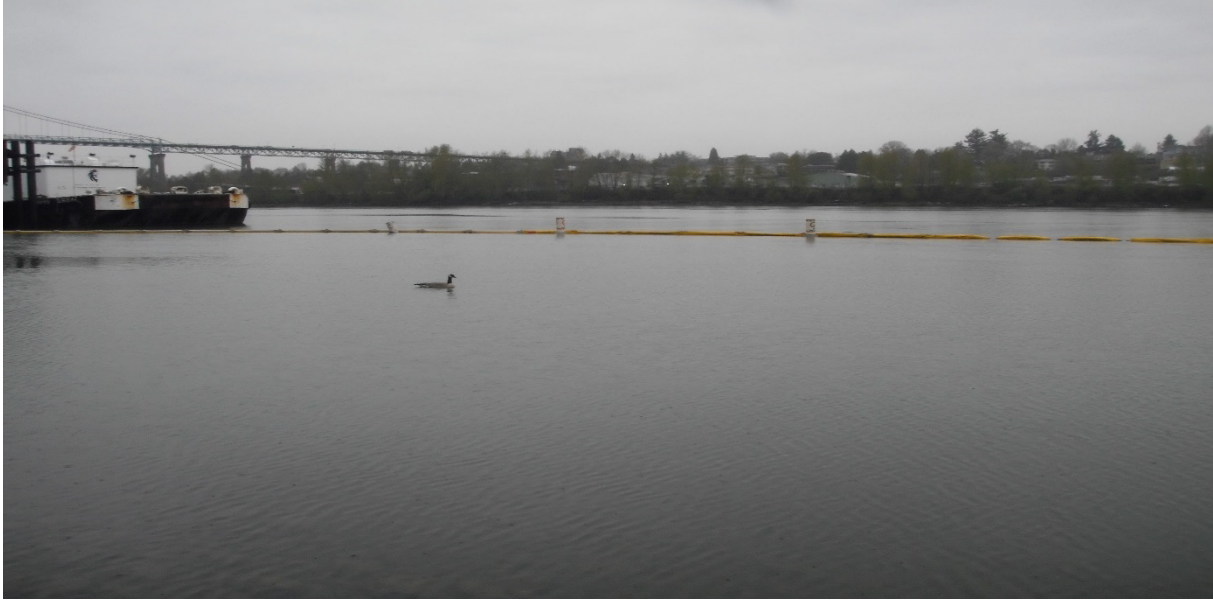
Photo 1

During the observation, a barge was moored at the ship dock, and the Centerline Logistics (Centerline) containment boom was in place from dock to dolphin. The three warning buoys identifying the cap area to mariners were in place as installed. The positions of the Centerline oil boom and warning buoys are shown in Photo 1.

Centerline Oil Boom Placement from Dock to Dolphin with Three Mariner Warning Buoys at Pilot Cap Area (4/20/2023)

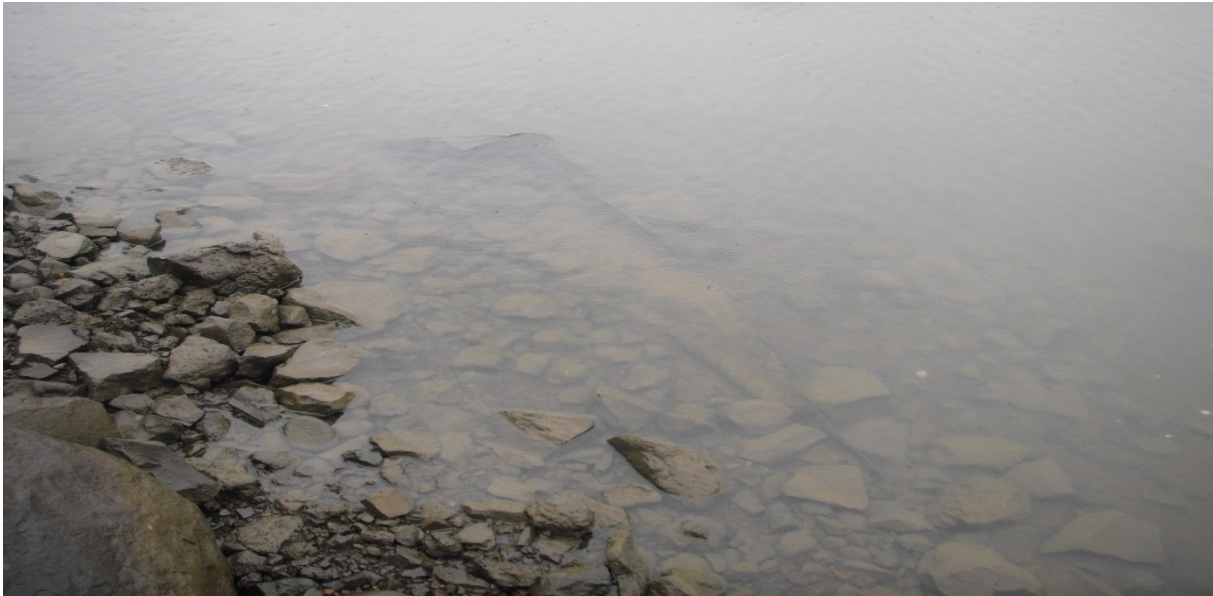
Photo 2

All organoclay mat material segments were submerged and only partially visible due to high river elevations (Photo 2). The visible segments of organoclay mat were in visually good condition.

Organoclay Mat Material at the Midpoint of the Cap Area (4/20/2023)

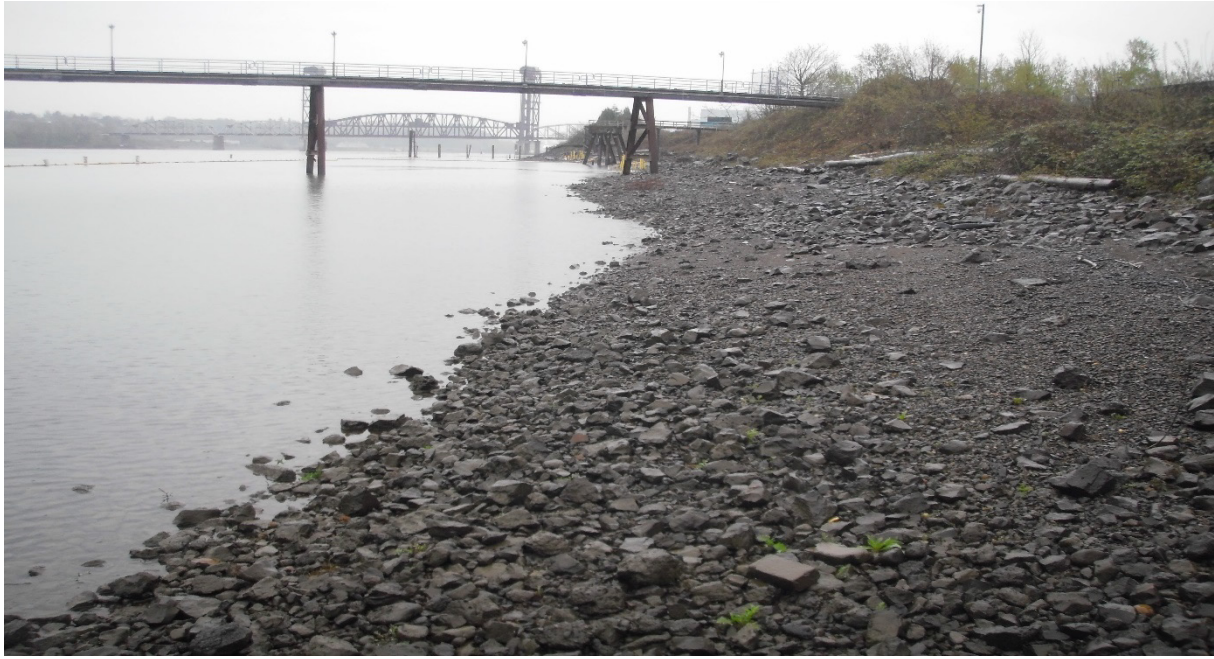
Photo 3 shows the water surface and shoreline immediately downriver of the sediment cap. No sheen was observed within the cap area.

Photo 3
Conditions Immediately Downriver of Cap Area Looking Upriver (4/20/2023)
