Re: May 2023 Monthly Progress Report  
Administrative Settlement Agreement and Order on Consent for Removal Action  
EPA Region 10 Docket No. CERCLA 10-2009-0255  
Gasco Sediments Site Within the Portland Harbor Superfund Site

Attachment A Monthly Visual Monitoring Report for Pilot Cap Vicinity

# Visual Observations Log Form

**Project:** NW Natural – Gasco

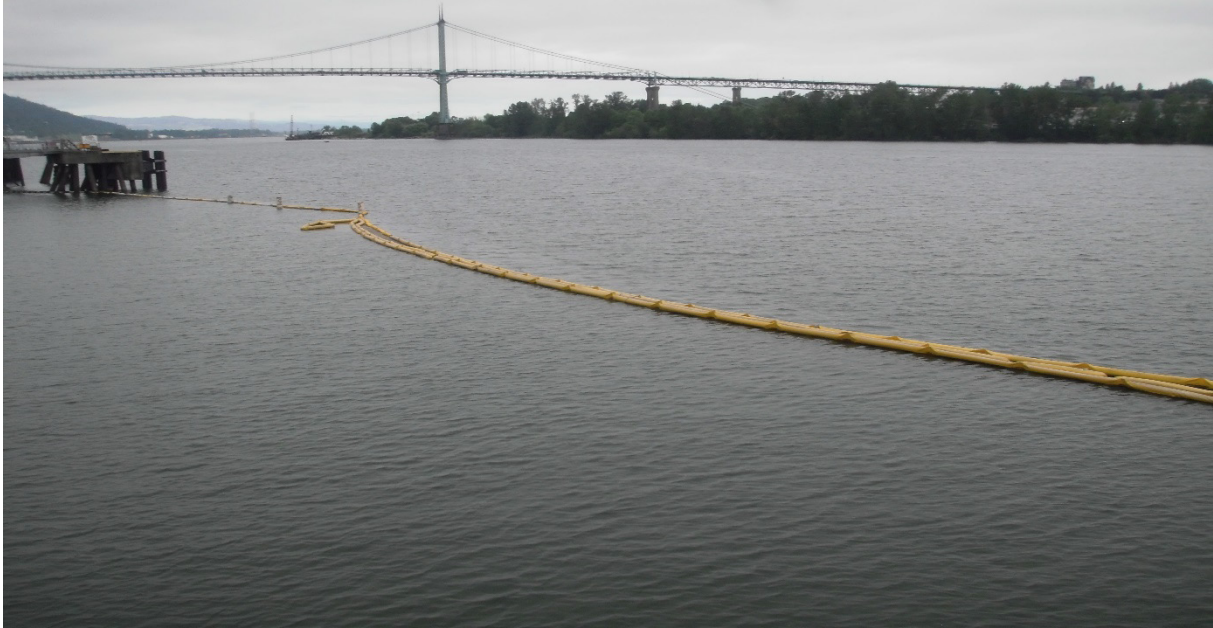
### Photo 1

During the observation, the Centerline Logistics (Centerline) containment boom was in place from dock to dolphin. The three warning buoys identifying the cap area to mariners were in place as installed. The positions of the Centerline oil boom and warning buoys are shown in Photo 1.

**Centerline Oil Boom Placement from Dock to Dolphin with Three Mariner Warning Buoys at Pilot Cap Area, Taken from the Dolphin (5/19/2023)**

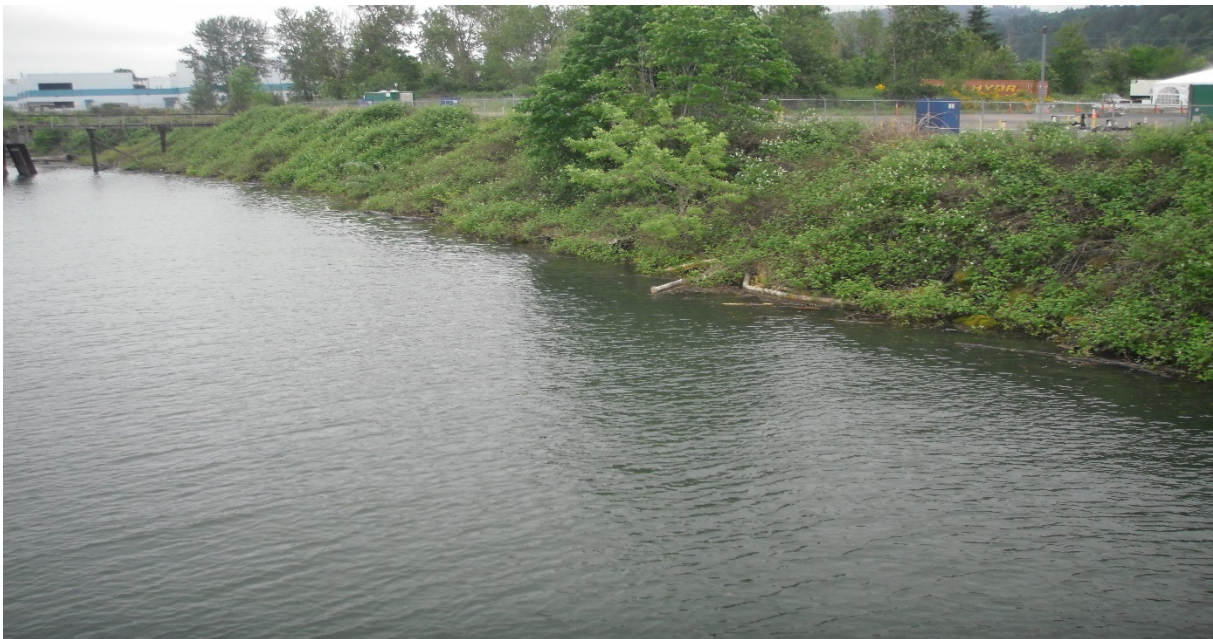
### Photo 2

No erosion was evident along the shoreline within the vicinity of the cap area; however, woody debris was observed as a result of high river level elevations.

All organoclay mat material segments were submerged and not visible due to high river elevations (Photo 2).

**Conditions Along the Shoreline of the Cap Area Due to Extremely High River Water Level Elevation, Taken from the Dock (5/19/2023)**

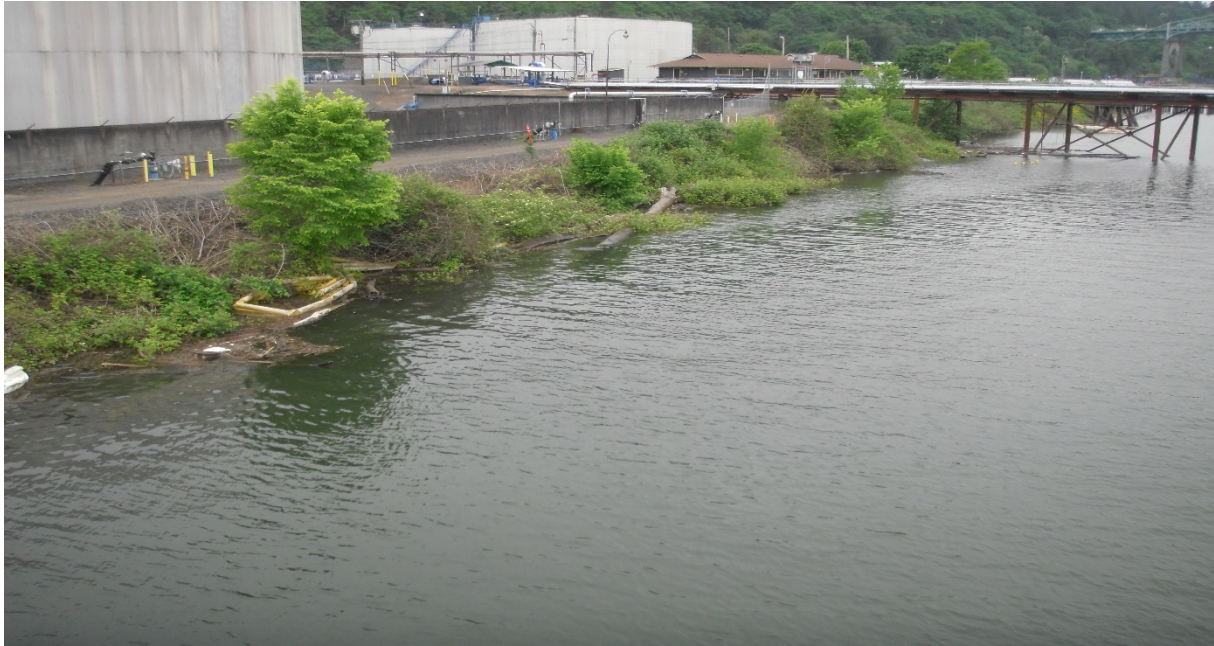
Photo 3 shows the water surface and shoreline immediately downriver of the sediment cap. No sheen was observed within the cap area.

**Photo 3**  
**Conditions Immediately Downriver of Cap Area Looking from the Dock (5/19/2023)**
