Re: June 2023 Monthly Progress Report  
Administrative Settlement Agreement and Order on Consent for Removal Action  
EPA Region 10 Docket No. CERCLA 10-2009-0255  
Gasco Sediments Site Within the Portland Harbor Superfund Site

Attachment A Monthly Visual Monitoring Report for Pilot Cap Vicinity

# Visual Observations Log Form

**Project:** NW Natural – Gasco

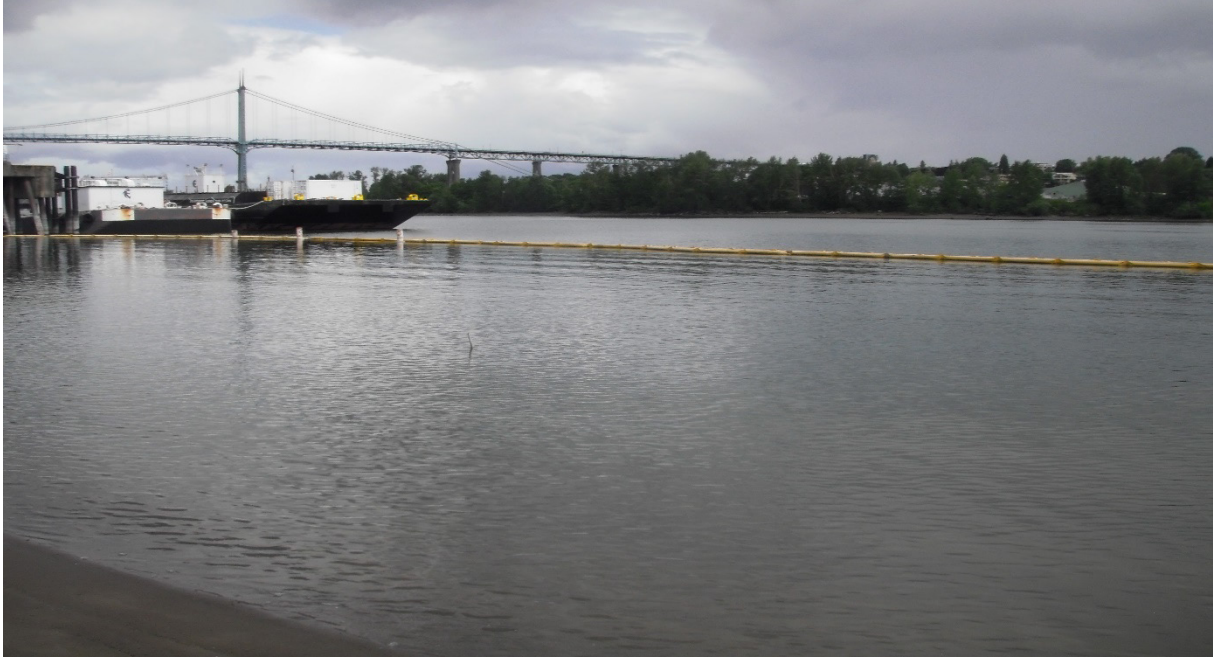
During the observation, two barges were moored at the dock, but the Centerline Logistics (Centerline) containment boom was in place from dock to dolphin. The three buoys identifying the cap area to mariners were in place as installed. The positions of the Centerline oil boom and warning buoys are shown in Photo 1.

**Photo 1**  
**Centerline Logistics Oil Boom Placement from Dock to Dolphin with Three Mariner Warning Buoys at Pilot Cap Area (6/19/2023)**

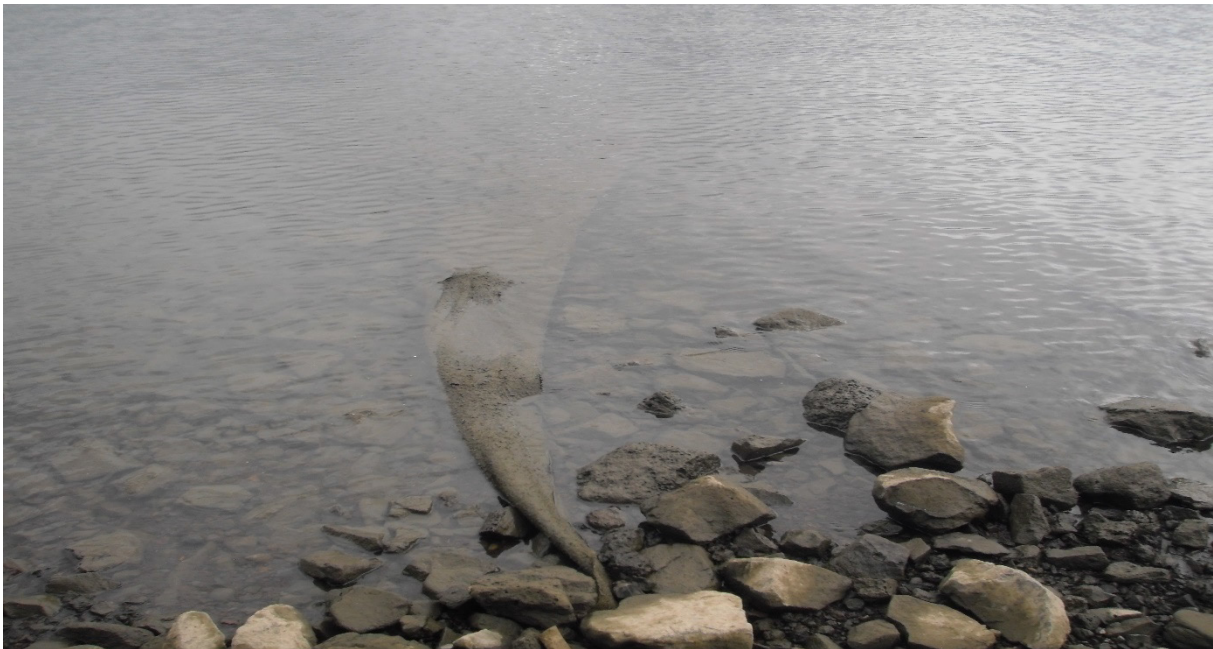
All potentially exposed organoclay mat material segments were submerged and only partially visible due to high river elevations (Photo 2). A 7-foot section at the lateral midpoint of the cap area was exposed at the water line. The visible, exposed segments of organoclay mat were in visually good condition.

**Photo 2**  
**Organoclay Mat Material at the Upriver End of the Cap Area (6/19/2023)**

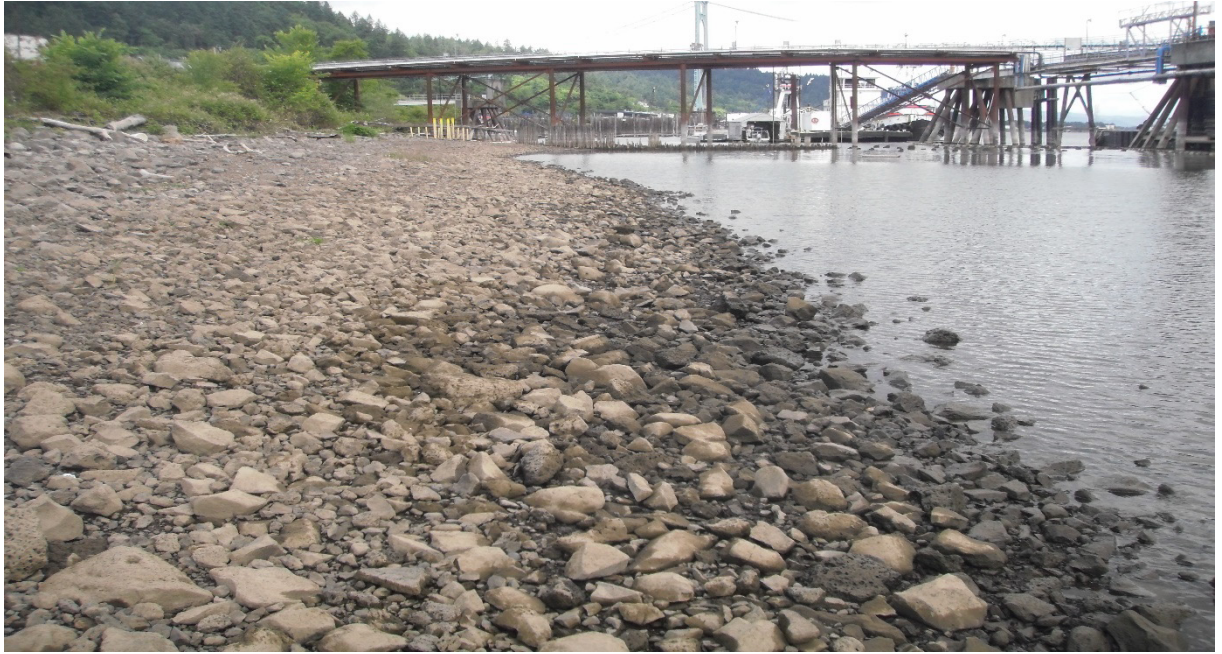
Photo 3 shows the water surface and shoreline immediately downriver of the sediment cap. No sheen was observed within the cap area.

**Photo 3**  
**Conditions Immediately Downriver of Cap Area Looking Downriver (6/19/2023)**
