Re: August 2023 Monthly Progress Report  
Administrative Settlement Agreement and Order on Consent for Removal Action  
EPA Region 10 Docket No. CERCLA 10-2009-0255  
Gasco Sediments Site Within the Portland Harbor Superfund Site

Attachment A Monthly Visual Monitoring Report for Pilot Cap Vicinity

# Visual Observations Log Form

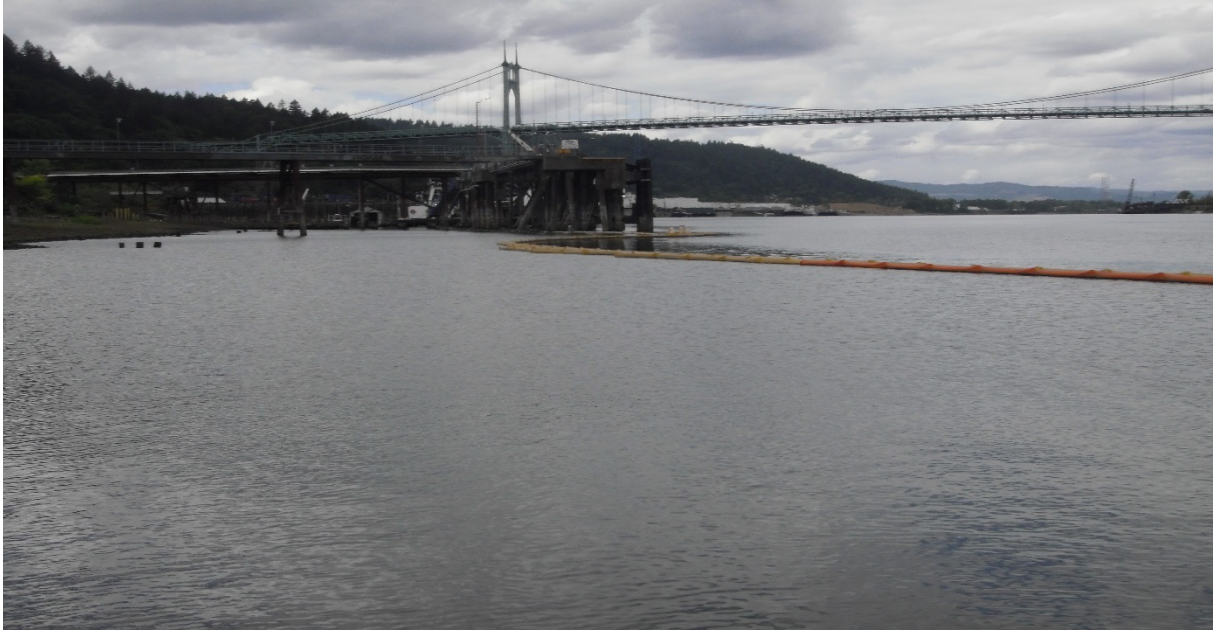
During the observation, the Centerline Logistics (Centerline) containment boom was in place from dock to dolphin. The three buoys identifying the cap area to mariners were in place as installed. The positions of the Centerline oil boom and warning buoys are shown in Photo 1.

**Photo 1**  
**Centerline Logistics Oil Boom Placement from Dock to Dolphin with Three Mariner Warning Buoys at Pilot Cap Area (8/22/2023)**

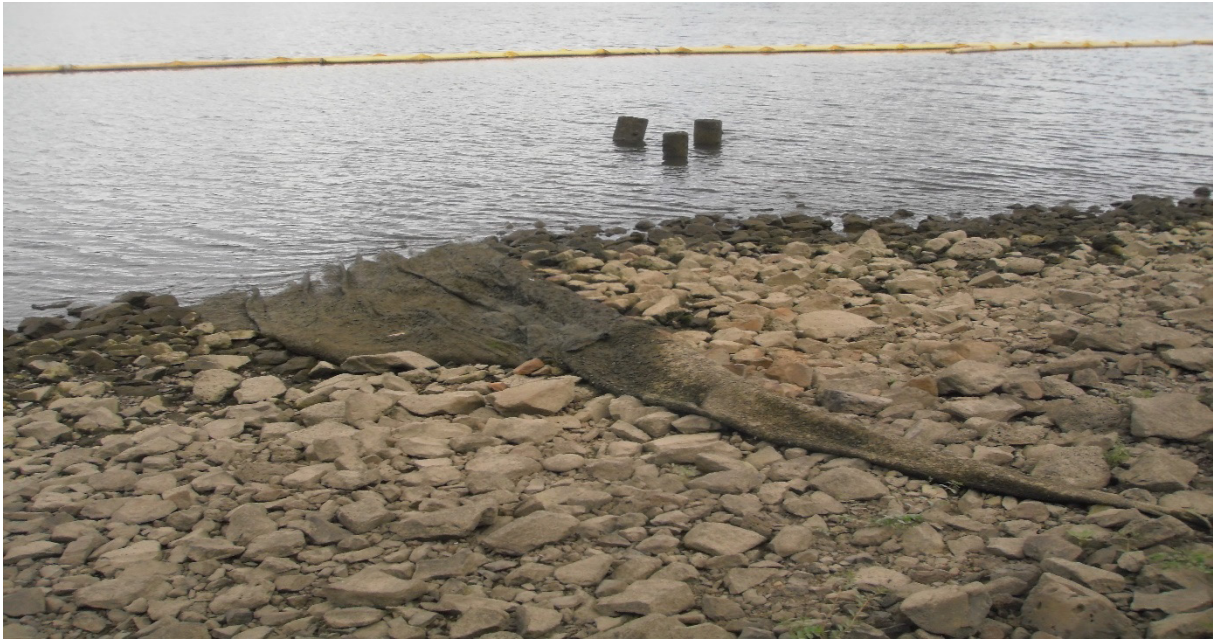
All exposed organoclay mat material segments were visible but partially submerged near the water’s edge (Photo 2). The visible, exposed segments of organoclay mat were in visually good condition.

**Photo 2**  
**Organoclay Mat Material at the Upriver Extent of the Pilot Cap Area (8/22/2023)**

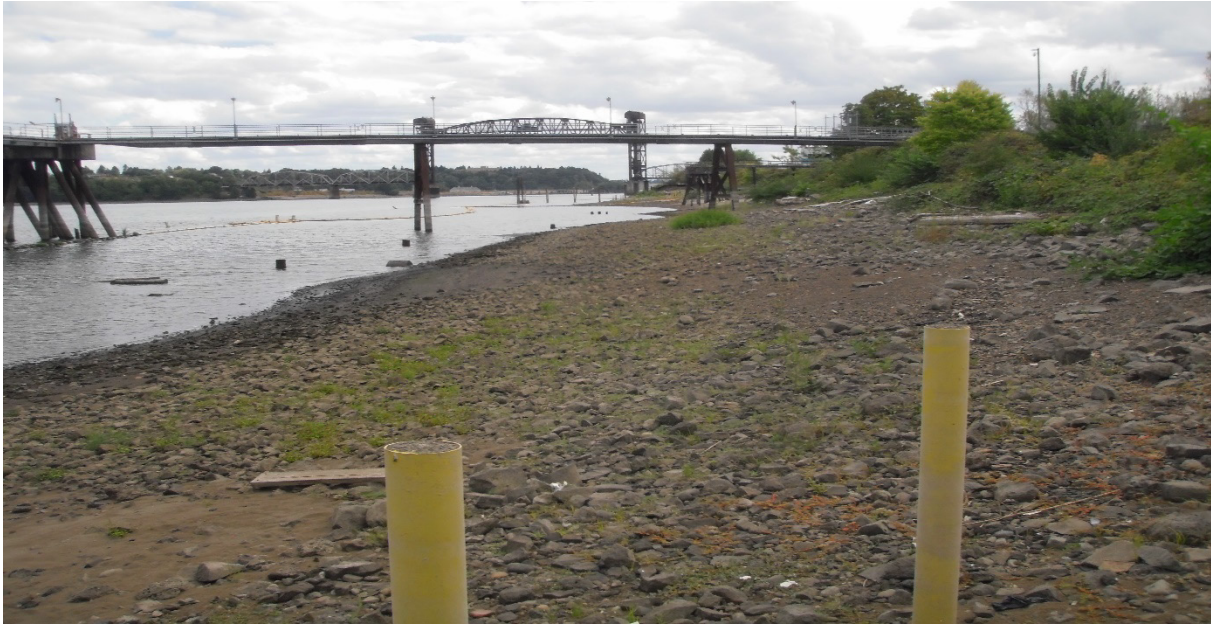
Photo 3 shows the water surface and shoreline immediately downriver of the sediment cap. No sheens were observed in the pilot cap area, in the area upriver of the of the pilot cap, or in the area down river of the pilot cap.

**Photo 3**  
**Conditions Immediately Downriver of Cap Area Looking Upriver Toward Cap Area**  
**(8/22/2023)**
