I. BCA Failed to Abide the Clear Markings of a CenturyLink Duct Bank

DAMAGE DETAIL : 900 PAIR BURIED CABLE - TELEPHONE EXCAVATION
 DATE OF DAMAGE: 08/14/13 CABLE LOCATE WAS ACCURATE
 LOCATION : NE 162ND AVE & NE18TH ST, VANCOUVER WA

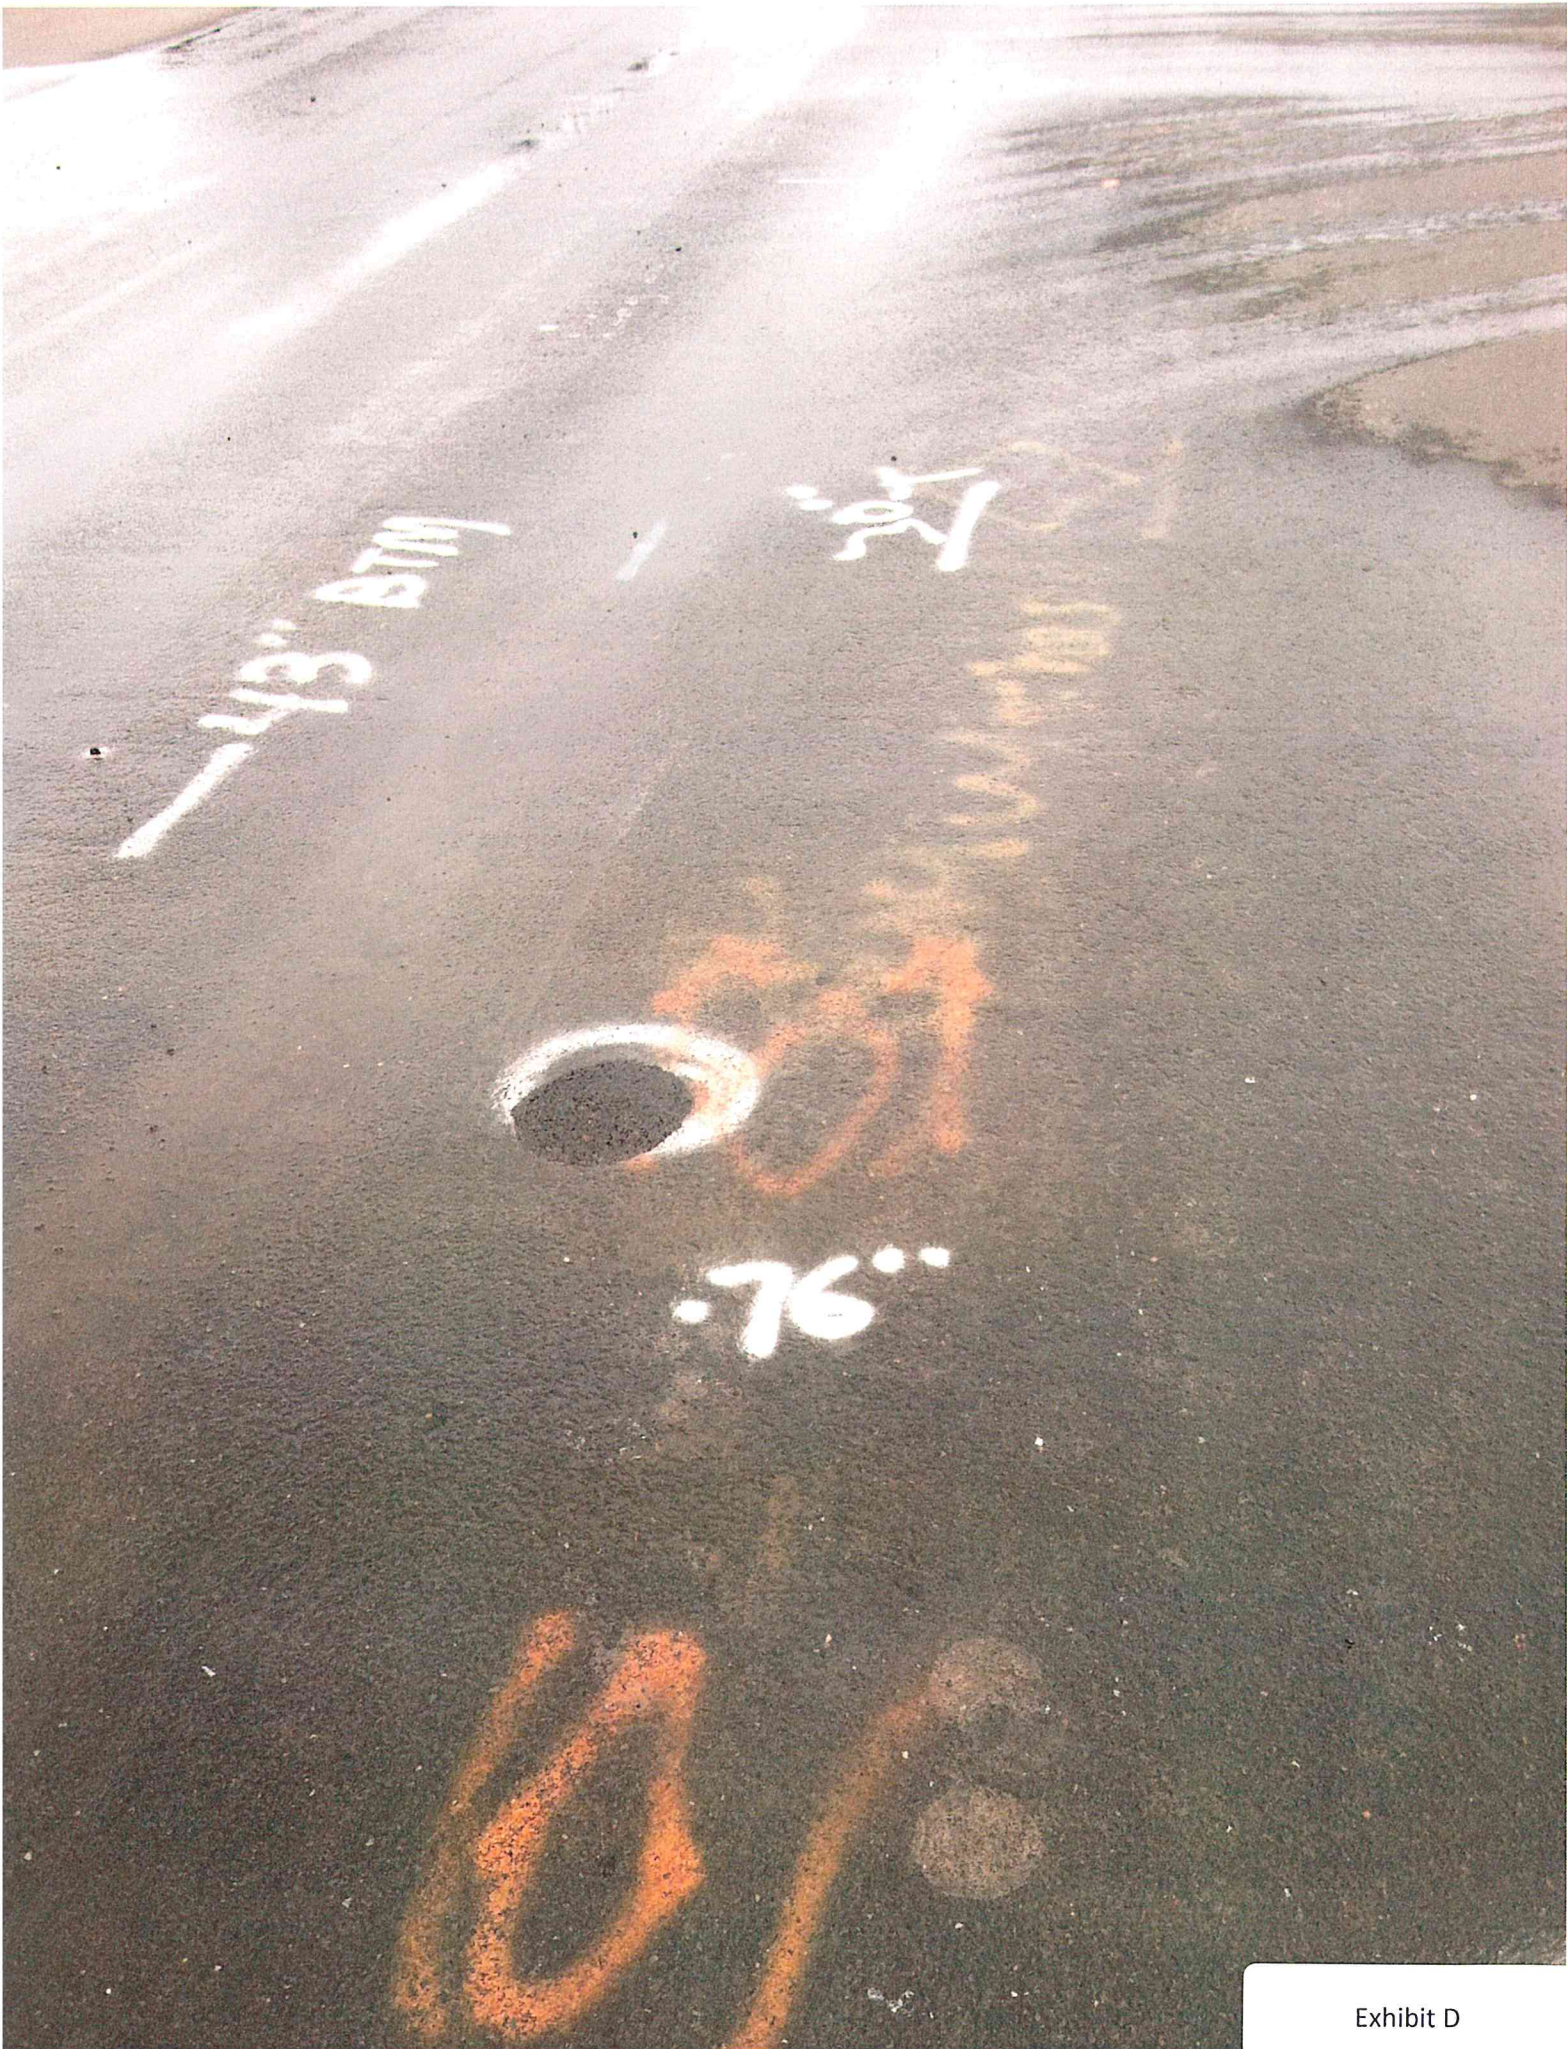
photos of the markings are attached hereto as Exhibit C and Exhibit D. BCA cut into the conduit facilities of CenturyLink, including a high capacity 900-count cable, and three conduits located atop one another at the Project Site (the “CenturyLink Facilities”). True and correct copies of photos of the conduit are attached hereto collectively as Exhibit E.

As noted above, CenturyLink’s duct bank was clearly marked as such with a diamond and two lines. Despite these markings, BCA proceeded with its work as if a single, different duct was the only duct facility in at the Project Site. This was not the case.

State law requires CenturyLink to have its facilities marked. *See* RCW 19.122.030(3)(a). The record here is that the CenturyLink duct bank was marked as a duct bank. *See* Exhibits C, D. At that point, it became incumbent upon BCA to investigate completely the marked facilities, including any conflict it encountered with the abandoned duct it found when potholing for the water line. Although the parties may differ as to the negligence of BCA, there should be no dispute that CenturyLink abided the law in having its duct bank clearly marked. CenturyLink also had available its plat maps for BCA to review. *See* Exhibit G. CenturyLink also was available for consultation. CenturyLink followed state law and the Complaint should be dismissed.
