Re: July 2023 Monthly Progress Report  
Administrative Settlement Agreement and Order on Consent for Removal Action  
EPA Region 10 Docket No. CERCLA 10-2009-0255  
Gasco Sediments Site Within the Portland Harbor Superfund Site

Attachment A Monthly Visual Monitoring Report for Pilot Cap Vicinity

# Visual Observations Log Form

**Project:** NW Natural – Gasco

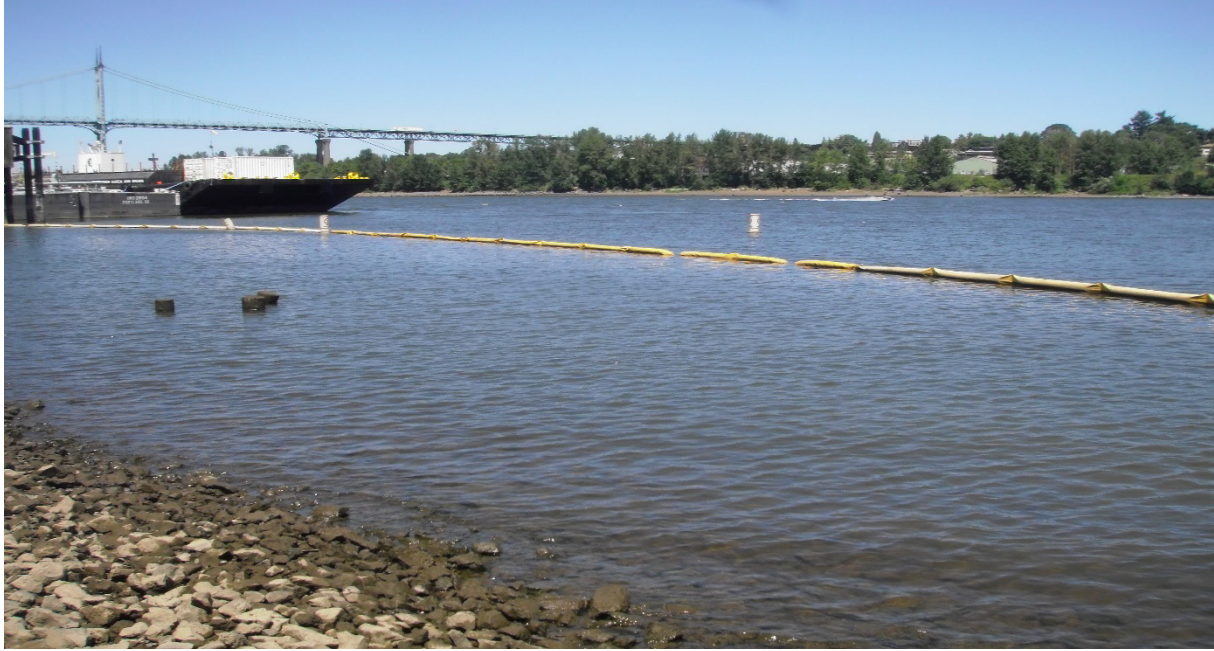
During the observation, two barges were moored at the ship dock, and the Centerline Logistics (Centerline) containment boom was in place from dock to dolphin. The three buoys identifying the cap area to mariners were in place as installed. The positions of the Centerline oil boom and warning buoys are shown in Photo 1.

**Photo 1**  
**Centerline Logistics Oil Boom Placement from Dock to Dolphin with Three Mariner Warning Buoys at Pilot Cap Area (7/18/2023)**

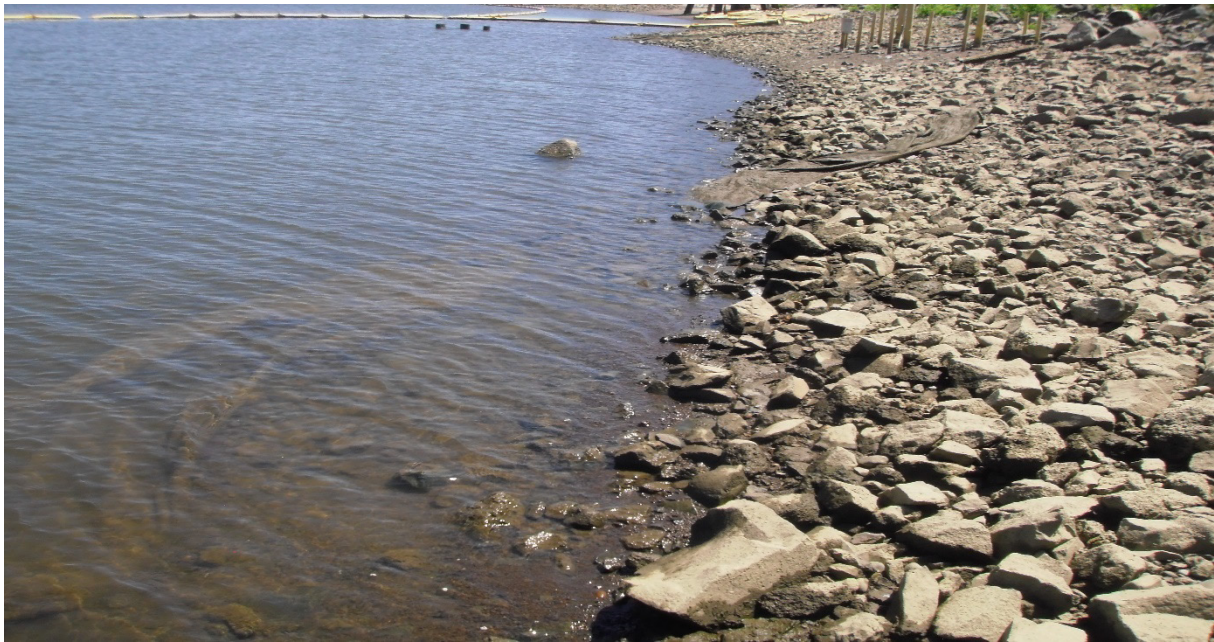
All exposed organoclay mat material segments were visible (Photo 2). The visible, exposed segments of organoclay mat were in visually good condition.

**Photo 2**  
**Organoclay Mat Material at the Downriver End of the Cap Area (7/18/2023)**

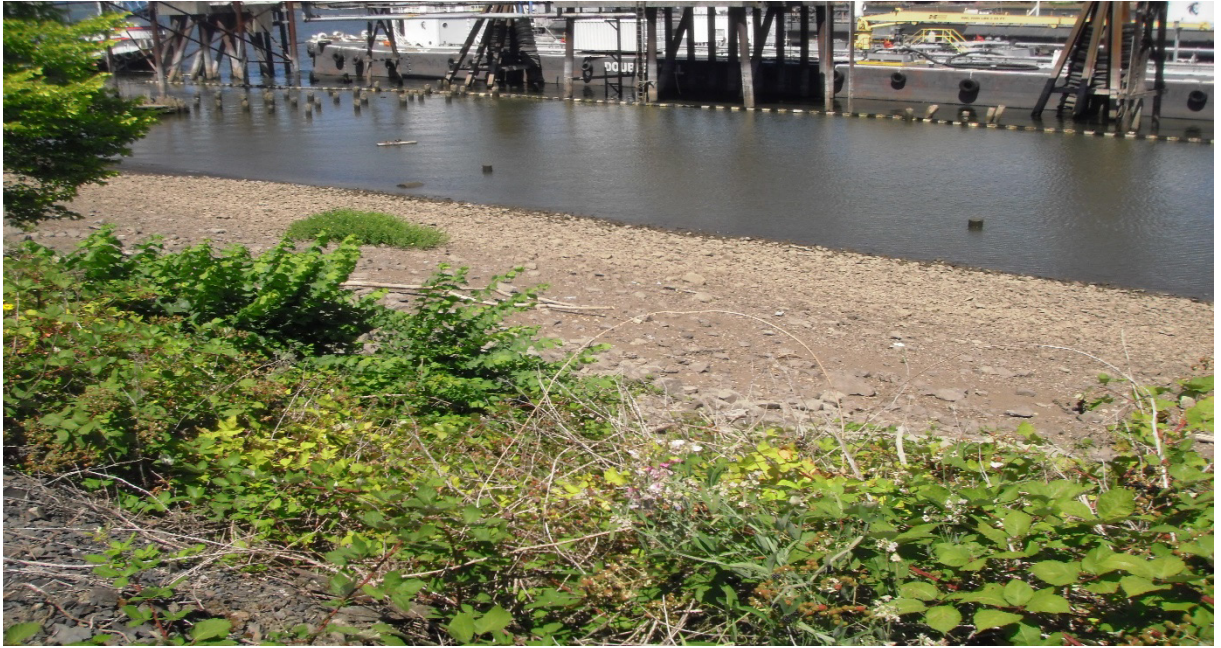
Photo 3 shows the water surface and shoreline immediately downriver of the sediment cap. No sheen was observed within the cap area.

**Photo 3**  
**Conditions Immediately Downriver of Cap Area Looking from Bank (7/18/2023)**
