DOCKET UE-152253

Union Gap Project Presentation.

Union Gap Phase II

Union Gap Substation Overview

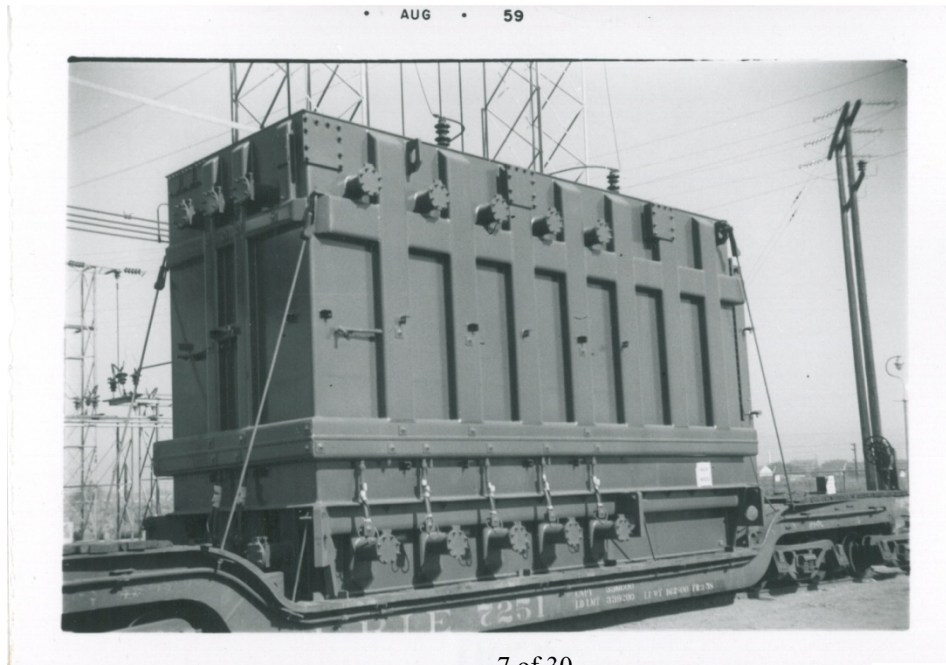
1959 – Added 230 kV Bus

- ▶ One 230-115 kV, 150 MVA transformer (T-2083) and single 230 kV line from Midway (Priest Rapids Dam).
- ▶ T-2083 was moved to Pomona Heights in 1972 when that station was constructed and is currently still in-service.

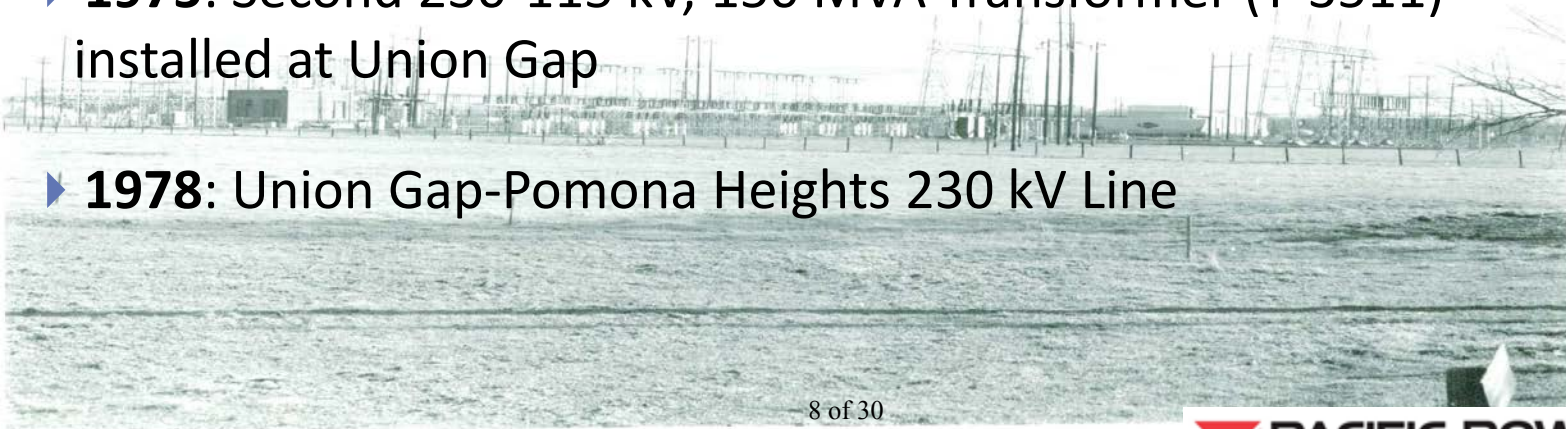
1966-1978

- ▶ **1966:** Second 230-115 kV, 150 MVA transformer (T-3194) at Union Gap
- ▶ **1972:** Pomona Heights provides second 230-115 kV source to Yakima upper valley
 - Union Gap T-2083 moved to Pomona Heights.
 - One 230-115 kV transformer at UG, one at POH.
- ▶ **1975:** Second 230-115 kV, 150 MVA Transformer (T-3511) installed at Union Gap
- ▶ **1978:** Union Gap-Pomona Heights 230 kV Line

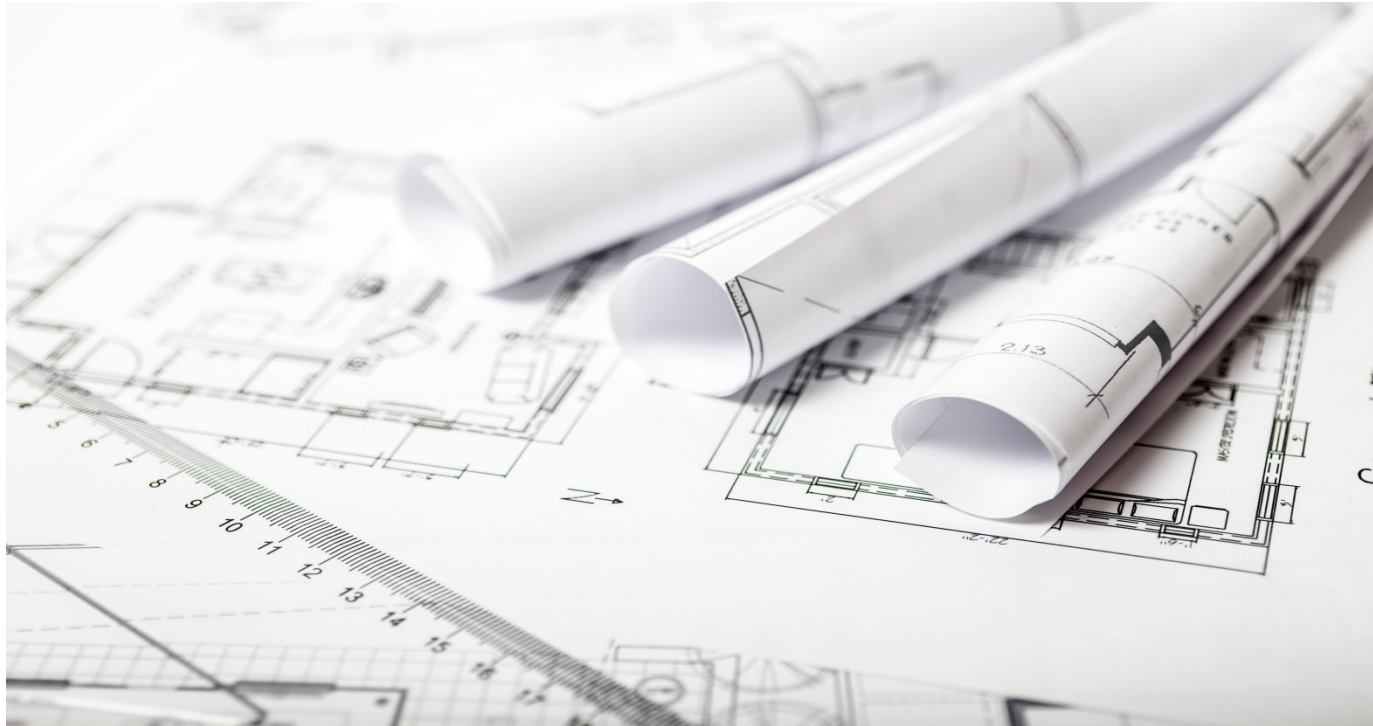
Further Details of the Union Gap Project

Project Overview – Phase I

- Phase I – Distribution Upgrades – Placed in Service in 2014
 - Relocate existing 12.47 kV distribution circuits
 - Construct 115-12.47 kV positions
 - Eliminate T-600/T-666, the original 115-69-12.47 kV transformers from circa 1931
 - Re-route 230 kV and 115 kV transmission lines
 - Construction November 2013 – August 2014

Project Overview – Phase II

- Phase II – 230kV Switchyard – To be Placed in Service 2016
 - New control house
 - Construct new 230 kV bus
 - Install new 230-115 kV, 250 MVA transformer
 - Construction July 2015 – March 2016

Project Overview – Phase III

- Phase III – 115kV Necessary Upgrades – To be Placed in Service 2017
 - Move existing 230-115 kV transformers
 - New 115 kV bus (position-by-position)
 - Construction April 2016 – May 2017
